# Vehicle Handover and Condition Record

| Project | Nidd Valley Grounds, Harrogate: van V-117 return |

| Vehicle registration and fleet reference | Fleet number V-117, registration on fleet register FR-2026 |
| Make and model | Medium panel van, diesel |

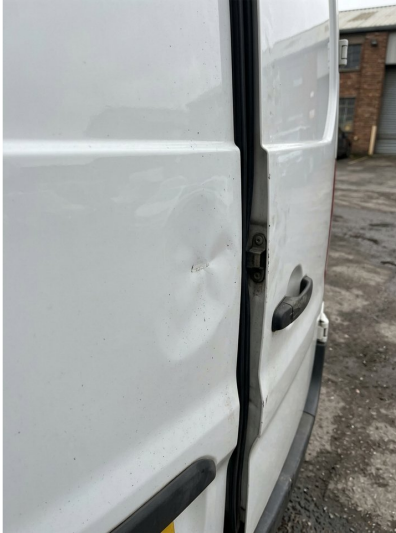
Condition observation 1: Nearside rear door

| Area or component | Nearside rear door |
| Observed condition or damage | Dent about 60 mm across at waist height, paint not broken. Not on the issue record. |

| Observation agreed? | Disputed |
| Comments or disagreement | Driver says the dent was there at issue and was missed on the check in March. |

| Further action 1: Check the March issue photos for the nearside rear door to settle the disputed dent. | |
| Outstanding limitations and information to pass on | Rear door dent disputed until the March issue photos are checked. |
