# Void Property Inspection

| Project | 27 Larch Close: void inspection (completed example) |
| Site address | 27 Larch Close, Wakefield |
| Inspection date | 14 Oct 2026 |

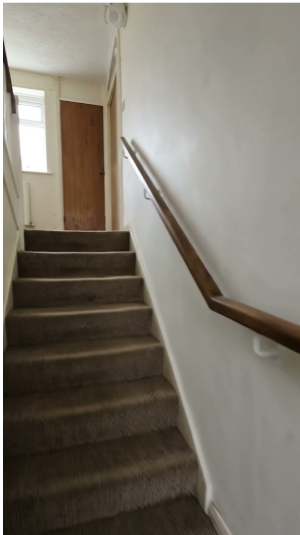
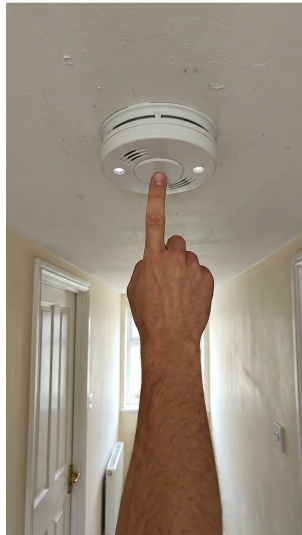
#### Rooms 1: Hall, stairs and landing

| Details | Stair carpet worn but sound, handrail secure. Hall and landing smoke alarms tested and working. |

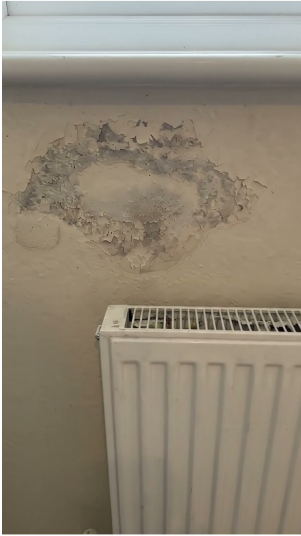
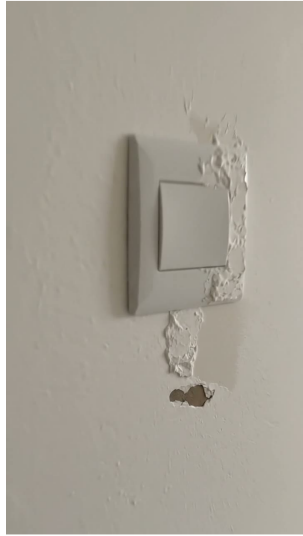
#### Rooms 2: Living room

| Details | Old damp patch above the radiator, dry to the touch, paint flaking. Plaster broken out round the light switch. Make good and redecorate. |

| Work needed | Mould wash and stain block the bathroom ceiling and bedroom 2. Redecorate bathroom, bedroom 2 and living room. |

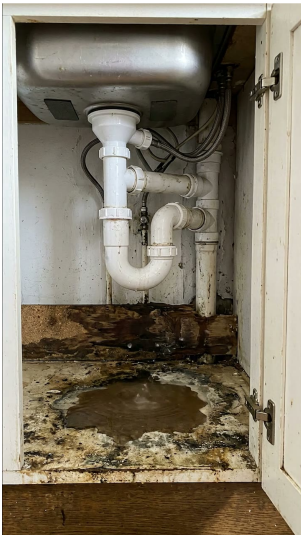
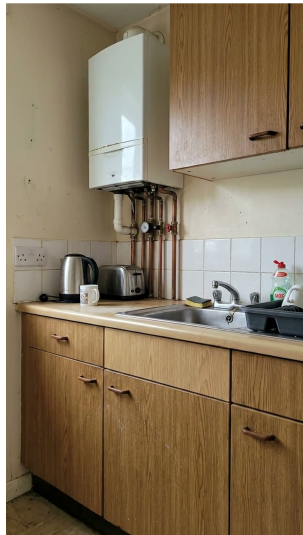
## Rooms 3: Kitchen

| Details | Sink trap leaking, base of the sink cupboard soaked and breaking up. Units fair otherwise. Combi boiler on the wall, no CO alarm in the room. |

| Work needed | Replace the bathroom extractor with a humidistat fan. Fit a CO alarm in the kitchen by the boiler. |

| Work needed | Replace the leaking sink trap, regrout and reseal the bath. |

| Work needed | Replace the rotten base panel in the sink cupboard. |

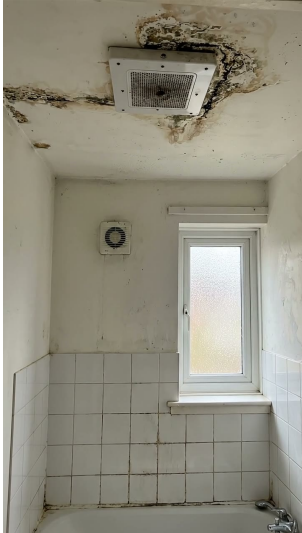
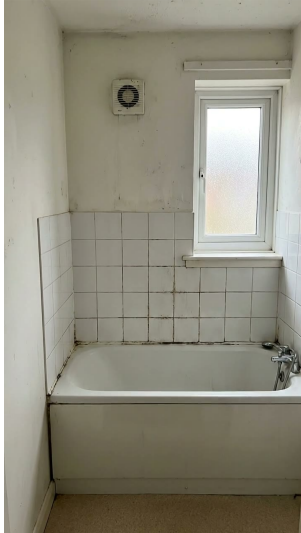
## Rooms 4: Bathroom

Black mould round the ceiling extractor and along the bath grout. Extractor fan not running. Fan to be replaced before the mould treatment.

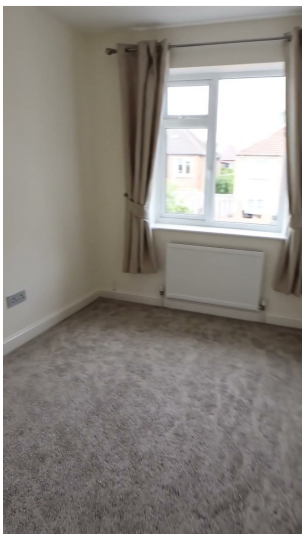
**Rooms 5: Bedroom 1 (front)****Room**

Carpet, curtains and radiator in good order. Light clean only.

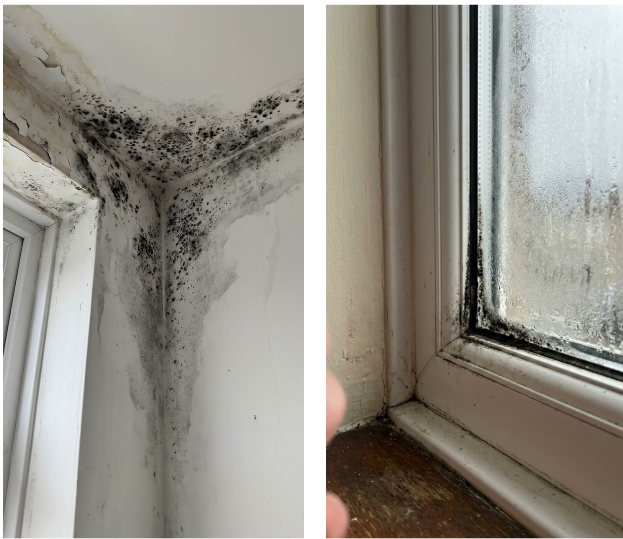
**Rooms 6: Bedroom 2 (back)**

| Details | Heavy black mould in the corner by the window, sealed unit misted with mould on the frame. Wardrobe and bags left behind. Likely condensation, cause to be confirmed. |

| Work needed | Full void clean throughout, clear the wardrobe and bags from bedroom 2. |

| Work needed | Replace the misted double glazed unit in the bedroom 2 window. |

| What needs doing? | Damp and mould team to visit, take readings and confirm the cause in the bathroom and bedroom 2. |
