## SITE SURVEY REPORT

# Water Leak Investigation

| Site | Kingsway House, Swindon |

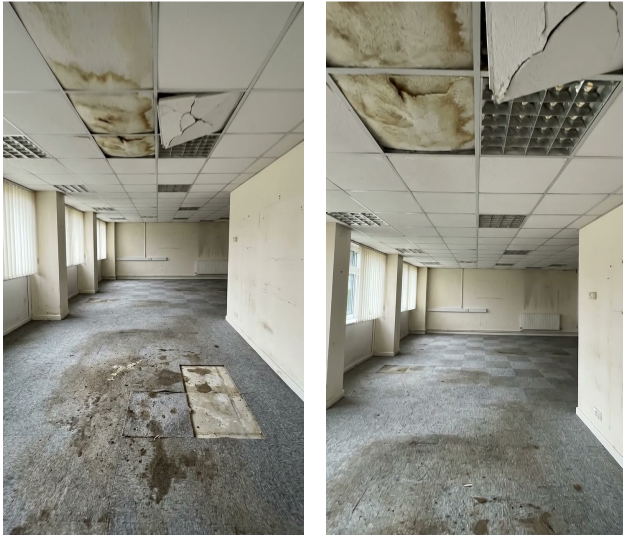
Observation or test 1: Office 1.04 ceiling below the second-floor tea point, 29/09/2026 09:10

Three tiles stained, one cracked and hanging. Soffit damp directly under the tea point, dry 1 m either side. Carpet tiles wet below. Photos WL-01 and WL-02.

| Further specialist tests or repair recommendation | Plumber to remake or replace the trap and check the waste where it passes through the floor. Recheck the ceiling for fresh water after a week of normal use before new tiles go in. |

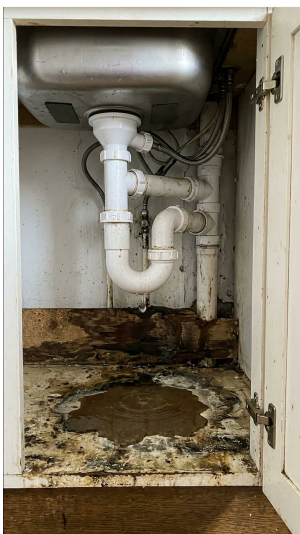
Second-floor tea point, sink base unit, 29/09/2026 10:05

Water dripping from the trap joint while the sink drained. Cupboard base soaked, stained and pooling. Photo WL-03.

| Possible source and reasoning | Most likely source is the leaking trap at the second-floor tea point. Water has soaked the cupboard base and run down the floor penetration for the waste pipe onto the first-floor ceiling. The staining follows tea point use, not rainfall. |

**Further action 1: Replace the sink trap and test the waste run at the tea point. Job BPM-4475.**

| Completion evidence | New trap fitted 1 October. No drips after 10 minutes of running water. Photo on job BPM-4475. |
