# Wi-Fi Site Survey

| Project | Old Mill Studios, Halifax: Wi-Fi survey |
| Site | Old Mill Studios, ground and first floor offices |
| Date of survey | 25 Sep 2026 |

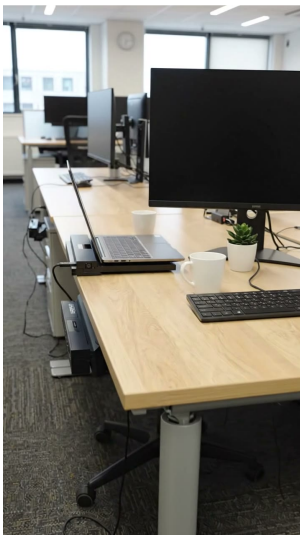
### Areas measured 1: First floor open plan

| Strongest signal (dBm) | -74 |
| Signal to noise ratio (dB) | 18 |
| Result against the target | Does not meet the target |
| Notes | One access point at the stair end covers the whole floor. Signal falls away past the second row of desks. |

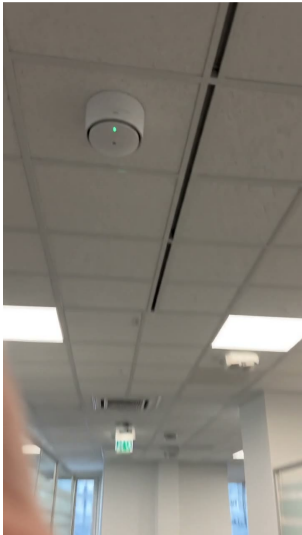
### Access point positions 1: AP-1

| Location | First floor corridor, existing position by the stair |

| Cable route back to the cabinet | Existing cable. Swap the access point only. |
