# Work Equipment Inspection

| Project | Unit 9, Larkfield Distribution Park, Swindon: monthly racking inspection (completed example) |
| Equipment | Pallet racking |

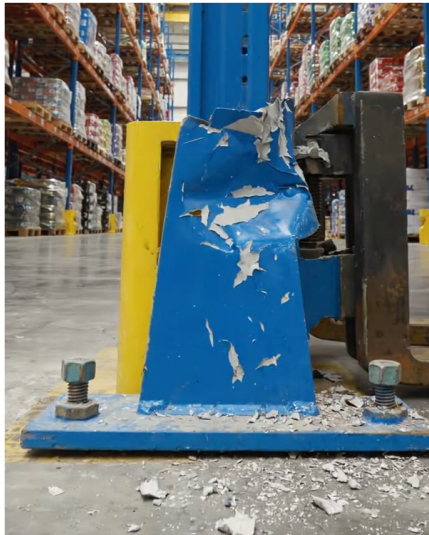
**Damage 1: Aisle 4, bay 12, front upright at floor level**

| What is the damage? | Upright crushed and torn at the base, about 300 mm above the floor. Looks like a forklift strike. |
| Risk category | Red: offload now |

Red. Offload the affected racking immediately and keep it out of use until it has been repaired.

Racking contractor, booked through J. Mensah, by 2 October 2026

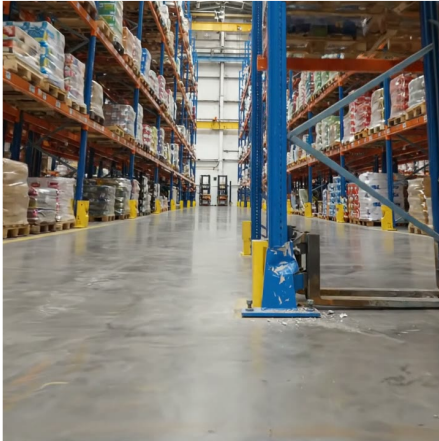
| Describe each defect and where it is | Aisle 4 bay 12: front upright crushed and torn at the base (red). Aisle 6 bay 3: column guard dented but still protecting the upright (green). |

| Further action needed | Replace the aisle 4 bay 12 upright and inspect the bay before it is reloaded. Check the aisle 6 bay 3 column guard again next month. |
