# Work Order and Service Report

| Site | Flat 2, 18 Larchfield Road, Leeds |

| Project | Flat 2, 18 Larchfield Road, Leeds: sink waste repair |
| Job or work order reference | EF-WO-48817 |

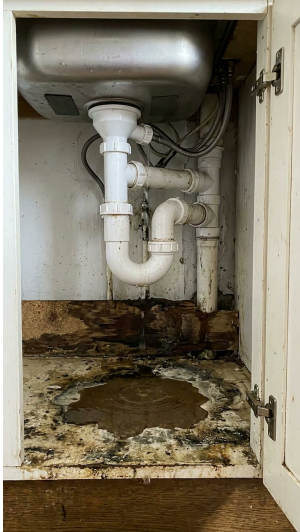
#### Before photos

Trap nut cracked and the waste joint at the wall loose. Cupboard base chipboard swollen and soft.

Removed the old trap and waste. Fitted a new trap and waste pipe to the wall connection. Cut out the swollen cupboard base and fitted a new moisture resistant board.

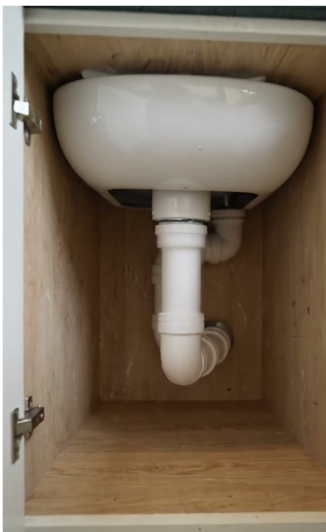
#### After photos

| Readings and results | Filled the sink and let it drain three times. Dry paper under the joints, no drips after 20 minutes. |
