## SITE SURVEY REPORT

# Building Survey

| Site | 12 Albion Terrace |

| Report reference | BS-2026-0187 (sample) |

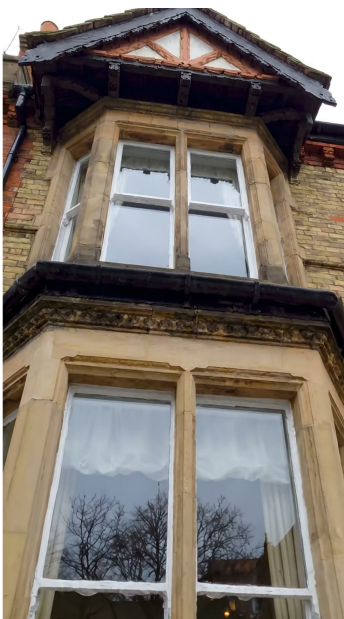
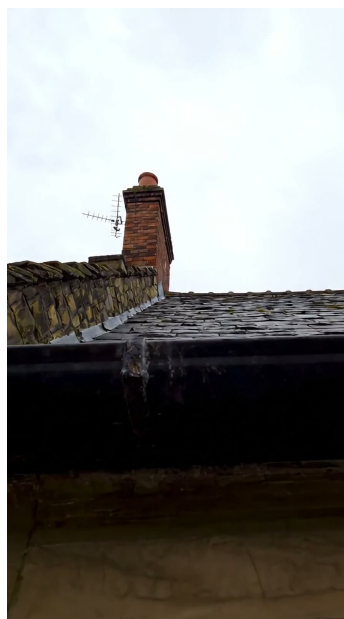
##### 1. External

Front elevation. Brickwork fair, gutter sagging above the bay. Pointing weathered at high level. Stone bay on two floors with timber sash windows. Slate roof and brick chimney stack viewed from the pavement with binoculars. Lead flashing at the party wall looks intact from here.

| D3 Rainwater pipes and gutters (2) | Gutter above the bay sags between brackets and will hold water. Staining on the stone below it. Refix to the correct fall and check the joints. Within 12 months |
| D4 Main walls (2) | Solid brickwork in fair condition. No cracking or bulging seen. Pointing is weathered at high level under the eaves. Repoint at high level in a mortar that suits the old brickwork. Within 12 months |

| <b>Repair 4, within 12 months</b> | Refix the gutter above the bay. Guide cost £350 |

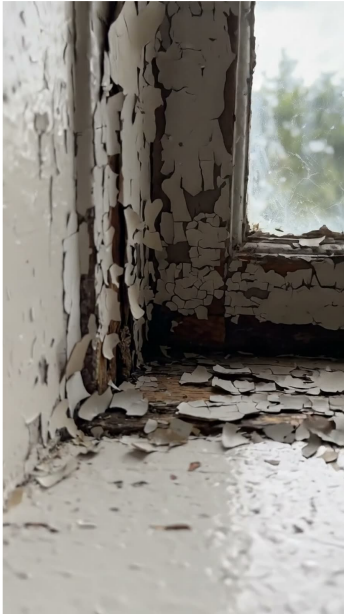
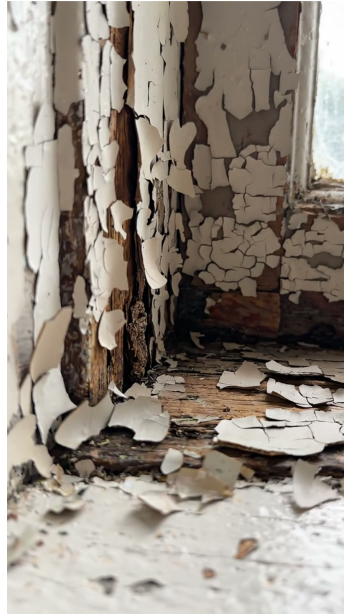
## 2. Windows

Original sashes. Paint failing, rot starting in the bottom rail. First floor front, left hand window. Paint has flaked back to bare timber on the frame and the sill. Timber is soft under the probe at the corner where the bottom rail meets the sill. Glass is intact.

| D5 Windows (2) | Original single glazed timber sashes. Paint has failed on the first floor front windows and rot has started in the bottom rail and sill of the left hand window. Cut out and splice in new timber, ease the two sashes that are painted shut, and redecorate all windows. Within 12 months |

| If the window repair is left | Bare timber will keep taking in water, the rot will spread into the frame and the repair will become a replacement |

| <b>Repair 2, within 12 months</b> | Splice repair and redecorate the sash windows. Guide cost £2,400 |

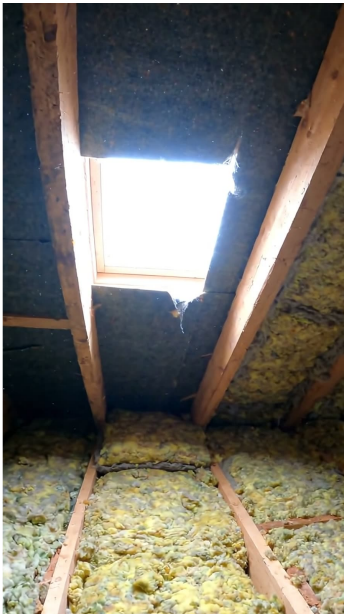
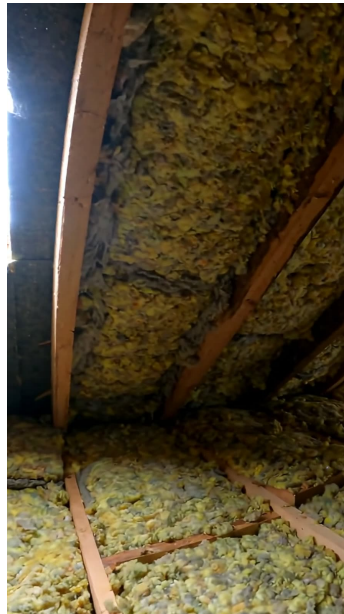
## 3. Roof space

Loft insulation 100 mil. Daylight through the felt by the chimney. The felt is torn at that point. Mineral wool between the ceiling joists, and more pushed between the rafters on one slope. Rafters are straight and dry to the touch, no staining seen on the timbers I can reach.

| D2 Roof coverings (3) | Natural slate, likely original, with moss on the slope. No slipped slates seen from the ground. Daylight is visible from inside the roof space beside the chimney, so there is a gap in the covering or the flashing at that point. Water can get in here. Investigate and repair urgently |

| E1 Roof structure (1) | Cut timber rafters and purlins. No sagging, splitting or staining seen on the timbers within reach. The felt under the slates is torn beside the chimney. See D2 |
| Loft insulation | Mineral wool, 100 mm deep between the joists. The recommended depth is 270 mm, so a top up of 170 mm is advised |
| Insulation between the rafters | Mineral wool has also been pushed between the rafters on one slope. Ask a roofing contractor to check that the roof space is still ventilated when the roof repair is done |

| <b>Repair 1, urgent</b> | Repair the roof covering and flashing at the chimney and patch the felt. Guide cost £900 |
| <b>Improvement</b> | Top up the loft insulation by 170 mm. Guide cost £600 |
