## SITE SURVEY REPORT

# Site Inspection: Level 2 Fit-out

| Site | Northgate Offices, Level 2 |

| Project | Northgate Offices, Level 2 office fit-out |

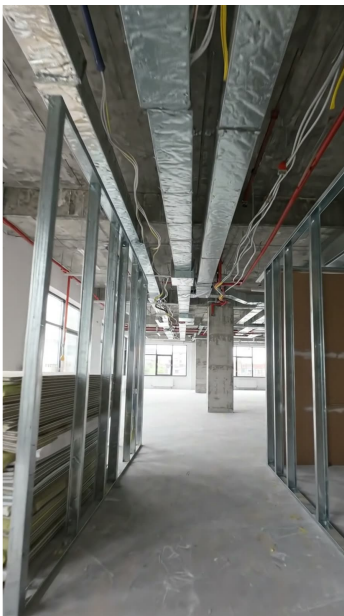
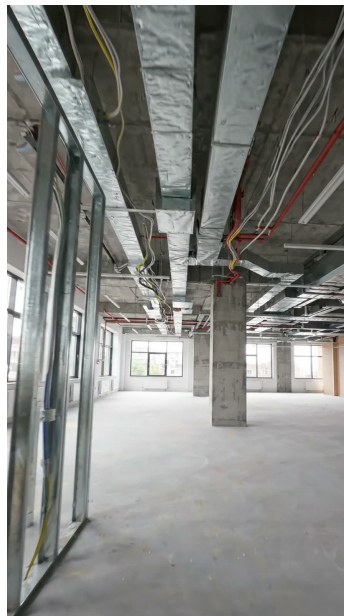
##### 1. Progress

Level 2 fit-out. Partitions up, ceilings open. On programme. Services first fix due to finish this week. Metal stud framing is complete along the corridor, boarded one side on the right. Ductwork and sprinkler pipework are in at high level. Plasterboard is stacked on the left, clear of the walkway.

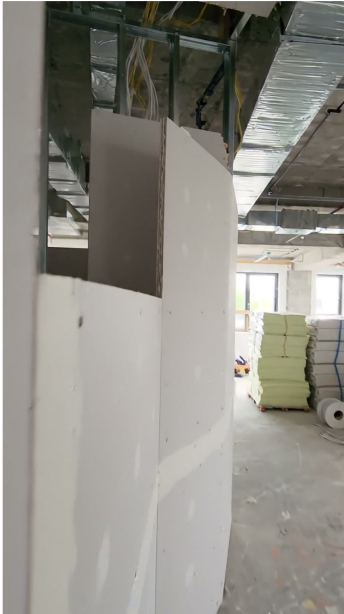
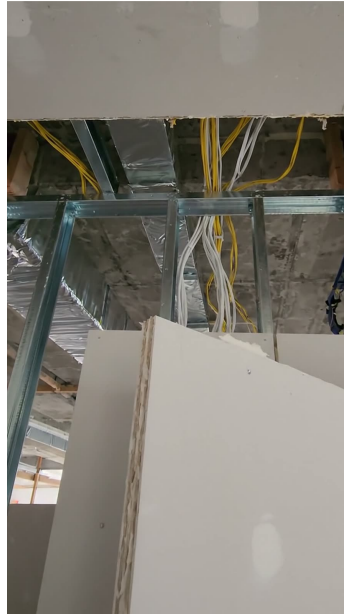
## 2. Partitions

Partition head not sealed to the slab by meeting room 4. Drylining to finish. Boards stop short of the soffit and the framing above is open. Cables and ductwork pass through the opening. Nothing to be closed up here until the head is boarded and sealed and I have seen it.

| <b>Finding F-03 (new)</b> | Partition head not sealed to the slab by meeting room 4. Boards stop short of the soffit |
| <b>Type</b> | Incomplete work |
| <b>When it needs to be put right</b> | Before it is covered up. The ceiling here stays open until the head is boarded, sealed and inspected |

| <b>Action</b> | Board and seal the head as shown on the partition drawings, with services openings sealed as detailed |
| <b>Action owner</b> | Drylining contractor |
| <b>Due</b> | Thu 1 Oct 2026, to be inspected on Fri 2 Oct 2026 |

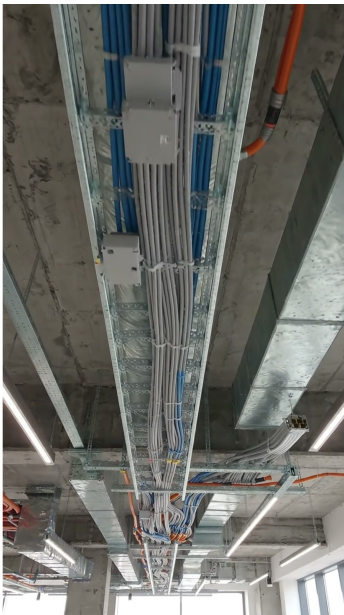
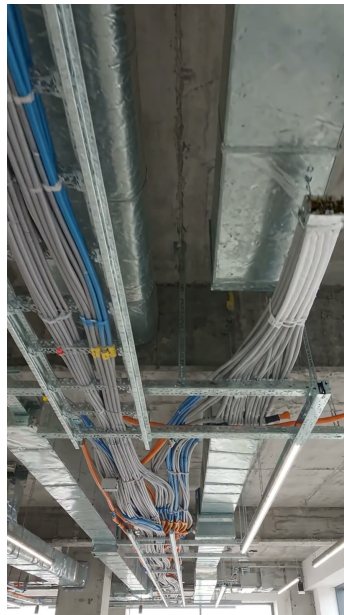
## 3. Services

Containment in, cabling pulled to zone B. Zone C still to do. Cable tray and basket are fixed and level, cables are dressed and tied. Ductwork is in alongside. Light fittings are hung in this bay.
