## SITE SURVEY REPORT

# Basement and Cellar Inspection

| Site | 22 Albion Terrace, Bath |

| Project | 22 Albion Terrace, Bath: cellar condition inspection (completed example) |

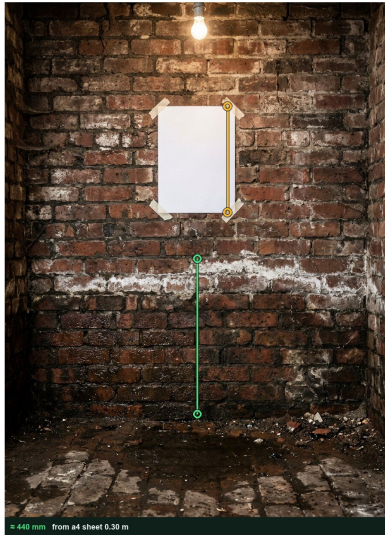
Highest damp or tide mark above the floor (mm): measuring photo

| Walls | Tide mark or salt deposits |
| Highest damp or tide mark above the floor (mm) | 440 |

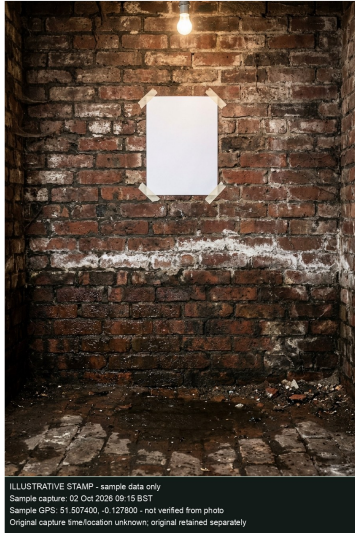
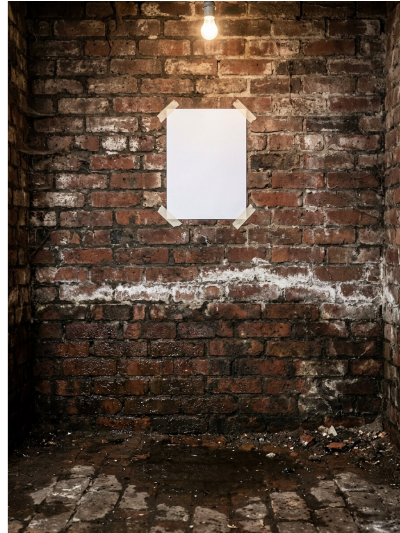
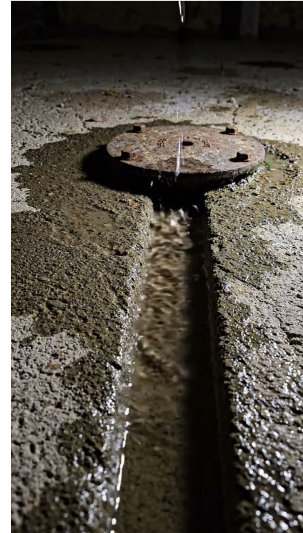
## Areas 1: Front vault

| Floor | Standing water |
| Depth of standing water (mm) | 20 |
| Where water appears to get in | Up through the floor, Wall and floor junction |
| Ventilation | Poor or none |

Likely cause Groundwater (rising water table)

Water is coming up through the front vault floor and at the wall and floor junction after weeks of heavy rain, with no sign of a leaking pipe, which fits groundwater. The drainage channel and sump are silted. Boxes stored on the floor are at risk.

Recommendation Specialist waterproofing survey

Move stored boxes off the floor onto shelving above the tide mark

Clear the silt from the drainage channel and sump

Get a survey from a structural waterproofing specialist before any cellar conversion

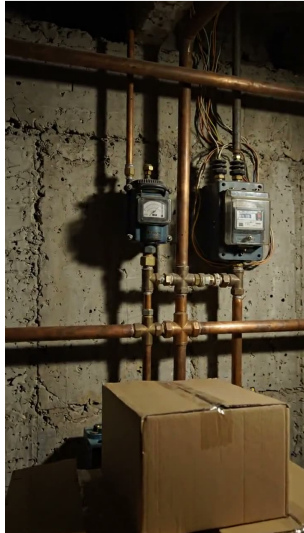
## Areas 2: Rear cellar (meters)

| Room, vault or area | Rear cellar (meters) |
|---|---|
| Walls | Damp patches |
| Highest damp or tide mark above the floor (mm) | 200 |
| Floor | Damp or stained |
| Where water appears to get in | Wall and floor junction |
| Mould growth? | Yes |
| Moisture readings (meter, units and where taken) | Stair stringer timber 16% on a pin meter at the bottom tread |
