# Crack Monitoring Record

| Project | 22 Larch Close, Ipswich: crack monitoring (completed example) |
| Reading date | 8 Oct 2026 |

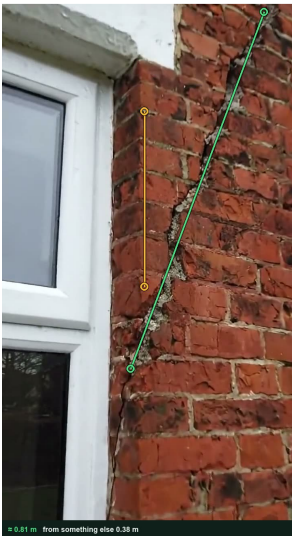
Length of the crack (m): measuring photo

| Length of the crack (m) | 0.81 |

Monitor T1, reading recorded on the sheet as 4 mm horizontal

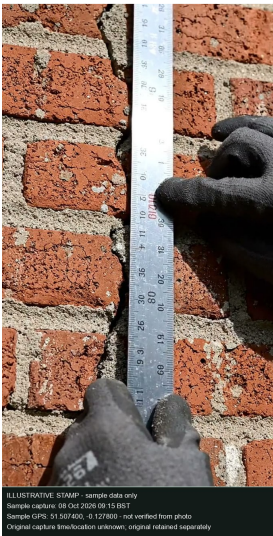
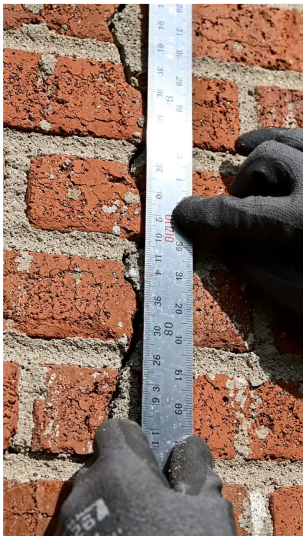
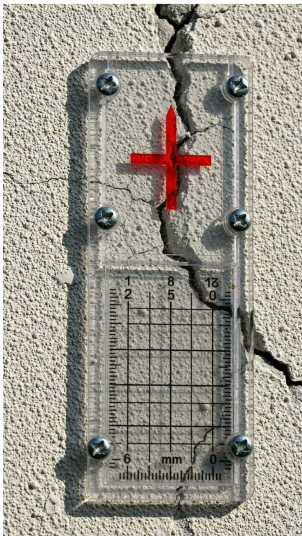
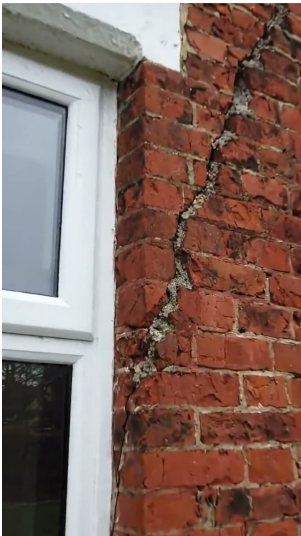
Photos (with a ruler or gauge in view)

| Location | Side elevation, from the kitchen window corner |
| Pattern | Stepped through the joints |
| Width along the crack | Wider at the top |
| Width at the marked point (mm) | 4 |
| Previous width at the same point (mm) | 3 |
| Change since the previous reading (mm) | 1 |
| Wider than the previous reading at the same point. BRE says widening over time can change the damage category. | |

Category 0, 1 or 2 (aesthetic)

**Further actions 1: Ask the drainage contractor to run a CCTV survey of the side drain run near C1.**

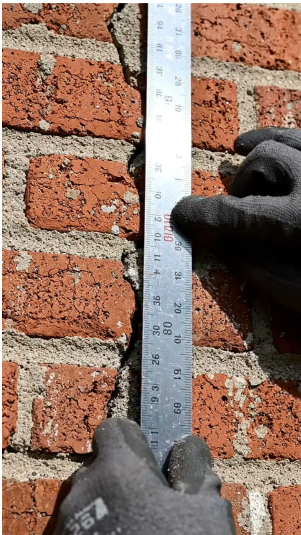
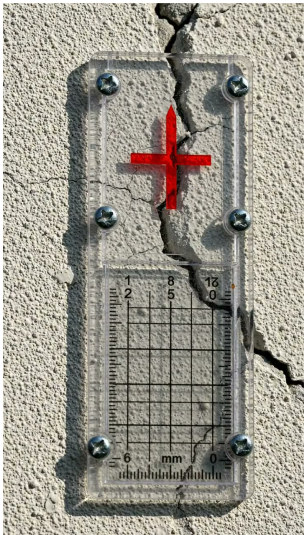
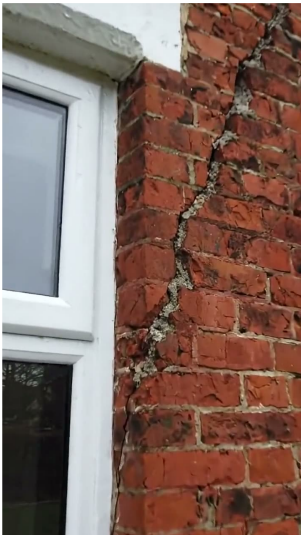
Crack width readings · Row 1 · Photos for this reading

| Reading date and time | Crack width at marked point (mm) | Previous width at same point (mm) | Change since previous reading (mm) | Measurement method | Notes / action taken |
|---|---|---|---|---|---|
| 08/10/2026 09:15 | 4 | 3 | 1 | Tell-tale monitor | Fictional width entry at the same marked point. Change +1 mm; this is not an assessment of structural significance. Photo evidence is from the original example record. |

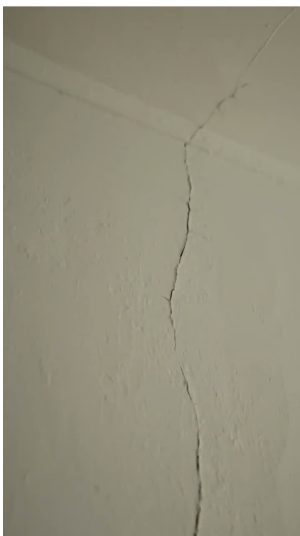
Photos (with a ruler or gauge in view)

| Location | Kitchen, above the door to the hall |

| Pattern | From the corner of an opening |
| Width at the marked point (mm) | 1 |
| Doors or windows nearby sticking? | Yes |
| Damage category (BRE Digest 251), if assessed | Category 0, 1 or 2 (aesthetic) |

**Further actions 2: Ease the kitchen door so it closes properly.**

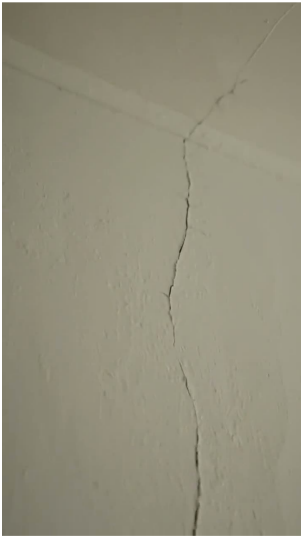
Crack width readings · Row 1 · Photos for this reading

| Reading date and time | Crack width at marked point (mm) | Previous width at same point (mm) | Change since previous reading (mm) | Measurement method | Notes / action taken |
|---|---|---|---|---|---|
| 08/10/2026 09:15 | 1 | 1 | 0 | Crack width gauge | Fictional worked example, transcribed from this record above. No additional test is implied. Photo evidence retained from the original example record. |
