# Culvert and Trash Screen Inspection

| Project | Millbrook Country Park: Mill Lane culvert inspection (completed example) |
| Inspection date | 2 Oct 2026 |
| Watercourse and culvert reference | Mill Beck, culvert CU-02 under Mill Lane |

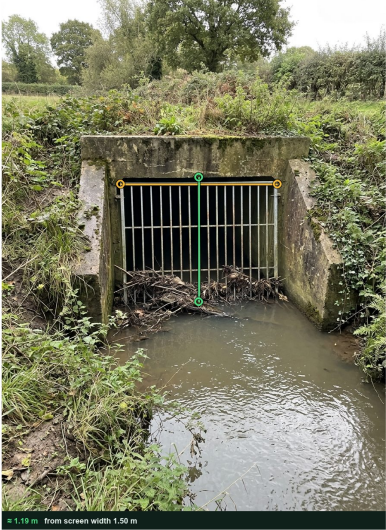
| Gap from the water to the top of the opening (m): measuring photo | |

| Gap from the water to the top of the opening (m) | 1.19 |
| Opening above the water (%) | 79 |

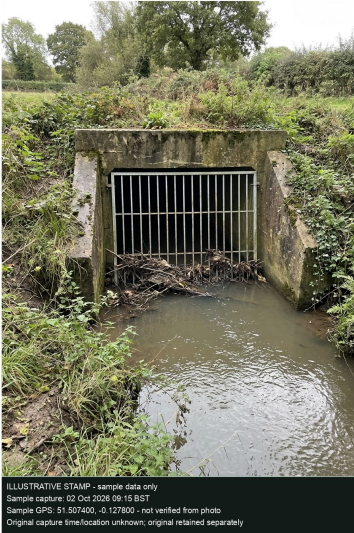
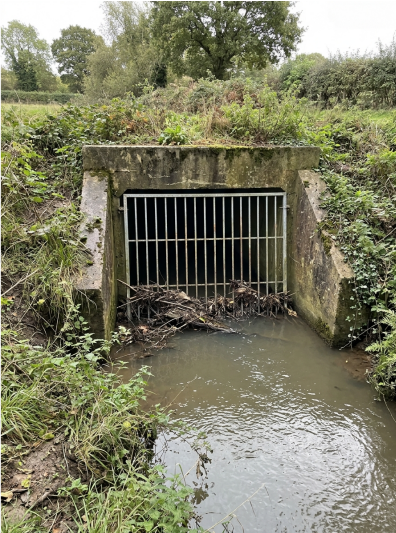
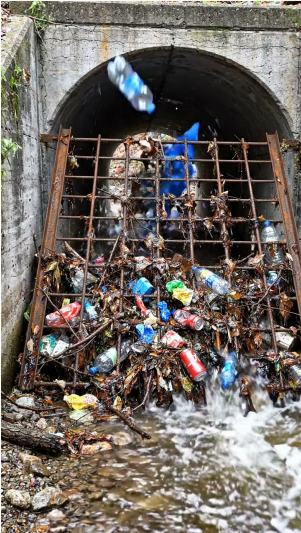
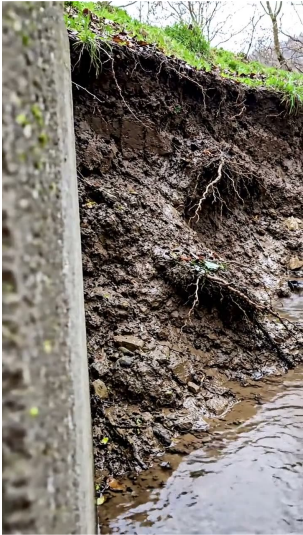
Photos (from the bank)

| What is wrong? | Branches, leaves and plastic caught across the lower third of the screen. |
| Share of the screen blocked (%) | 35 |
| Against the clearance trigger | Over the trigger |
| What is wrong? | Vertical crack in the concrete headwall, left of the screen. |
| What is wrong? | Bank eroded beside the left wing wall. |

| How it was cleared, and where the debris went | Raked from the screen platform by two staff under the parks safe system of work, bagged and taken to the depot. |

#### Further actions 1: Structural check of the headwall crack and the eroded bank.

#### Further actions 2: Re-inspect the screen after the forecast heavy rain.
