# Fence and Boundary Inspection

| Date | 29 Sep 2026 |
| Site | Ashby Lane Depot |

| Project | Ashby Lane Depot: boundary fence inspection (completed example) |

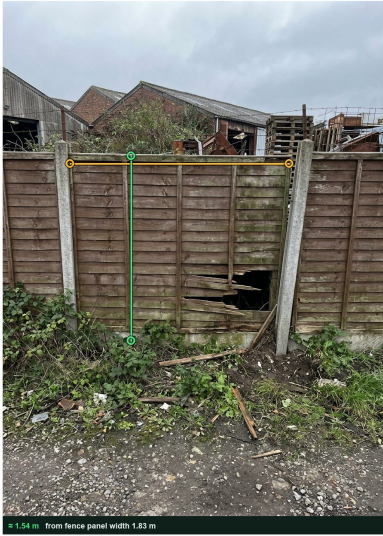
Height (m): measuring photo

| Height (m) | 1.54 |

| Against the height needed | Lower than needed |
| What is wrong? | Post 14 leaning after the storm, panel beside it broken with a gap at ground level. Panels about 1.54 m high, measured from a photo. |

| How the breach was made safe | Two temporary mesh panels clipped across the gap and the post propped. |

| What needs doing? | Replace post 14 and the broken panel, then remove the temporary mesh. |

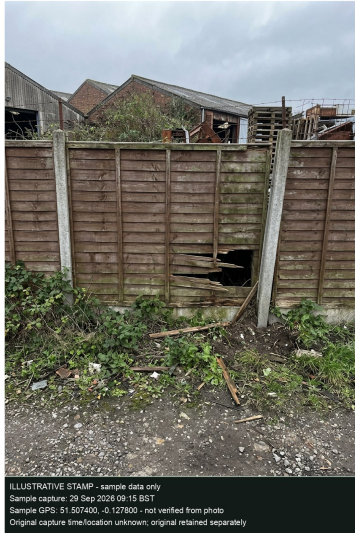
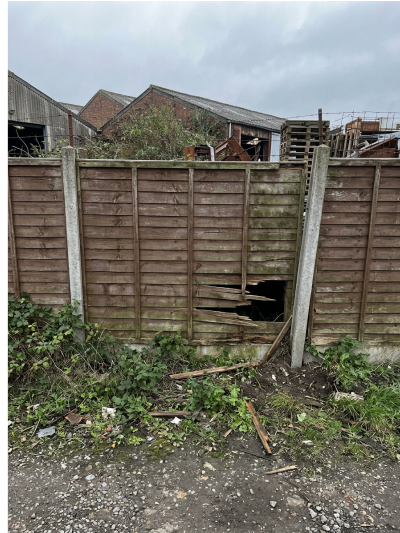
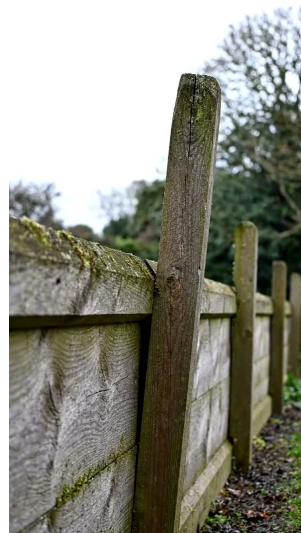
| Posts upright and firm | Defect |
| Panels, rails or mesh intact | Defect |
| No gaps under or through | Defect |

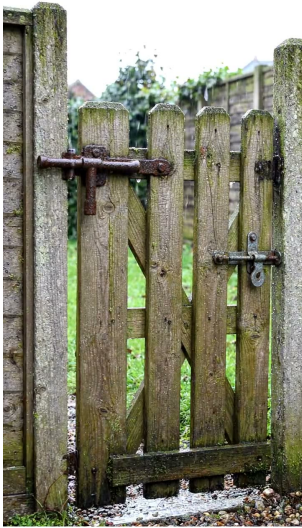
| Hinges and posts | Defect |
| Closes and stays shut | Defect |
| What is wrong? | Gate has dropped on its top hinge and does not latch without lifting. |

| What needs doing? | Rehang the footpath gate so it closes and latches. |
