# Highway and Car Park Safety Inspection

| Site | Northgate Retail Park |

| Project | Northgate Retail Park: monthly car park and footway inspection (completed example) |
| Inspection date | 5 Oct 2026 |

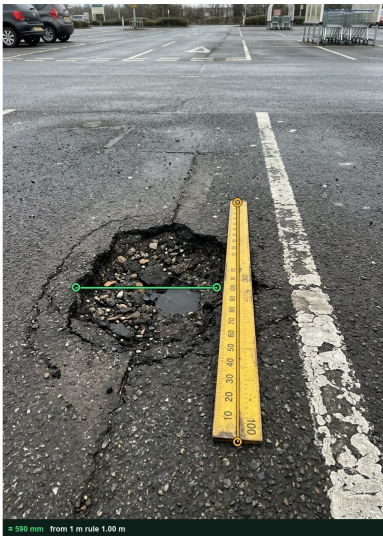
#### Width (mm): measuring photo

| What is wrong? | Pothole in the aisle surface, edges breaking up. 55 mm deep by rule; size measured from a photo against a 1 m rule. |
| Depth or height (mm) | 55 |
| Width (mm) | 590 |

| Response | Make safe within 24 hours |

| What needs doing? | Patch repair the aisle C pothole. |

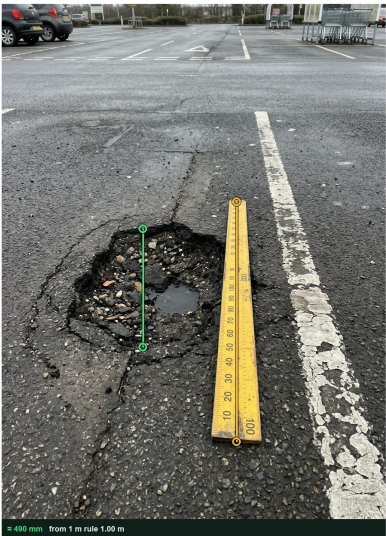
Length (mm): measuring photo

Length (mm) 490

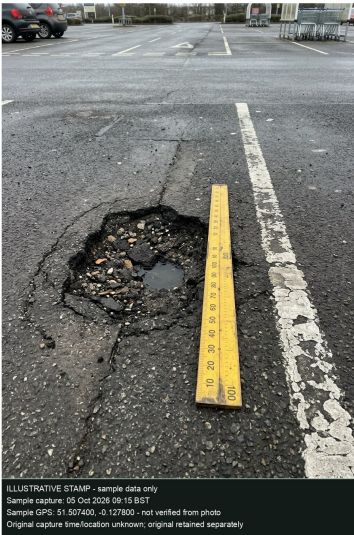
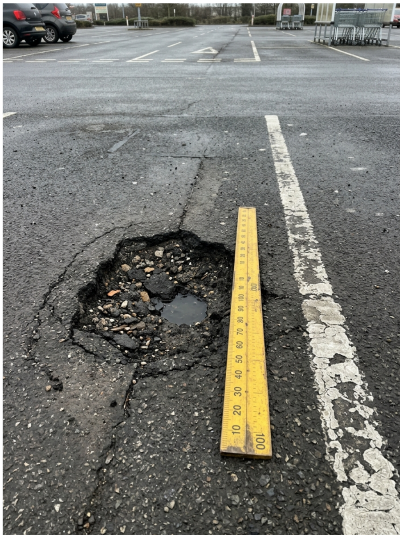
| Against your investigatory level | At or over the level |

| Made safe on site (coned or signed)? | Yes |

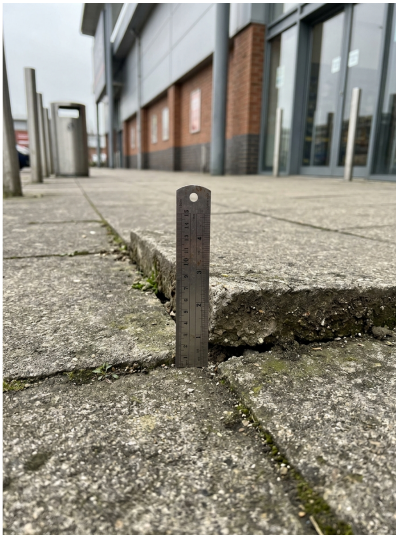
| What is wrong? | Lifted paving slab, 25 mm upstand at the joint. |
| Depth or height (mm) | 25 |
| Against your investigatory level | At or over the level |

| Response | Repair within 28 days |

| What needs doing? | Relay the slab outside unit 4 and repair lamp column 12. |
