# Housing Disrepair Inspection

| Project | 14 Ash Grove: disrepair claim inspection (completed example) |
| Claim or complaint reference | DIS-2026-118 |

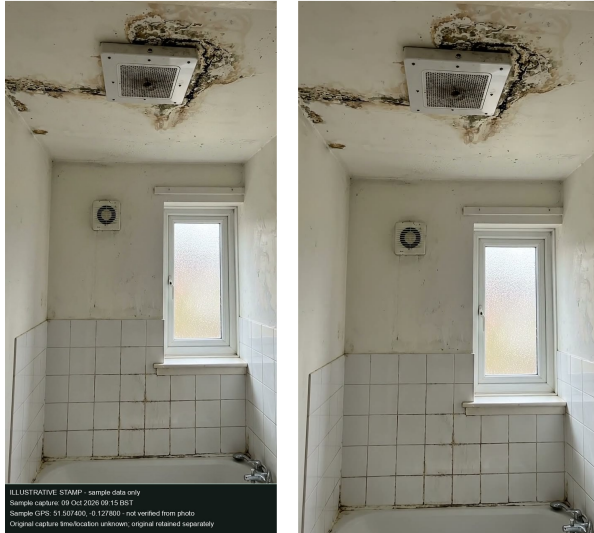
| Rooms 1: Bathroom | |

| Rooms 1: Bathroom | |
|---|---|
| Defect found | Black mould on the ceiling over the bath; extractor fan not working. |
| Category | Damp and mould |
| Likely cause | Disrepair |
| Damp meter reading on the affected area (as displayed) | 28 |
| Reading on a dry wall in the same home | 11 |
| Area affected (m²) | 0.54 |

Replace the extractor fan; mould wash and stain block.

Urgent

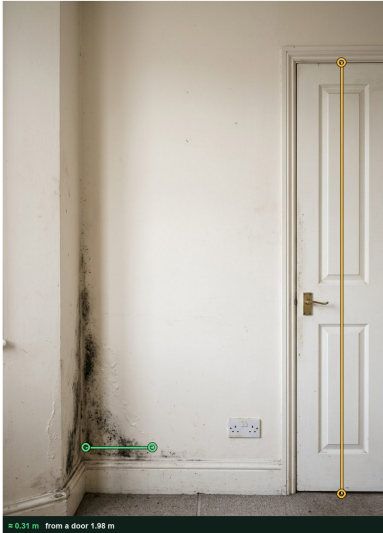
Width of the damp or mould (m): measuring photo

| Defect found | Black mould from the skirting up the external wall corner beside the door; plaster damp to the touch. Gutter above leaking at a joint. |
| Width of the damp or mould (m) | 0.31 |

| Work needed | Repair the gutter joint, then mould wash, let the wall dry and redecorate with a stain block. |

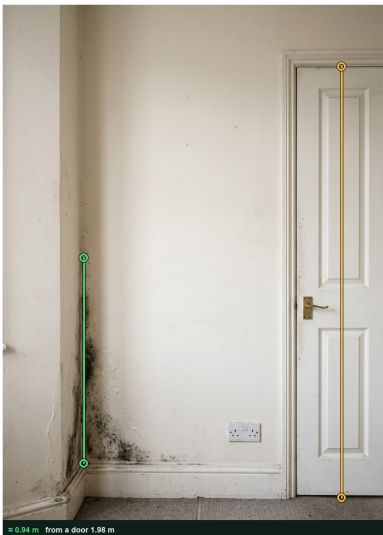
Height of the damp or mould (m): measuring photo

0.94

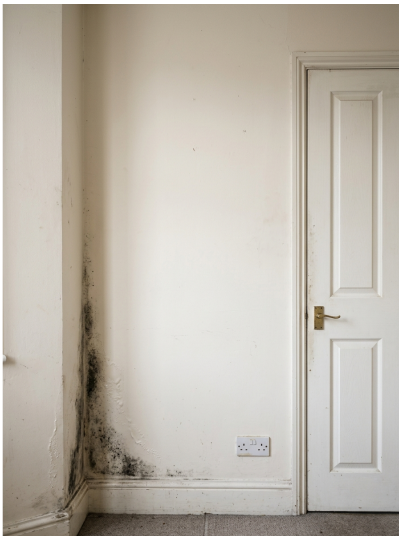
## Rooms 2: Bedroom 1, external wall corner

| Category | Damp and mould |
| Damp meter reading on the affected area (as displayed) | 34 |
| Affected area above the dry wall (meter units) | 23 |

0.29

| Priority | Urgent |

| What needs doing? | Repair the leaking gutter joint above bedroom 1. |

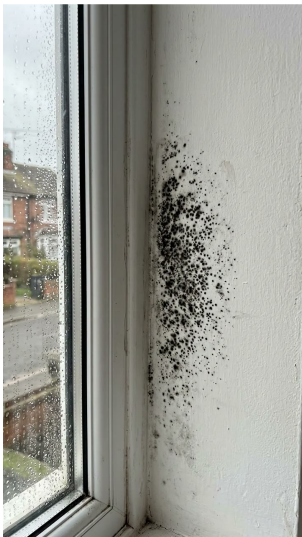
Rooms 3: Bedroom 1

| Defect found | Mould on the window reveal; frame seals failed, with draughts and water getting in at the frame. |
| Category | Windows and doors |
| Likely cause | Disrepair |

| Work needed | Reseal the frame, treat the mould and make good the reveal. |
| Priority | Routine |
