# Manhole Inspection

| Project | Brookfield Retail Park: manhole cover inspection (completed example) |
| Inspection date | 6 Oct 2026 |

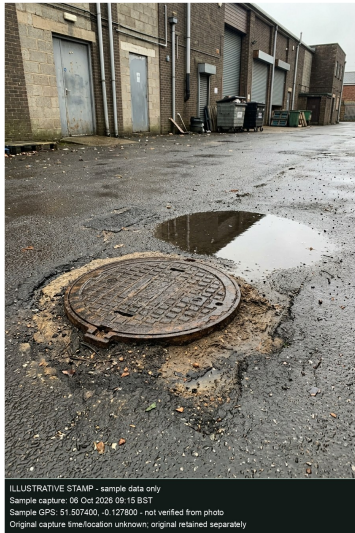
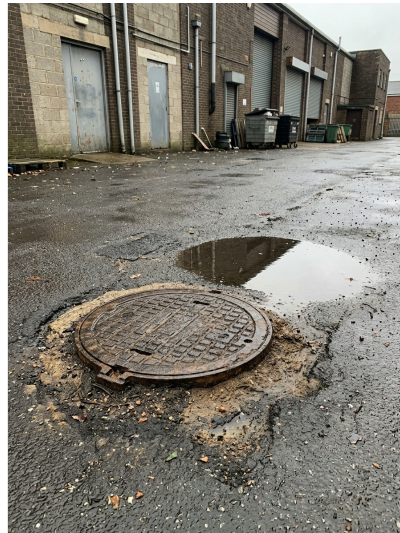
| Cover reference | MH-05 |

| No standing water, silt or sewage staining | Defect |
| Sewage smell? | Yes |
| Result | Repair needed |
| What is wrong? | Silt and sewage staining round the cover after rain, possible blockage downstream. |

| Reported to (owner, water company or highway authority) and reference | MH-05 reported to the water company sewer flooding line, ref SW-448201 |

| What needs doing? | Follow up the water company visit to MH-05 and check the yard after the next heavy rain. |

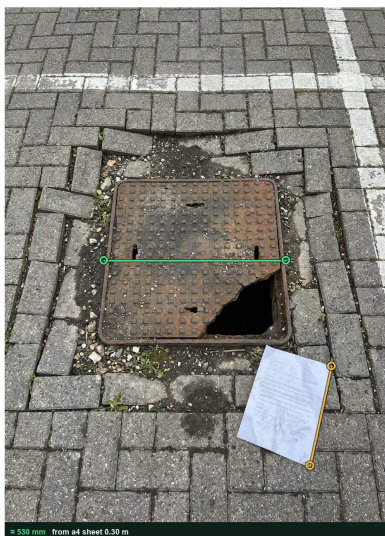
Clear opening length (mm): measuring photo

| Clear opening length (mm) | 530 |

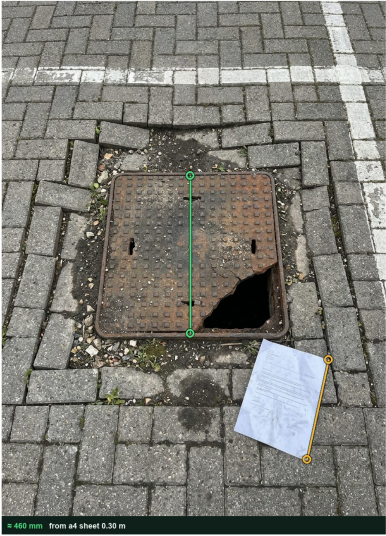
Clear opening width (mm): measuring photo

Clear opening width (mm) 460

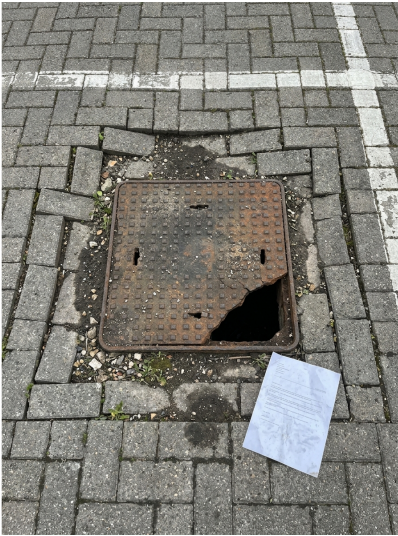
| Cover reference | MH-03 |

| Cover: no cracks, breaks or missing pieces | Defect |
| Sits level and does not rock | Defect |
| Frame and surround: no sinking, cracking or loose blocks | Defect |

| Step between the cover and the surround (mm) | 25 |
| Step against the trip level | At or over |
| Result | Dangerous: made safe and kept clear |
| What is wrong? | Corner of the cast iron cover cracked off, cover rocks under load and paving round the frame has sunk. |

| How it was made safe (barrier, cones, temporary cover) | Bay 41 coned off and barrier placed over the cover, centre manager told at 09:10. |

| What needs doing? | Replace the MH-03 cover and frame and relay the surrounding paving. |
