# Property Damage Report

| Project | Unit 3, Willow Court Business Park: escape of water from the first floor tea point (completed example) |
| Date of this report | 13 Oct 2026 |

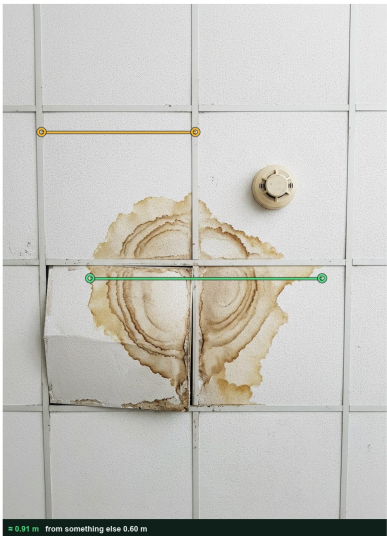
Width of the damage (m): measuring photo

| Description | Worst stain across two tiles below the tea point, measured from the 600 mm ceiling grid. Four more tiles stained and one collapsed. |
| Severity | Severe |
| Width of the damage (m) | 0.91 |

#### Further actions 1: Moisture readings after 7 days, then replace the ceiling tiles and carpet tiles.

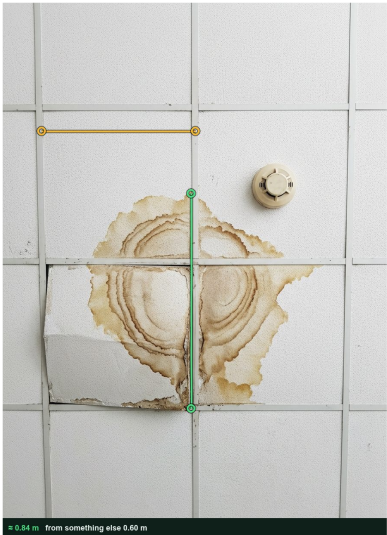
Length or height of the damage (m): measuring photo

Length or height of the damage (m) 0.84

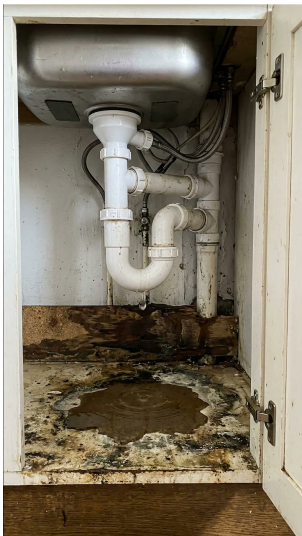
| Description | Trap joint leaking. Base unit floor swollen and stained. |
| Severity | Moderate |

| Temporary repairs done to stop further damage | Water off to the tea point, trap joint remade, wet ceiling tiles taken down, ceiling lights in the wet area isolated and dehumidifiers set up. |

#### Further actions 2: Replace the tea point sink base unit.
