# Roof Anchor and Eyebolt Inspection

| Site | Queens House |

| Project | Queens House: annual anchor and eyebolt examination (completed example) |
| Inspection date | 3 Oct 2026 |

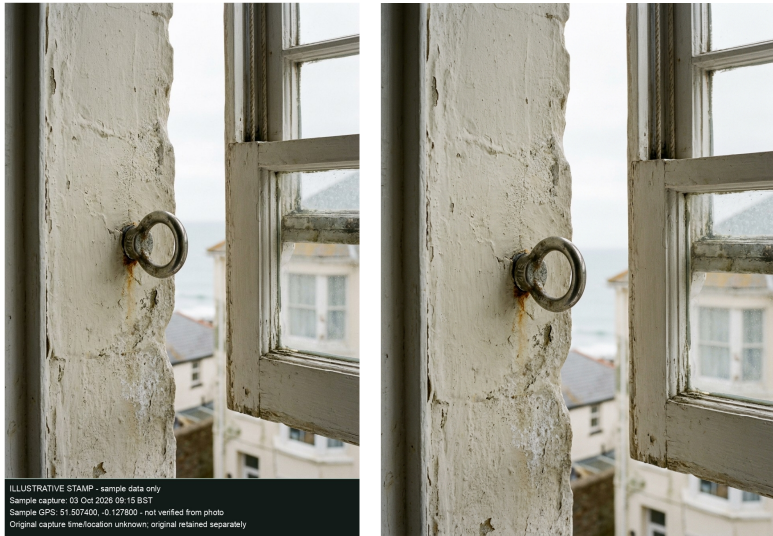
| No corrosion or damage | OK |
| Fixing secure and fully engaged | OK |
| Surrounding structure sound | OK |
| Result | Pass |

| No corrosion or damage | OK |
| Fixing secure and fully engaged | OK |
| Surrounding structure sound | OK |
| Test load, duration and result | Static pull test at 6 kN to the installer's instructions, held 15 seconds, no movement |

| Result | Pass |

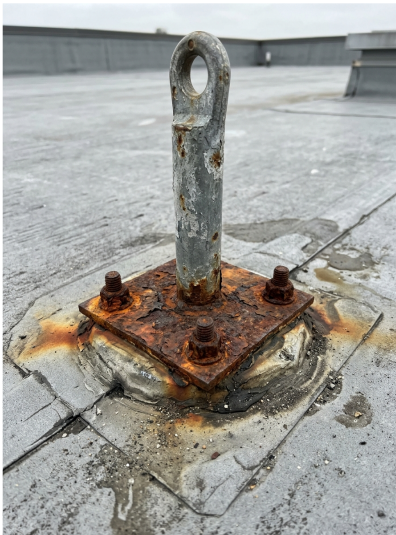
| Anchor reference | RA-01 |

| No corrosion or damage | Defect |
| Result | Withdrawn from use |
| Why withdrawn | Heavy corrosion at the base plate and bolts. Tagged out of use, building manager told. |

Withdrawn from use. Label it or remove it so nobody clips on, and do not use it until it is repaired or replaced and passes inspection.

At least one anchor is withdrawn from use. Tell the building manager today, and make sure the access plan for window cleaning or roof work does not rely on it.
