# Roof Survey and Measure

| Project | 31 Victoria Terrace: roof survey and measure for a re-roof quote (completed example) |
| Site address | 31 Victoria Terrace, Bangor |
| Survey date | 5 Oct 2026 |

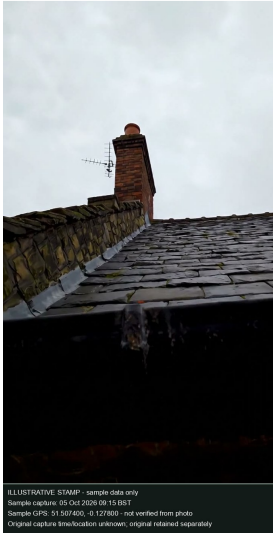
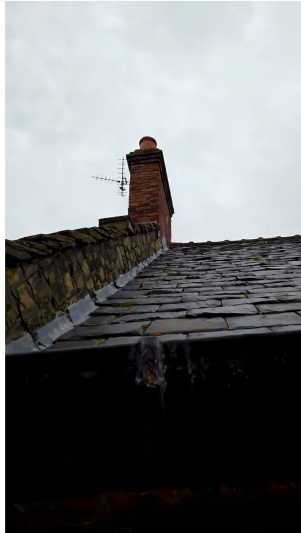
| Condition | Fair |
| Defects | Some slipped slates near the chimney. |

| Work recommended | Strip and re-slate the front slope with new breathable membrane and battens; refix the rear slope; new lead to the chimney; replace the front gutter. |
