# Scaffold Inspection Register

| Project | Hartley Road flats, Bristol: weekly scaffold inspection (completed example) |
| Date of inspection | 12 Oct 2026 |

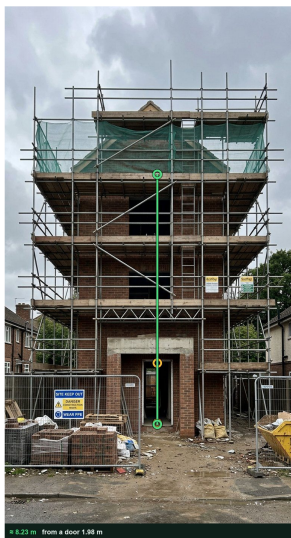
Height to the top working platform (m): measuring photo

| Height to the top working platform (m) | 8.23 |

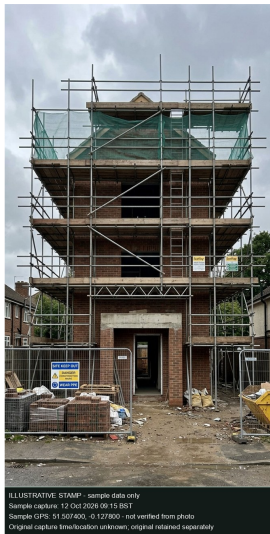
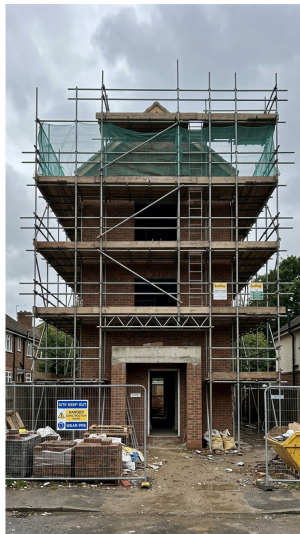
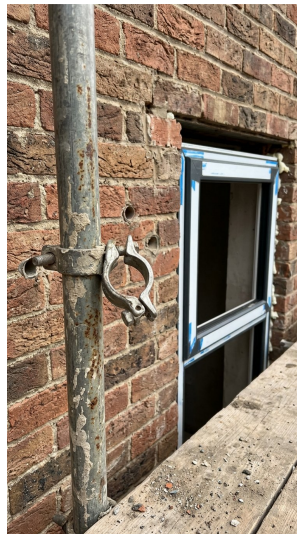
Scaffolds and lifts inspected 1: B-01

| Ties and anchors in place, none removed, tested where required | Defect |
| What is wrong? | One tie missing at lift 3, bay 6: removed for window fitting and not replaced. |

| Result | Safe to use with a restriction |
| What is the restriction? | Lift 3, bays 5 to 7 closed until the tie is replaced by the scaffold contractor. |

##### Further actions 1: Replace tie at lift 3, bay 6 on B-01 and re-inspect.

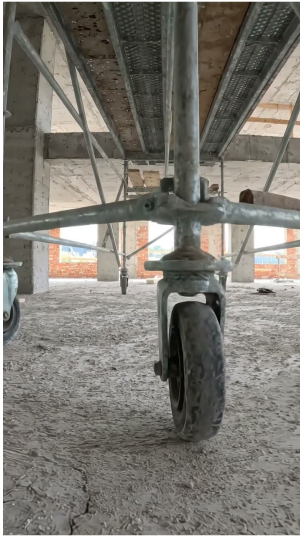
## Scaffolds and lifts inspected 2: T-03

| Ground, sole boards and base plates sound, level and undisturbed | Defect |
| What is wrong? | Castor brake not locked on one leg. |
| Scaffold tag or status board shows the current inspection | Defect |

Tag still shows the inspection of 1 October.

| Result | Not to be used |
| How was it taken out of use (tag removed, access barred) and who was told? | Tag reversed to do not use and access barred. Site manager P. Lyle told at 07:40. |

##### Further actions 2: Lock T-03 castors, re-inspect and re-tag before use.
