# Dry Rot and Timber Decay Inspection

| Site | 9 Chapel Row, Hebden Bridge |

| <b>Project</b> | 9 Chapel Row, Hebden Bridge: timber decay inspection (completed example) |

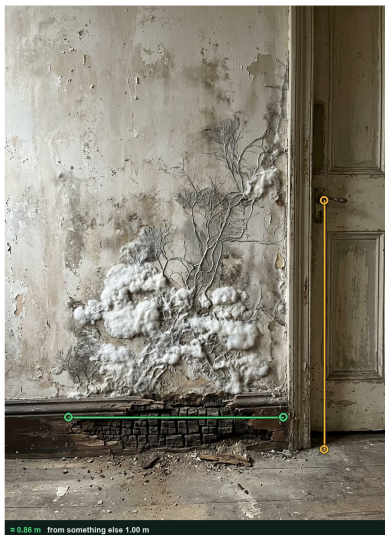
Length of the affected timber or area (m): measuring photo

| Length of the affected timber or area (m) | 0.86 |

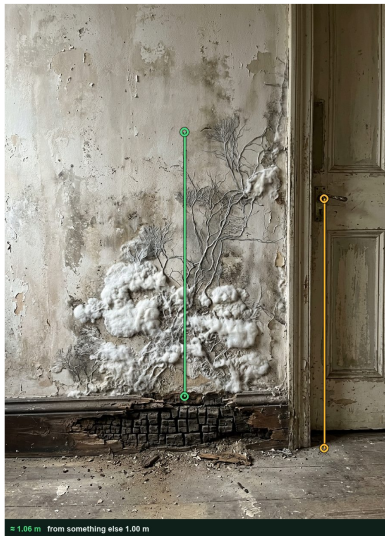
Height or width of the affected area (m): measuring photo

| Height or width of the affected area (m) | 1.06 |

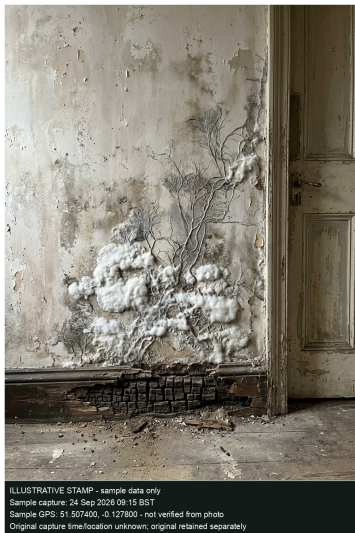
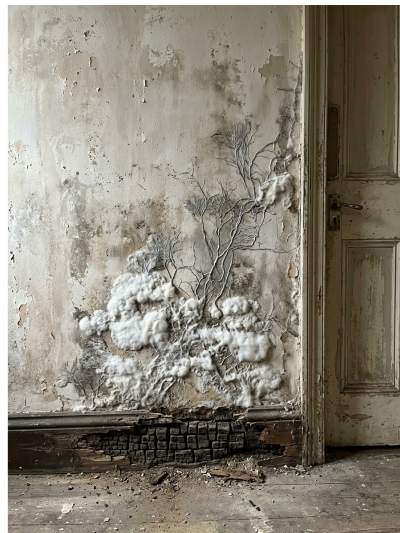
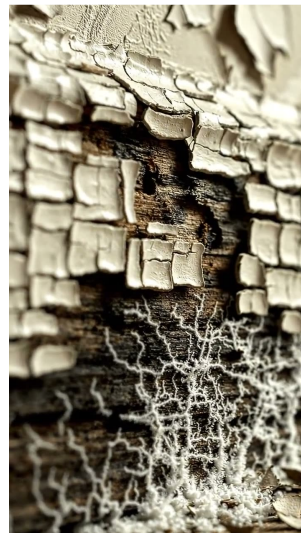
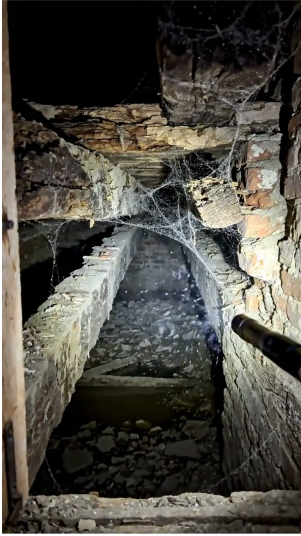
| <b>Room or area</b> | Front room, party wall side by the door |

| Signs seen | Darkened timber, Cracking into squares, Shrinking or distortion, Musty smell |
| Moisture meter reading on the timber (as displayed) | 31 |
| Against the threshold | At or above the threshold: wet enough for decay |
| Suspected cause (to be confirmed by a specialist) | Dry rot suspected |

Property Care Association: dry rot can grow through masonry and through very small cracks, away from the timber it is feeding on. Check timbers beyond this area, including in the next room, and get a detailed survey by a specialist.

Further actions 1: Book a specialist timber survey of the front room, hall and the party wall side.

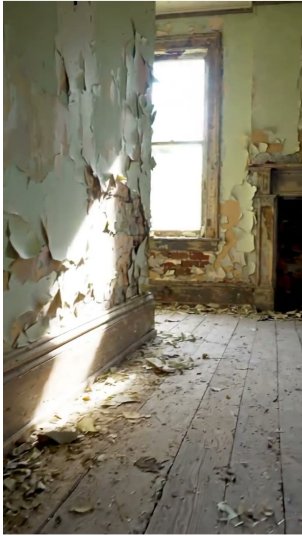
| Room or area | Hall |
| Signs seen | Darkened timber, Soft or crumbling timber |
| Moisture meter reading on the timber (as displayed) | 24 |
| Against the threshold | At or above the threshold: wet enough for decay |
| Suspected cause (to be confirmed by a specialist) | Wet rot suspected |

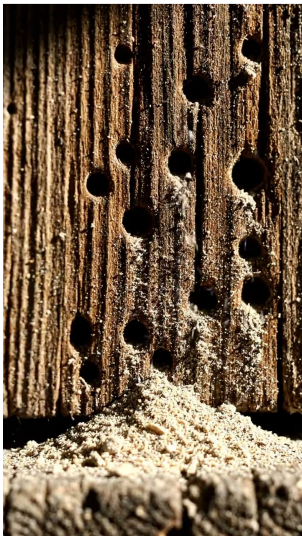
| Room or area | Loft |
| Signs seen | Small round exit holes |
| Moisture meter reading on the timber (as displayed) | 14 |
| Suspected cause (to be confirmed by a specialist) | Wood-boring insects suspected |

Property Care Association: the common furniture beetle leaves small round exit holes about 1 to 2 mm across. Bore dust (frass) around holes can suggest activity but can be misleading, so a qualified professional should confirm whether it is active before any treatment.
