# Tree Condition Survey

| Project | St Anne's Primary School: tree survey (completed example) |
| Survey date | 4 Oct 2026 |
| Surveyor and qualification | H. Lowe, arboriculturist (Lantra Professional Tree Inspection) |

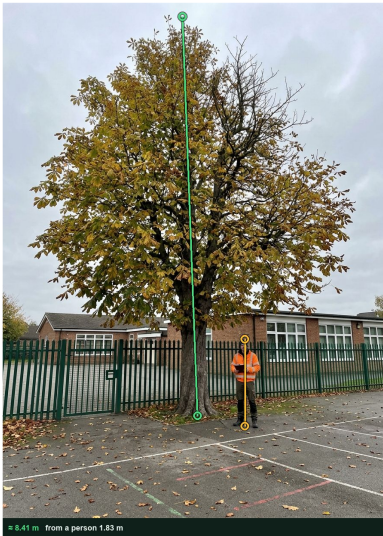
## Height (m): measuring photo

| Height (m) | 8.41 |

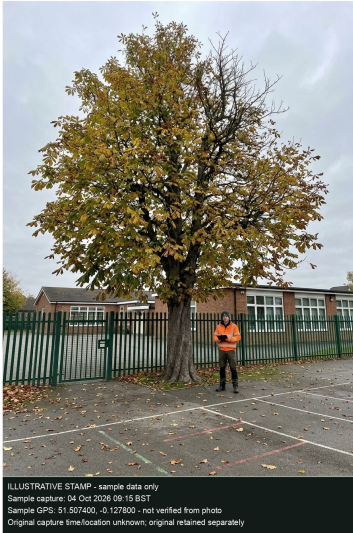
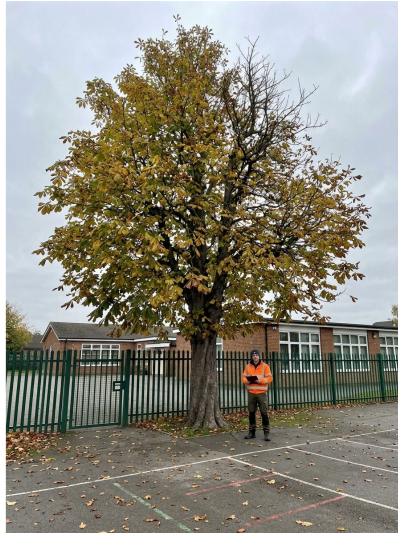
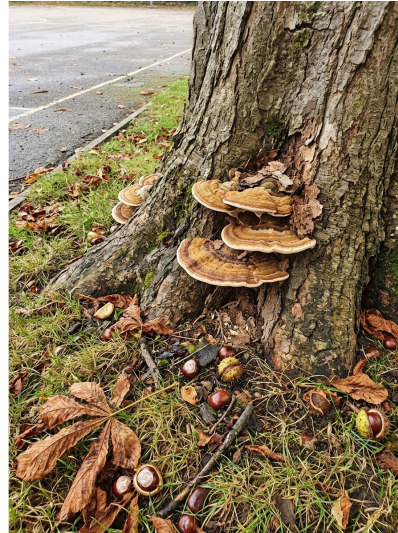
| Tree number | T1 |

| Condition | Poor |
| Defects | Fungal fruiting bodies, Deadwood |
| Risk | High |

High risk. Consider restricting access below the tree until the work is done.

| Recommended work | Further investigation |
| Urgency | Within 1 month |

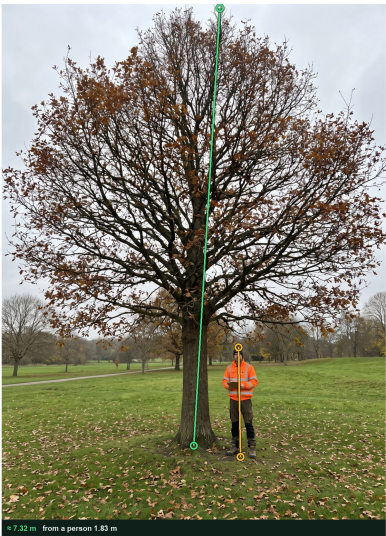
Height (m): measuring photo

| Height (m) | 7.32 |

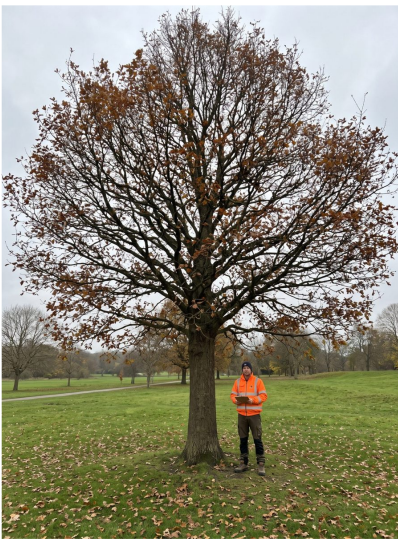
| Tree number | T2 |

| Condition | Good |
| Defects | None seen |
| Risk | Low |

| Recommended work | No work |

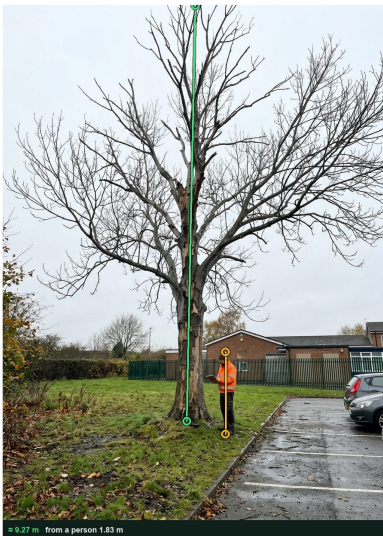
Height (m): measuring photo

Height (m) 9.27

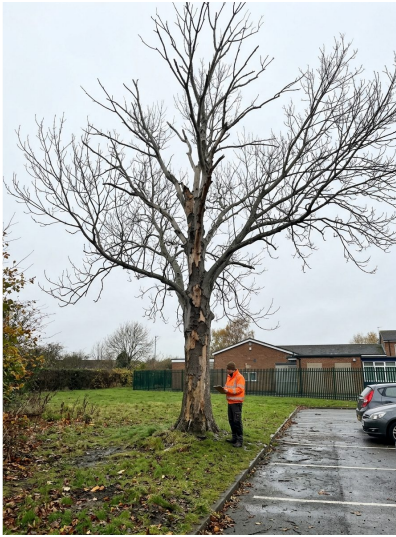
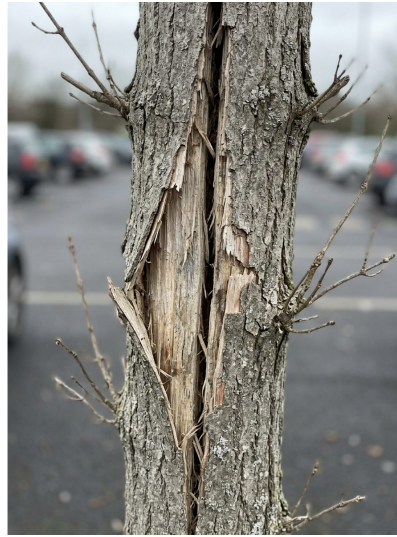
Tree number T3

Condition Dead

Defects Deadwood, Cracks or splits

Risk High

High risk. Consider restricting access below the tree until the work is done.

Recommended work Fell

Immediately

Give the planning authority written notice before felling dead tree T3 (5 days' notice for a dead tree, not a 6 week section 211 notice); cordon the car park bays now.
