# Utility Survey Record (PAS 128)

| Project | Riverside Primary: utility survey for new classroom block (completed example) |
| Survey date | 6 Oct 2026 |

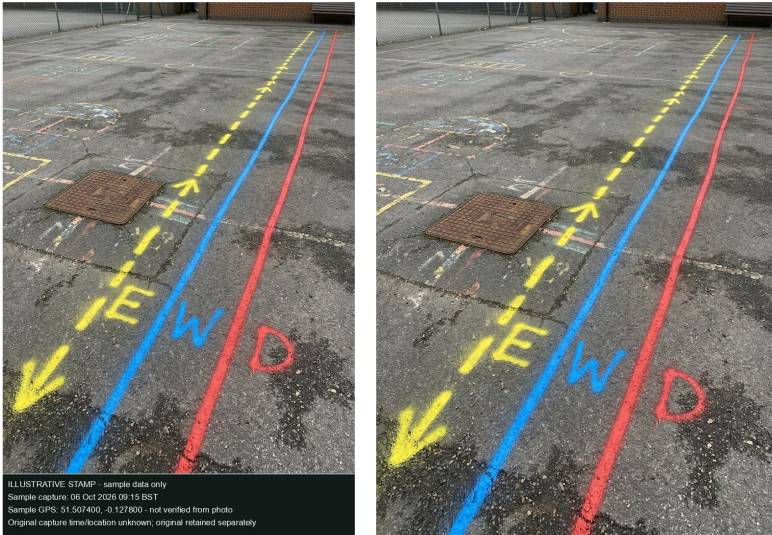
Site photos and marked-out services

| Visible evidence found | Manhole or chamber covers, Valve or stop tap covers, Reinstatement scars |

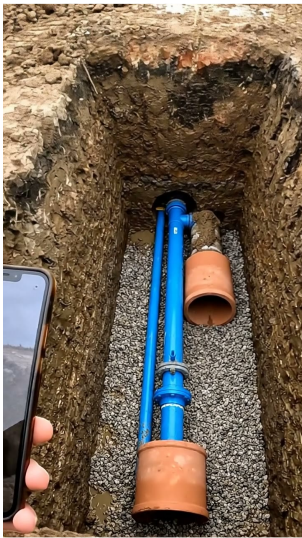
**Photos**

| Utilities 2: Foul or surface water drainage | |
|---|---|
| Utility | Foul or surface water drainage |
| Location or line reference | Line D1, MH1 to MH2 |

| Depth to top (m) | 1.40 |
| Depth found by | Trial hole or chamber (seen) |
| Quality level | QL-A |
| Size and material, if known | 150 mm clay |

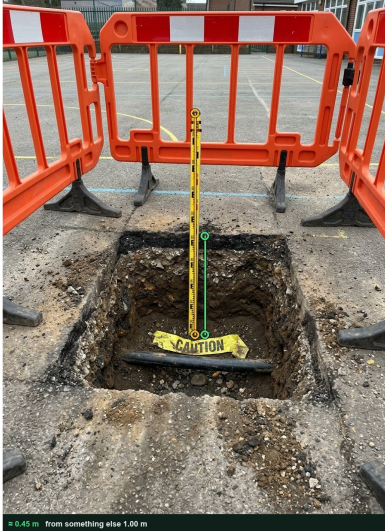
Depth to top (m): measuring photo

| Depth to top (m) | 0.45 |

| Depth found by | Trial hole or chamber (seen) |
| Quality level | QL-A |
| Size and material, if known | Armoured cable |

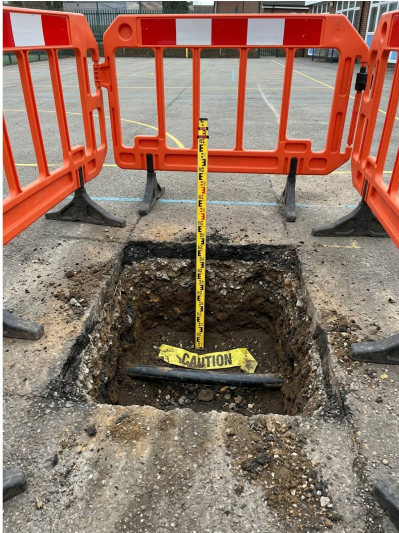
Photos

| Utility | Electricity |
| Location or line reference | Line E1, school kitchen supply |
