# Window and Door Survey

| Site | 18 Elm Grove, Chester |

| Project | 18 Elm Grove, Chester: replacement windows and back door (completed example) |
| Survey date | 16 Oct 2026 |

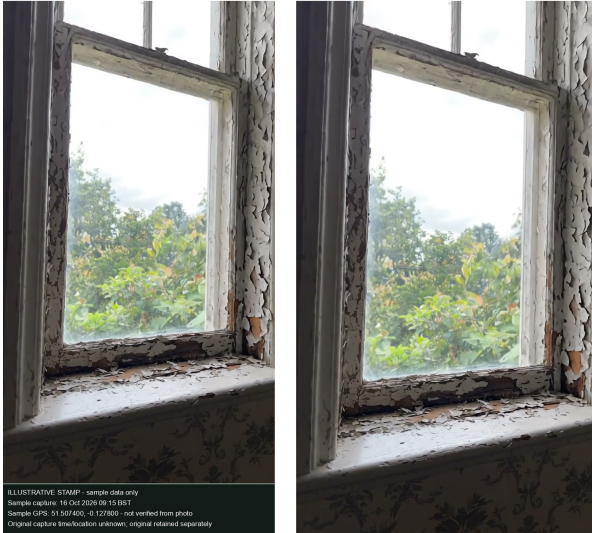
| Reference (for example W1 or D1) | W1 |

| Existing condition | Poor |
| Must this window provide an escape route (for example a habitable room on the first floor)? | Yes |
| Clear opening width when open (mm) | 500 |
| Clear opening height when open (mm) | 1050 |
| Clear opening area (m <sup>2</sup> ) | 0.53 |

| Cill, internal finish and making good | Replace the internal cill board and make good the plaster to the reveals. |

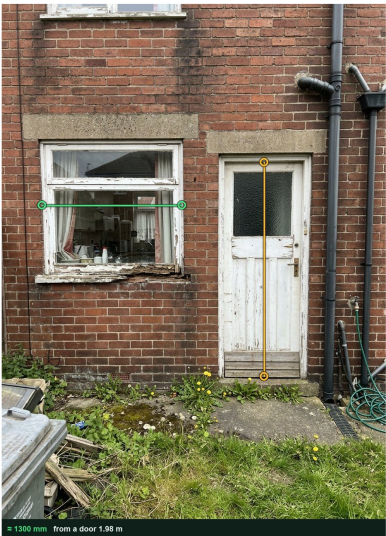
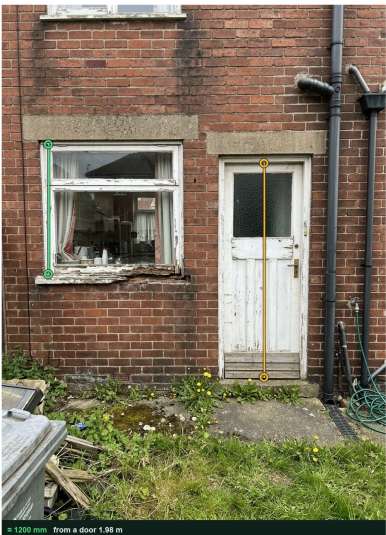
| Reference (for example W1 or D1) | W3 |

| Measured as | Estimate from a photo (check with a tape before ordering) |
| Width (mm) | 1300 |

Height (mm)1200

**Further actions 1: Tape W3 on the fitting visit before the frame is ordered (photo estimate used for the quote).**

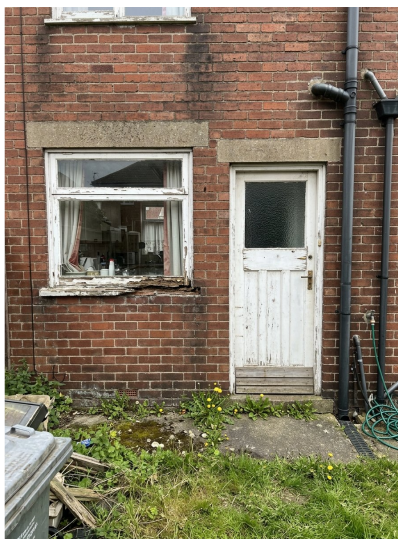
| Existing condition | Failed |
| Replacement priority | Urgent: failed, unsafe or not secure |

Bottom rail and sill rotten through; opener will not close. Measured from the photo for the quote: tape it on the fitting visit before ordering.

Approved Document F: replacing windows makes a home more airtight, so ventilation must be no worse than before. One way is trickle vents in the new windows of at least 8000 mm<sup>2</sup> equivalent area in habitable rooms and kitchens, and 4000 mm<sup>2</sup> in bathrooms.

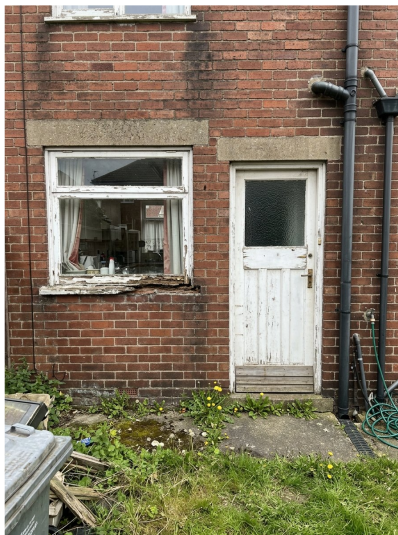
| Reference (for example W1 or D1) | D1 |

| Existing condition | Poor |
| Replacement priority | Urgent: failed, unsafe or not secure |

| Is any glazing within 800 mm of the floor, or within 1500 mm of the floor in a door or in a side panel within 300 mm of a door? | Yes |

Critical location. Approved Document K says glazing here should break safely (safety glazing tested to BS EN 12600), resist impact without breaking, be in small panes, or be permanently protected.

| Cill, internal finish and making good | Lock keep split; the door is held shut with a bolt. New threshold and making good to the step. |

| Notes for the fitters | Kitchen window and back door first: the door is not secure. Customer works from home in the front bedroom, so fit W1 on day one of the second visit. |

Further actions 2: Temporary hasp on the back door until the new door is fitted.
