## SITE SURVEY REPORT

# Quarterly Asset Inspection

| Site | Harbour House |

| Report reference | AI-2026-Q3-017 (sample) |

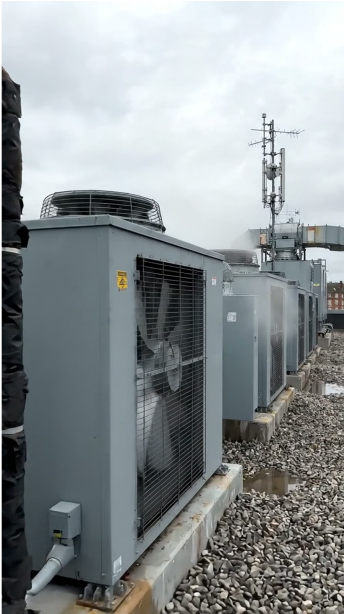
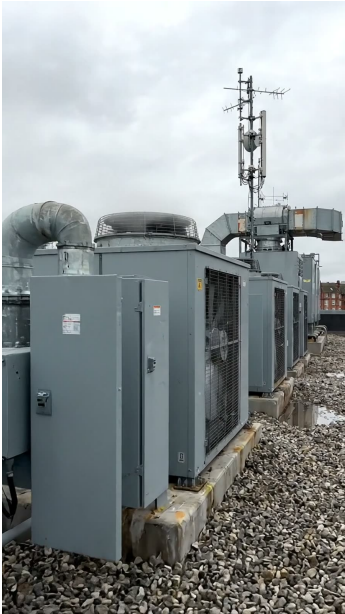
1. Condensers  
Roof condensers 1 to 4. Fins clean on 1 and 2, 3 needs a wash. Fixings and anti-vibration mounts sound. Fan guards in place on all four. Standing water on the roof ballast beside the plinths, and rust staining on the plinth under unit 1.

| Coils and fins | CU-01, CU-02 and CU-04 clean. CU-03 coil face dirty, about a third of the face covered |
| Air on and air off, CU-03 | 16.0 °C on, 26.0 °C off. Difference 10.0 °C |

| Defect 1 | CU-03 coil dirty. Fair |
| Effect | Less air through the coil. The air leaves 1.5 °C warmer than at CU-01 |
| Observation 1 | Rust staining on the plinth under CU-01. Steelwork sound |
| Observation 2 | Standing water on the roof ballast beside the plinths |

| Action | Coil wash at the next visit |
| Action | Monitor. Photograph again at the next round |

| Action | Reported to the client to check the roof outlets. Owner: building manager, Harbour House Management |

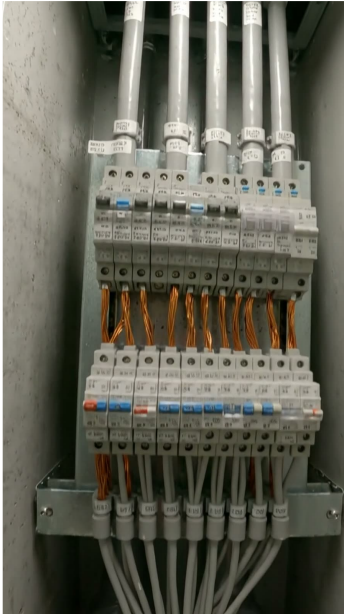
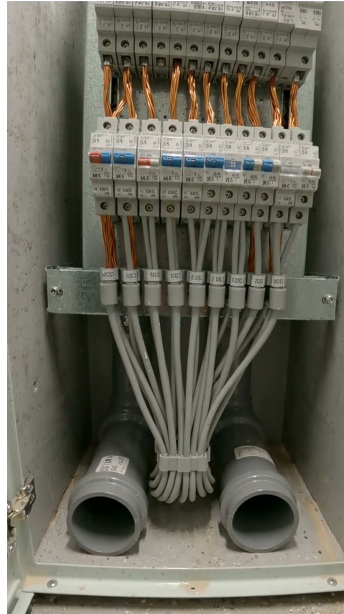
Riser DB2. No signs of heat, covers secure. No scorching or discolouration on the devices or the cable ends. Circuits and cables are labelled. Cupboard is dry and clear of stored items. Looked at only, nothing touched and nothing tested.

| Surface temperature | 27.0 °C at the warmest device, 21.0 °C in the cupboard. Difference 6.0 °C. Taken with a hand held infrared thermometer |

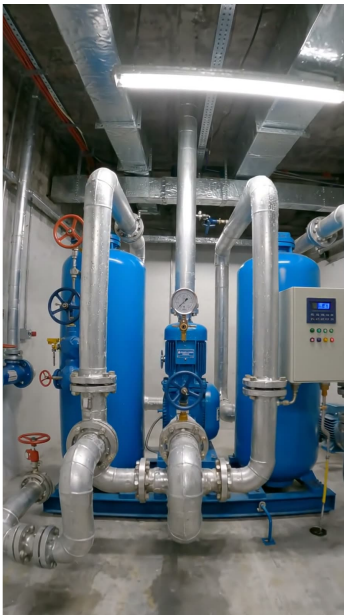
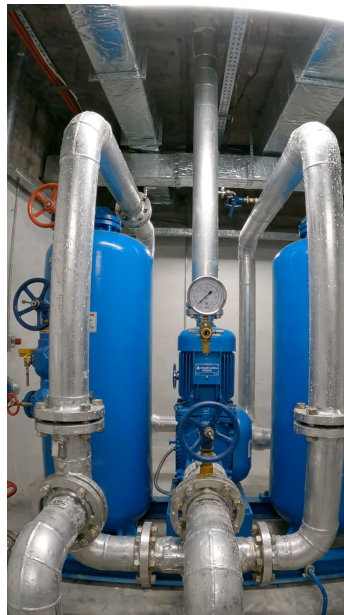
Booster pumps running, no leaks. Condition good. Gauge reads 4.2 bar. No unusual noise or vibration. Flanges and valves dry, floor dry under the set. Control panel shows no fault lamps.

| Pressure on the gauge | 4.2 bar. Set range 4.0 to 4.5 bar |
