## SITE SURVEY REPORT

# Damp and Mould Inspection

| Site | Flat 12, Elm Court |

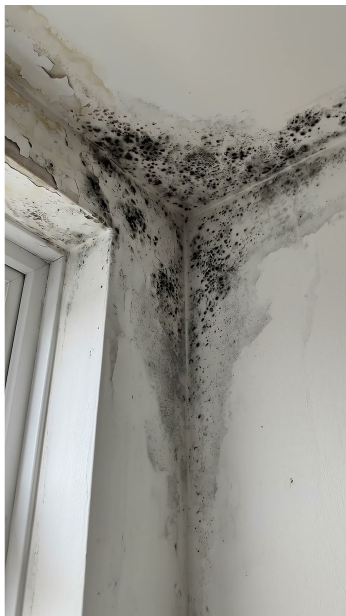
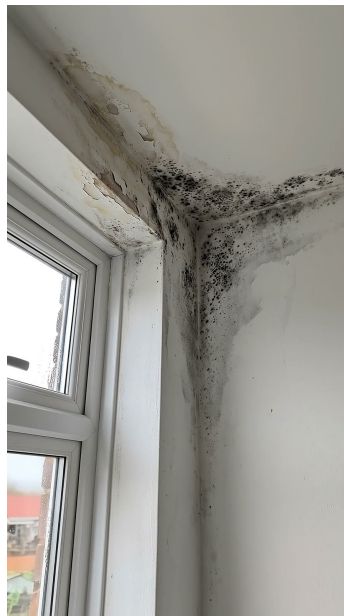
##### 1. Location and extent

Back bedroom, corner by the window. Black mould spreading across the ceiling and down the external wall. About 0.6 square metres, worst where the ceiling meets the external wall. Paint is flaking above the window head. Trickle vent is closed and there is no extractor in the room.

| Back bedroom, where | Ceiling corner and external wall beside the window |
| Back bedroom, area affected | About 0.6 m <sup>2</sup> |
| Back bedroom, air | 17.5 °C, 72% relative humidity. Estimated dew point 12.4 °C |
| Back bedroom, coldest surface | 13.0 °C at the ceiling and external wall junction, 0.6 °C above the dew point |

| Safety work | Clean and treat the mould in the back bedroom and bathroom. Replace the bathroom fan with a humidity controlled fan that runs on. Clear the back bedroom trickle vent. Free the radiator valve |

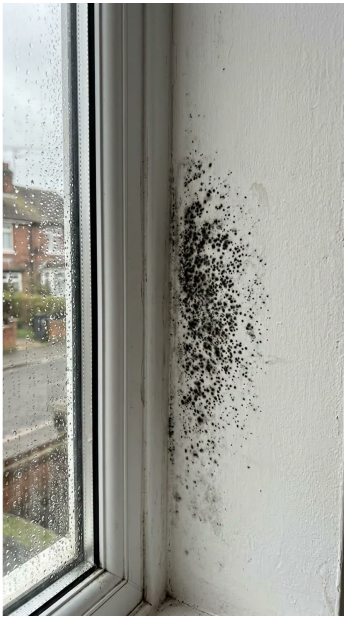
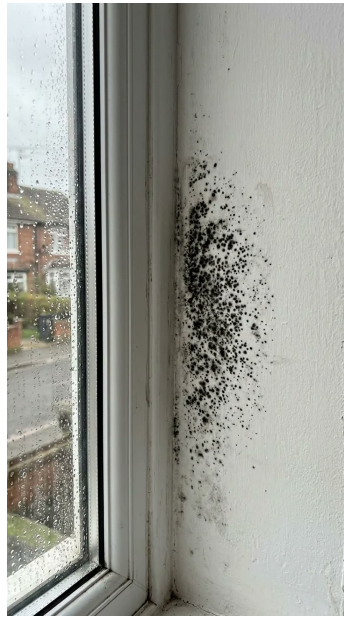
**2. Close-up**

Close-up beside the window reveal. Dense black spotting on the plaster, heaviest next to the frame. Surface is damp to the touch. Condensation on the glass and on the inside of the frame.

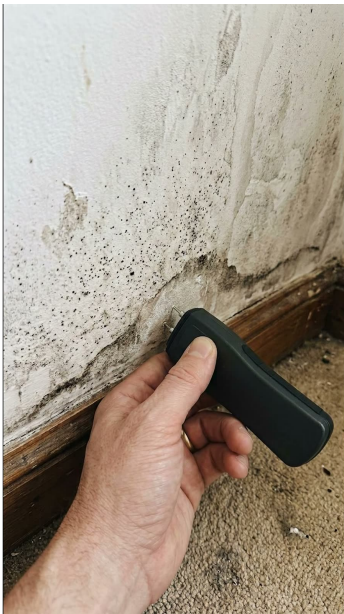
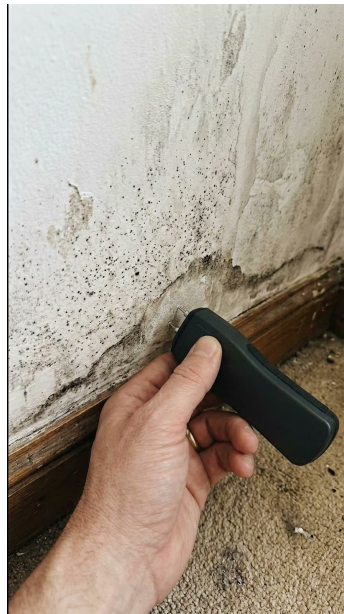
**3. Moisture reading**

Meter on the plaster above the skirting, external wall. Reading 28 on the relative scale in the stained area. Same wall one metre along reads 14, internal wall reads 12. Skirting timber 14 percent. No tide mark and no salts.

| Back bedroom, moisture meter | 28 in the stained area. 14 one metre along the same wall, 12 on the internal wall |

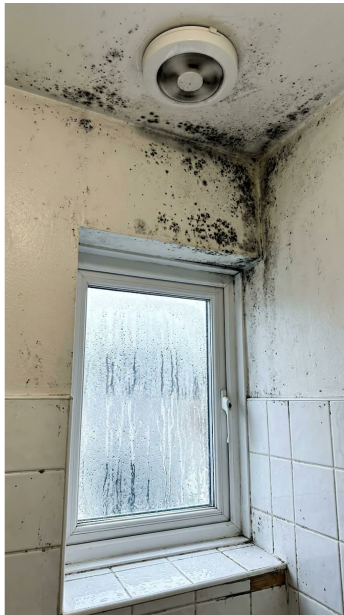
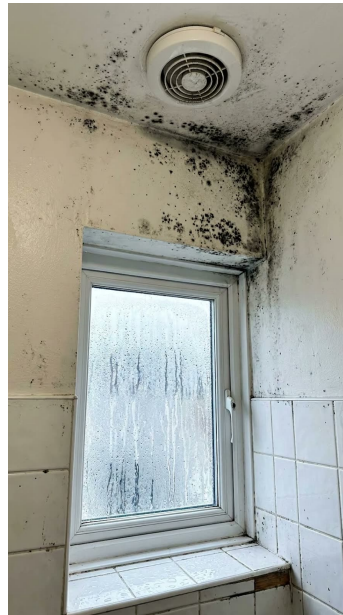
**4. Likely cause**

Bathroom. Mould across the ceiling and above the window. Extractor fan is fitted but not running, no airflow with the light on. Window is running with condensation. Bath seal and pipework checked, dry, no sign of a leak.

| Bathroom, where | Ceiling, with spotting above the window |
| Bathroom, area affected | About 0.5 m <sup>2</sup> |
| Bathroom, air | 19.0 °C, 78% relative humidity. Estimated dew point 15.1 °C |
| Bathroom, coldest surface | 14.6 °C at the ceiling. Below the dew point, condensation visible |

| Bathroom extractor fan | Fitted, not working. No airflow with the light on |
