# Site Risk Assessment

| Site | Plot B, Meadow Lane Development |

| Assessment reference | RA-2026-0187 (sample) |

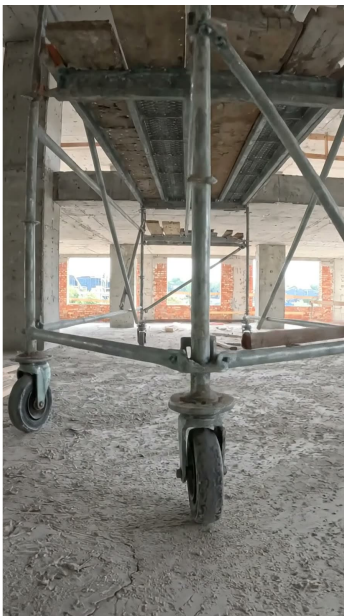
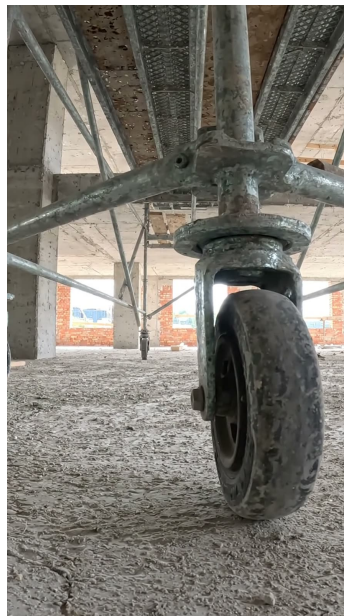
##### 1. Work at height

Tower on level ground, brakes on, outriggers set. Controls in place. Crew briefed before starting. Ground floor shell, mobile tower for the ceiling fixing. Castors are sitting on the floor slab, firm and level. Platform is fully boarded. Bracing is all in.

| Controls already in place | Brakes, outriggers, guardrails. Tower on firm, level ground. Platform fully boarded with toeboards |
| Rating with current controls | Likelihood 1, severity 4. Score 4, low |

| Further action | None needed before work starts. Nobody on the tower when it is moved |

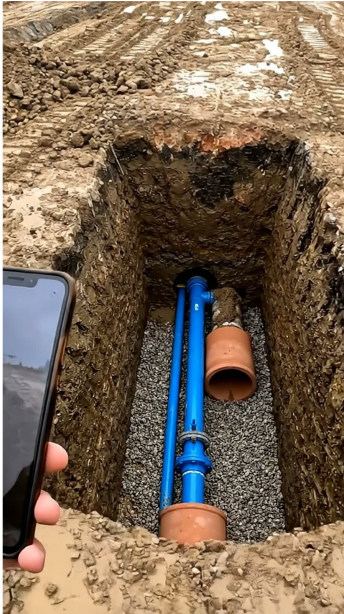
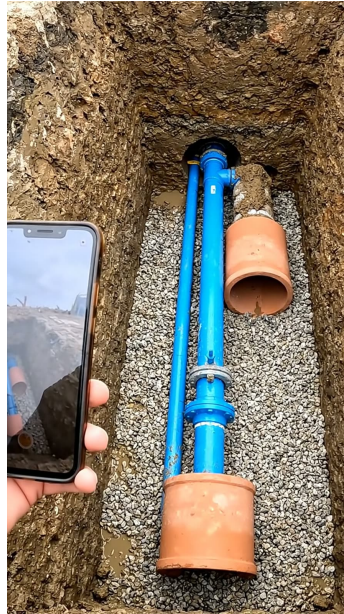
## 2. Excavations

Trench by the east wall unguarded. Barriers needed before work starts. Service trench is open, with the water pipes and drainage laid on a gravel bed. Sides are cut straight with no support. Nothing around the edge to stop anyone walking into it. Vehicle tracks run close to the far end.

| Hazard | Open excavation with an unguarded edge |
| Rating with current controls | Likelihood 4, severity 4. Score 16, high |

| Further action | Fit barriers around the trench. Keep vehicles and stored materials back from the edge. Groundworks supervisor to confirm the support and inspection arrangements before anyone enters the trench |
| Done on and checked by | Fri 25 Sep 2026, 09:10. Barriers fitted round the trench. Checked by R. Shaw before the area was opened again |

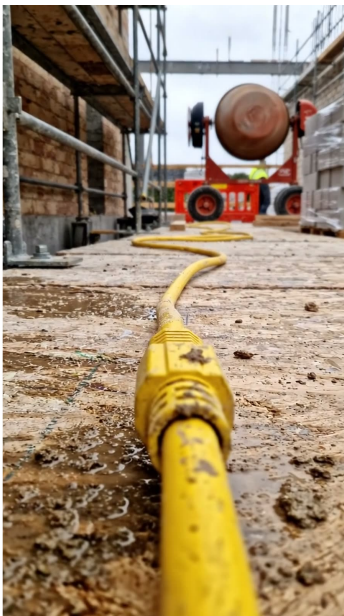
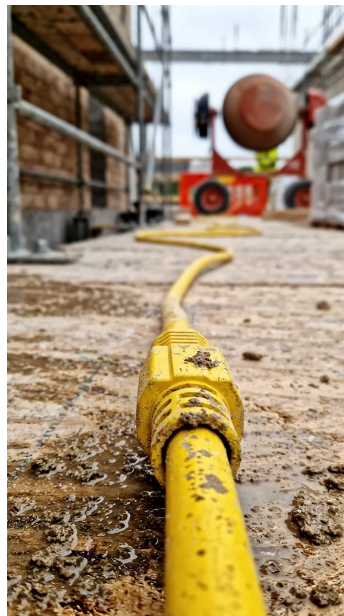
## 3. Trip hazards

Lead across the walkway. Reroute overhead, then brief the crew. Yellow extension lead runs along the walkway beside the scaffold, with a connector lying on the boards. Boards are wet and muddy. Mixer is set up at the far end behind a barrier.

| Hazard | Extension lead across the walkway. Wet, muddy boards |
| Rating with current controls | Likelihood 4, severity 2. Score 8, medium |

| Further action | Reroute the lead overhead. Check the lead and connector for damage before it goes back into use. Clear the mud and grit the boards |
| Done on and checked by | Fri 25 Sep 2026, 08:20. Lead rerouted at high level and checked, boards cleared and gritted. Checked and photographed by R. Shaw |
