# Site Safety Inspection

| Site | Plot B, Meadow Lane Development |

| Report reference | SI-2026-0925-B (sample) |

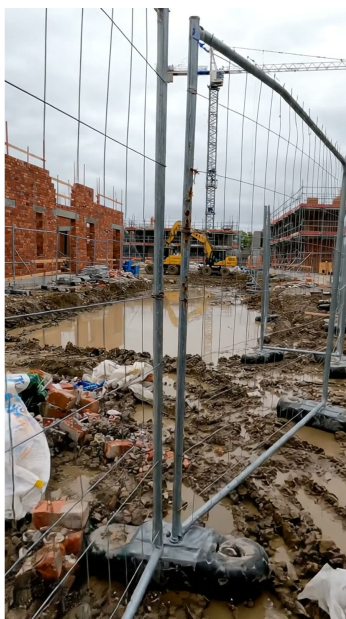
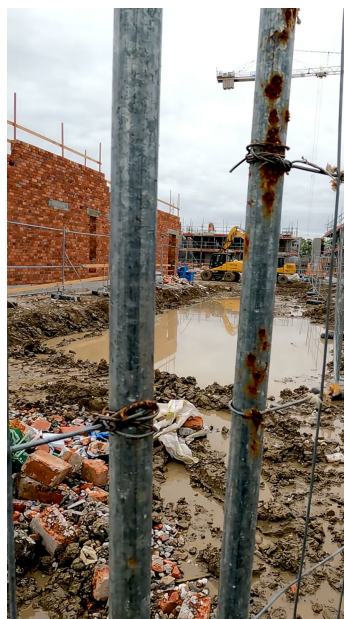
##### 1. Perimeter and access

| Condition of the fence | One panel loose beside gate 2. Panels on the north run tied with wire, not coupled |
| Walkways inside the fence | Standing water, brick rubble and a bulk bag on the route along the north fence |

Heras panel loose by gate 2. Public access risk, fixing now. Rest of the perimeter secure. Panels here are tied with wire, not coupled. Feet are sitting in standing water and there is brick rubble and a bulk bag against the fence line. Excavator working beyond the fence and the tower crane is in use.

| Hazard 1 | Loose fence panel beside gate 2. Members of the public could get on to the site |
| Hazard 1, risk | Likelihood 4, severity 4. Score 16, high |

| Hazard 3 | Standing water, rubble and a bulk bag on the walkway along the north fence. Slip and trip risk |
| Hazard 3, risk | Likelihood 3, severity 2. Score 6, low |

| Hazard 1, action taken | Panel re-clipped with two couplers at 07:42 |

| Hazard 1, further action | Replace wire ties with couplers along the north run. Owner: R. Osei, Site Manager. Due: Fri 25 Sep 2026 |
| Hazard 3, further action | Clear the rubble and the bag, pump out the water, lay stone. Owner: T. Price, groundworks foreman. Due: Tue 29 Sep 2026 |

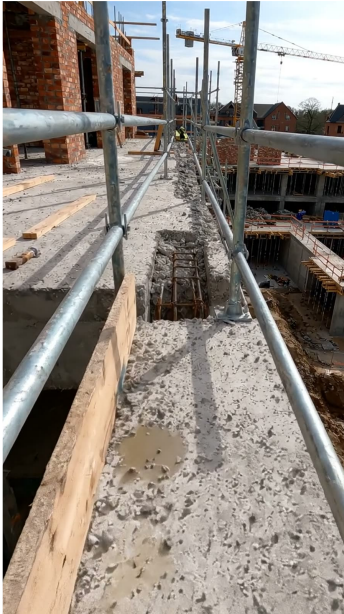
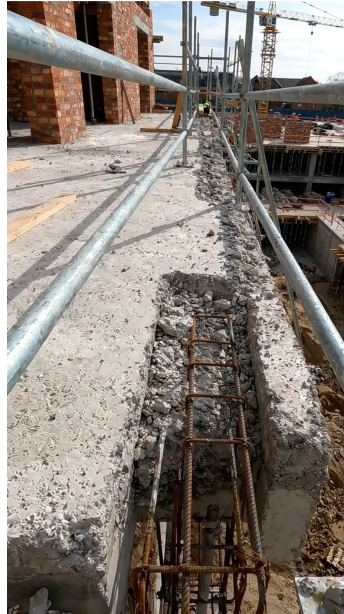
## 2. Edge protection

| Guardrails | Tube guardrails on the main run. End bay beside the loading point has no guardrail |
| Openings in the slab | One open pocket with bare starter bars. Not covered, bars not capped |

First floor slab edge. Tube guardrails are up along this run, top rail and mid rail. Guardrail missing on the first floor slab edge at the end bay. Stop work there until fixed. Open pocket in the slab here with bare starter bars, not capped or covered. Loose timber and a hammer left on the slab.

| Hazard 2 | Guardrail missing at the end bay of the first floor slab edge, Block B1. Fall of about 3.2 metres |
| Hazard 2, risk | Likelihood 4, severity 5. Score 20, high |
| Hazard 4 | Open pocket in the first floor slab with bare starter bars. Trip and impalement risk |
| Hazard 4, risk | Likelihood 3, severity 4. Score 12, medium |

| Hazard 2, action taken | Work stopped at the end bay at 07:55. Area closed off with barriers 2 metres back from the edge |
| Hazard 2, further action | Fit top rail, mid rail and toe board. Check before the area is used again. Owner: D. Lowe, scaffold supervisor, Ridgeway Scaffolding Ltd. Due: Fri 25 Sep 2026 |
| Hazard 4, action taken | Pocket covered with a fixed board at 08:05 |
| Hazard 4, further action | Cap the starter bars. Owner: S. Mensah, concrete frame supervisor. Due: Mon 28 Sep 2026 |

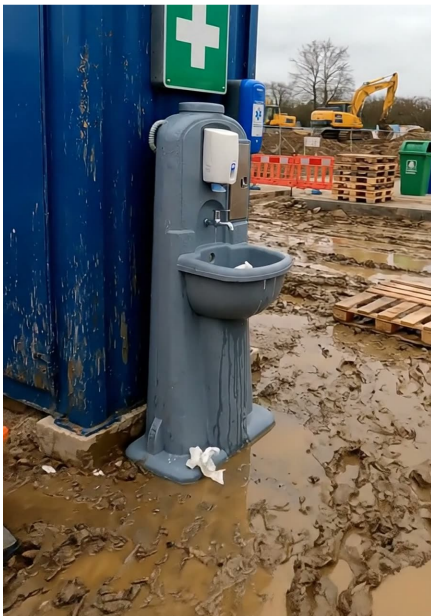
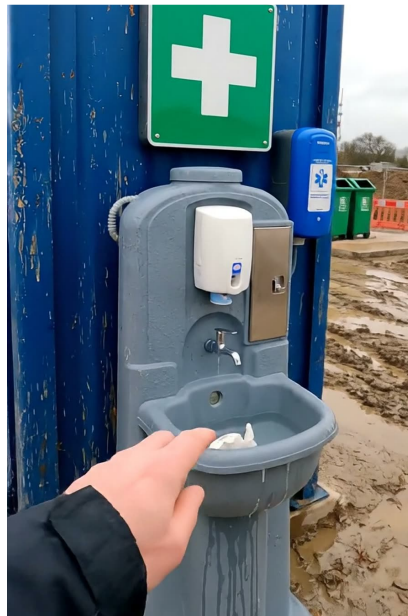
## 3. Welfare

Welfare cabin clean, hand wash stocked, first aid point in place. Soap in the dispenser and the tap is running. First aid sign is clear from the walkway. Ground around the wash station is wet and muddy, needs stone or matting.

| Condition | Clean and orderly. Ground around the wash station wet and muddy |

| Result | No hazard raised. Observation passed to the site manager: lay stone or matting at the wash station |
