## SITE SURVEY REPORT

# Stock Condition Survey

| Site | 14 Hawthorn Road |

| Survey reference | SCS-2026-0914 (sample) |

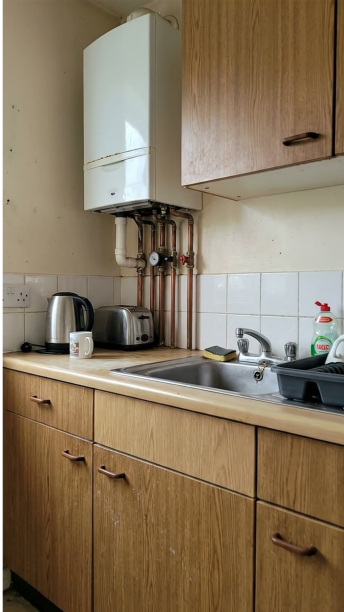
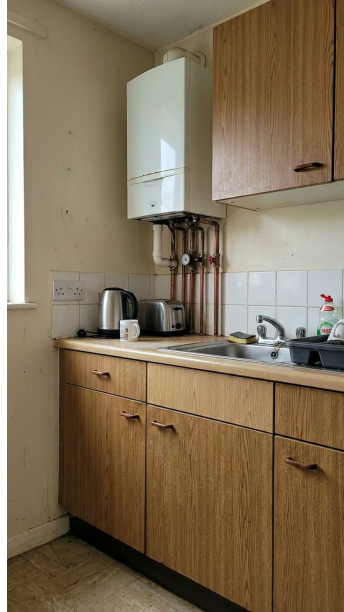
**1. Kitchen and heating**

Kitchen fitted around 2008, units fair. Combi boiler, no leaks on the pipework. Worktop edge lifting by the sink, doors and hinges all working. Wall tiles sound. No carbon monoxide alarm seen in this room.

| Kitchen | Inspected up close. Fair. 2008, age 18. Standard lifetime 30 years. Worktop edge lifting by the sink. Estimated remaining life 6 years, replace about 2032 |

| Work in the next 12 months | Replace the misted sealed unit in the back bedroom. Renew the bathroom grout and bath sealant. Refix the kitchen worktop edge |

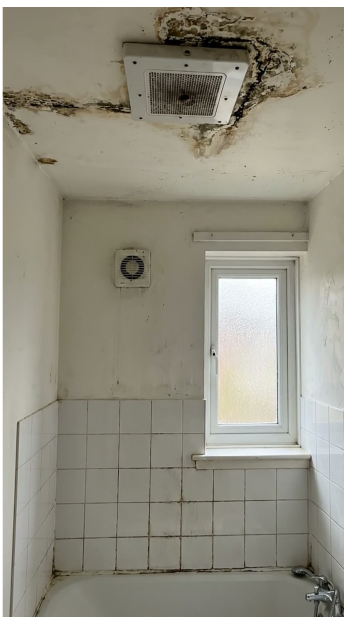
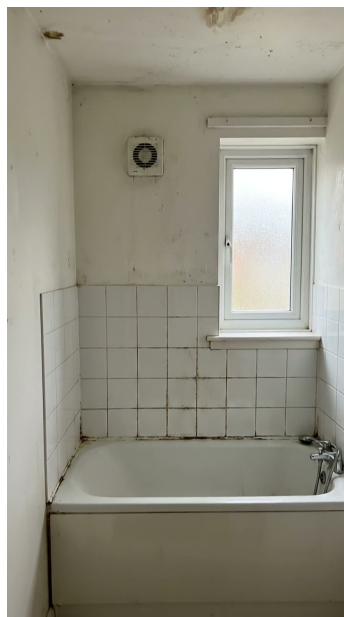
**2. Bathroom**

Bath and basin fair. Grout failing on the splashback, mould on the ceiling. Staining and flaking paint around the ceiling vent. Sealant at the bath edge is black and coming away. Wall fan is fitted, to be tested.

| Hazard 1 | 11. Damp and mould growth. Bathroom ceiling around the vent. About 0.4 m <sup>2</sup> of mould and staining, grout failing on the splashback |
| Hazard 1, outcome | Needs making safe within 24 hours: No. Scored: No. Reported to the repairs team on the day, repair reference R-604118 |

| Bathroom | Inspected up close. Fair. 2005, age 21. Standard lifetime 40 years. Bath, basin and WC working. Grout and bath sealant failing. Estimated remaining life 10 years, replace about 2036 |

| What urgent work, and who was told? | Damp and mould in the bathroom and at the back bedroom window, R-604118, raised with the repairs team on the day as a damp and mould hazard. For a social landlord, Awaab's Law requires a standard investigation within 10 working days, starting the day after the landlord became aware, so by Fri 9 Oct 2026. Refix the stair handrail bracket and check all fixings, R-604119. Fit a carbon monoxide alarm in the kitchen. Resident told |

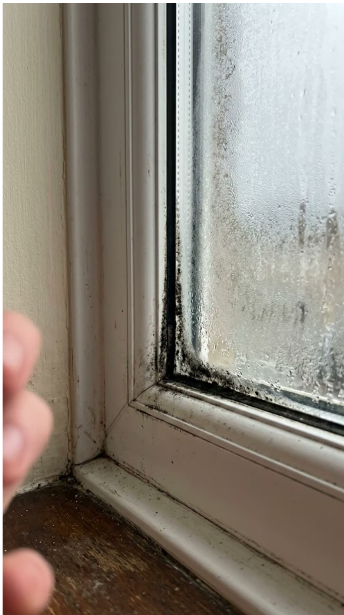
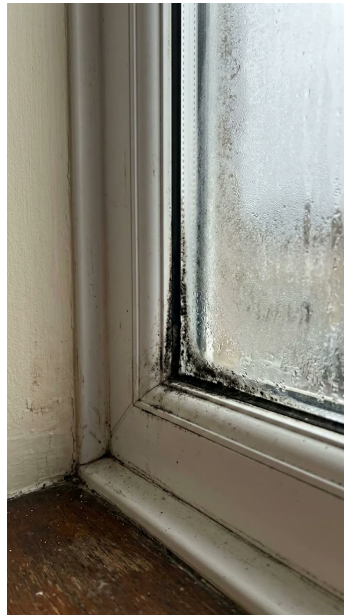
### 3. Windows

Bedroom window, sealed unit misted. Mould on the sealant at the corner. Frame is sound and the window opens and locks. Condensation on the inside of the glass.

| Hazard 2 | 11. Damp and mould growth. Back bedroom window, mould on the sealant at the corner of a misted sealed unit |
| Hazard 2, outcome | Needs making safe within 24 hours: No. Scored: No. Reported on the day with hazard 1, repair reference R-604118 |

| Windows | Inspected up close. Fair. uPVC double glazed, 2004, age 22. Standard lifetime 40 years. One sealed unit misted in the back bedroom. Estimated remaining life 12 years, replace about 2038 |

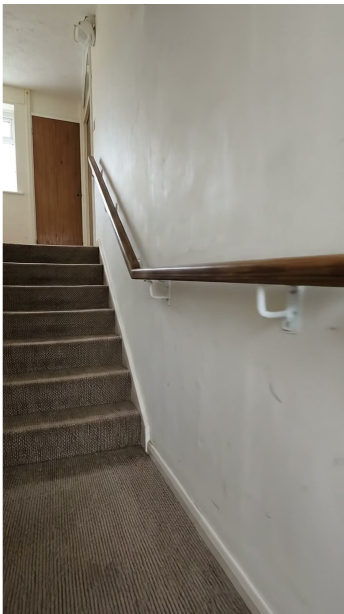
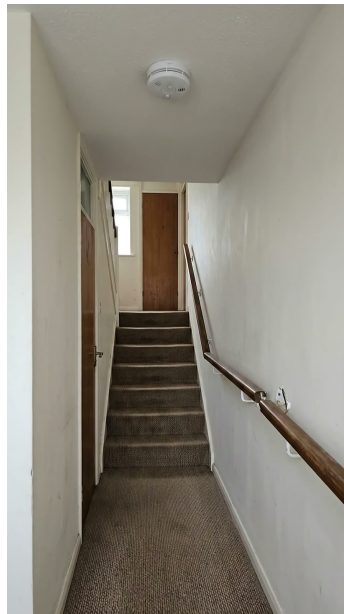
### 4. Safety and hazards

Smoke alarm fitted in the hall. Check the stair handrail fixings, possible falls hazard. One bracket on the lower rail has come away from the wall. Stair carpet is secure, no loose edges.

| Hazard 3 | 2. Falling on stairs etc. Handrail loose or missing: one bracket on the lower stair handrail has come away from the wall. Stair carpet secure |
| Hazard 3, outcome | Needs making safe within 24 hours: No. Scored: No, scored assessment requested. Reported to the repairs team on the day, repair reference R-604119 |
