# Boat Condition Visual Inspection

| Site | Example UK boatyard / small motorboat MB-021 |

| Report reference | DEMO-BOAT-001 |

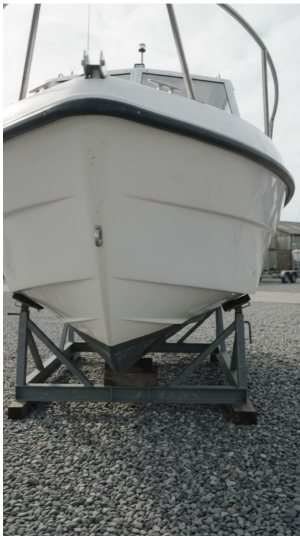
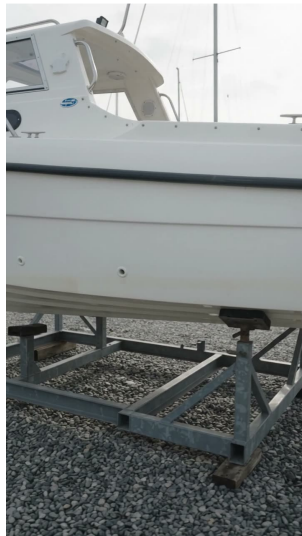
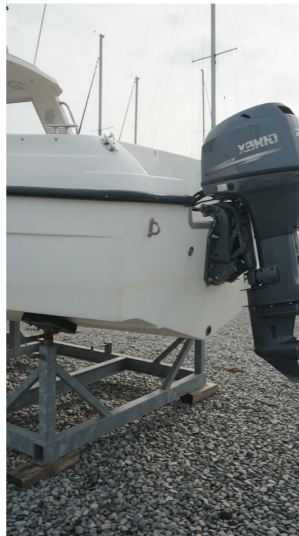
WC-01 / Flow example frames at 00:01, 00:04 and 00:07

1. The small motorboat is shown on hardstanding from an accessible ground-level position.  
Illustrative observation - verify against the real site before use.

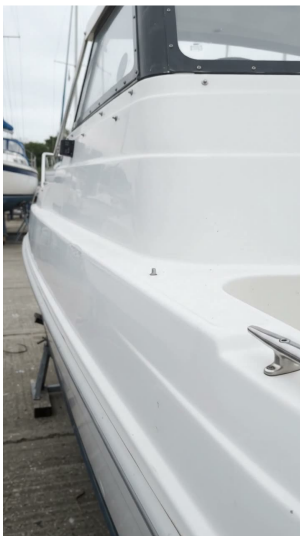
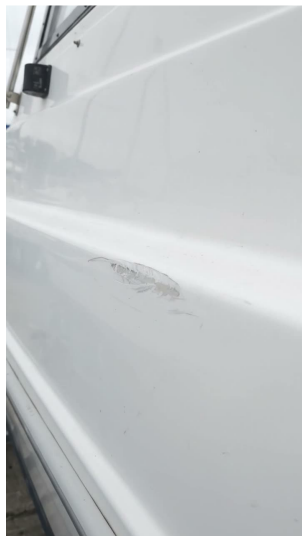
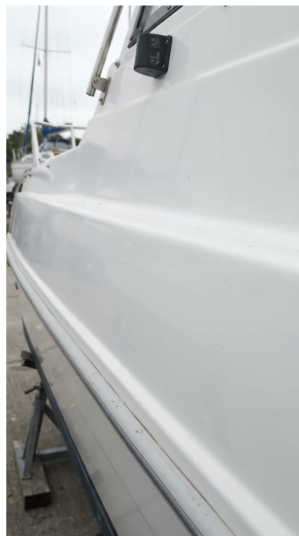
WC-02 / Flow example frames at 00:01, 00:04 and 00:07

1. The camera follows an accessible hull side; any apparent surface mark needs in-person verification.  
Illustrative observation - verify against the real site before use.

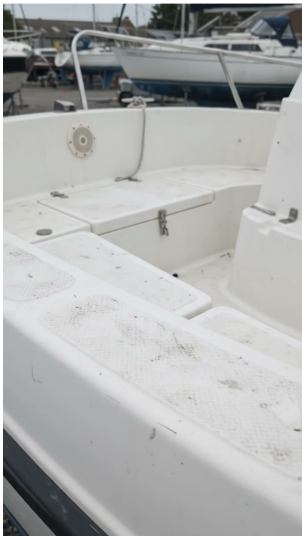
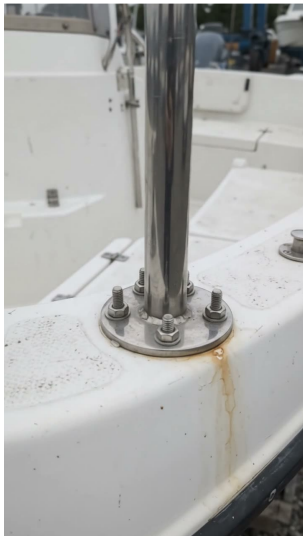
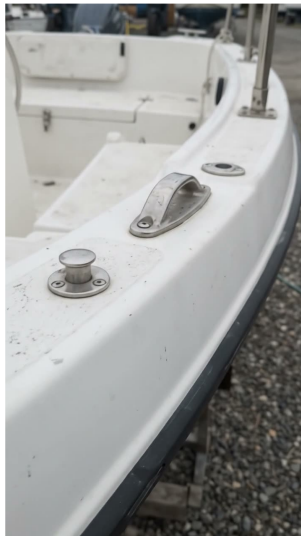
WC-03 / Flow example frames at 00:01, 00:04 and 00:07

1. Deck fittings and surrounding surfaces are filmed in a short close view.  
Illustrative observation - verify against the real site before use.

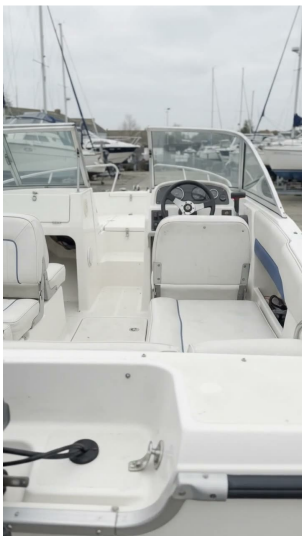
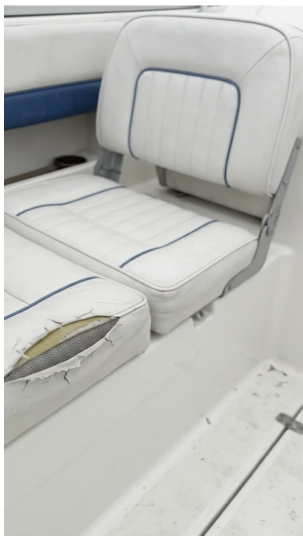
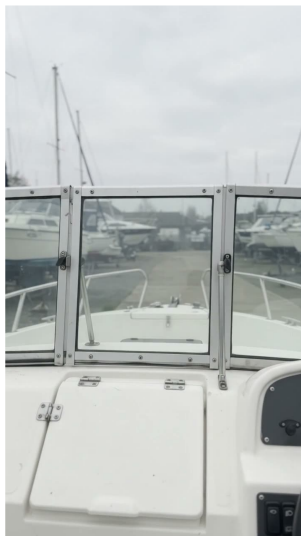
WC-04 / Flow example frames at 00:01, 00:04 and 00:07

1. The open cockpit and visible seating are recorded; closed spaces and systems remain unchecked.  
Illustrative observation - verify against the real site before use.
