# Concrete surface visual inspection

DEMO-CONCRETE-001

Example commercial site / retaining wall CW-01

09 October 2026

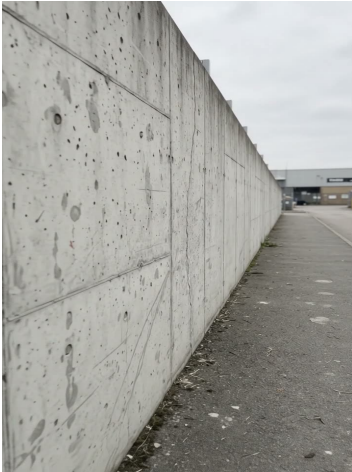
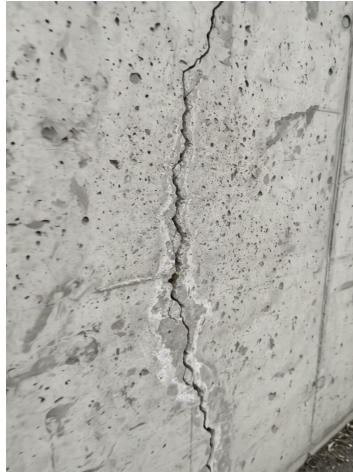
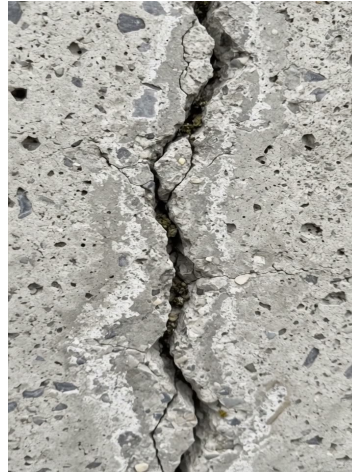
### 01 Whole wall and location

The example retaining wall and adjacent path are visible in a wide view.

Confirm the asset reference and access limits at the real site.

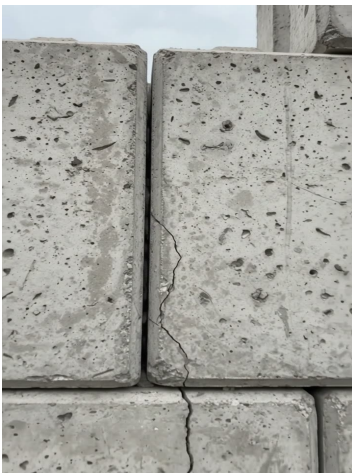
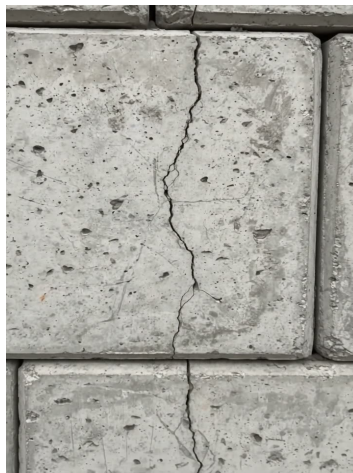
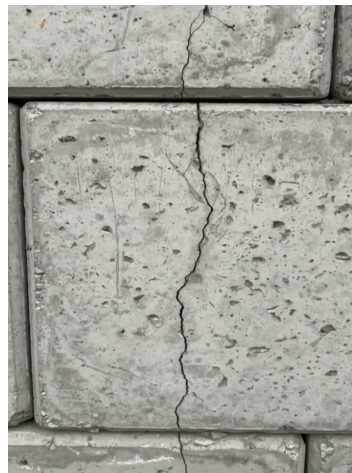
### 02 Visible surface crack

A narrow surface crack is visible near one vertical joint.

Have the crack assessed and measured by a competent person if required.

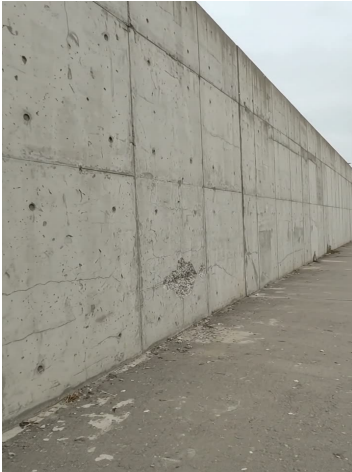
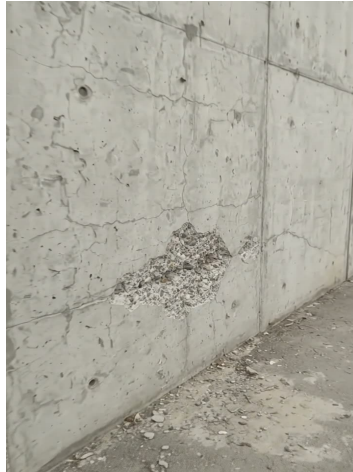
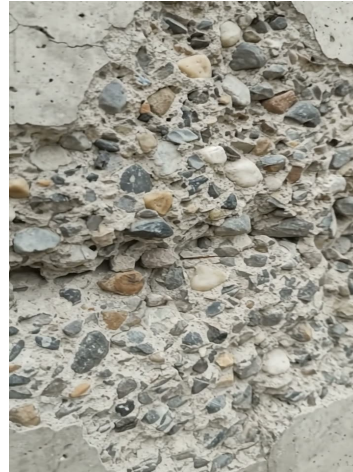
### 03 Rough-looking surface area

A rough-looking patch is visible near the wall base; its extent and cause need an in-person check.

Check for loose material and arrange competent repair assessment.

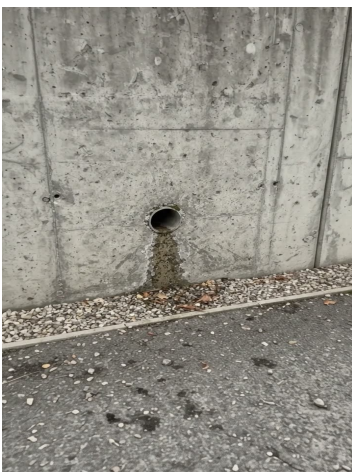
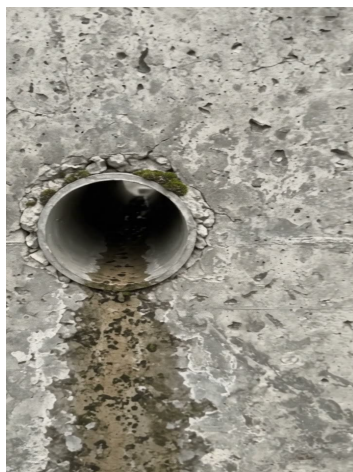
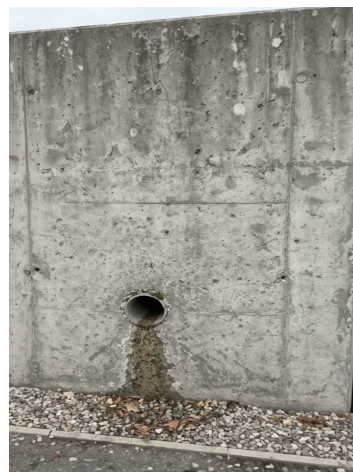
### 04 Lower edge and drainage context

The lower wall edge, outlet and adjacent staining are shown.

Investigate the outlet and any source of moisture separately.
