# Crack monitoring visual route

DEMO-CRACK-MONITORING-001

Illustrative semi-detached house / four separate scenes

Illustrative second monitoring visit

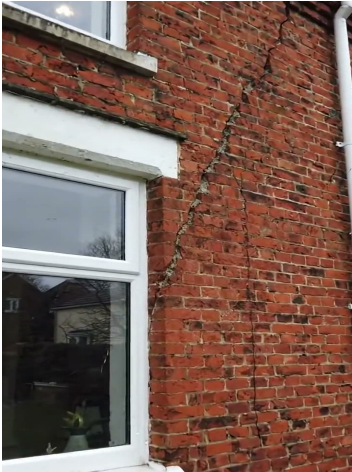
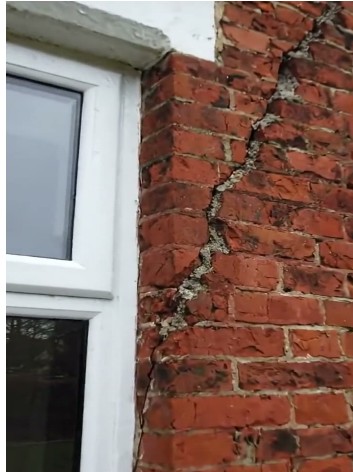
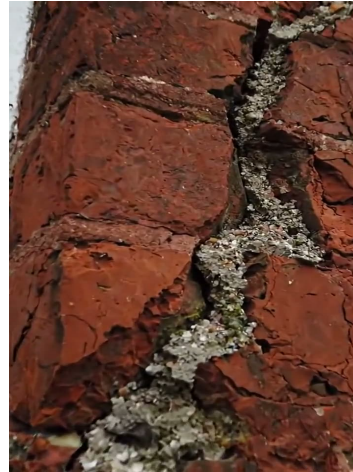
### 01 Wall and crack location

A brick side wall is shown with a stepped crack running up from a window corner.

Mark the wall and crack on a sketch so the next visit films the same place.

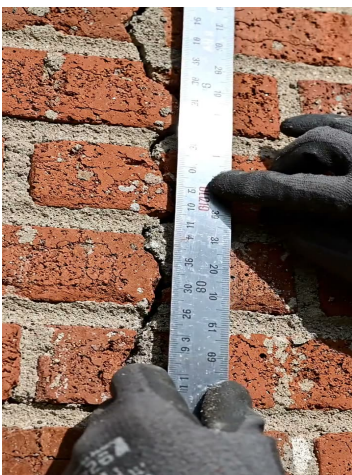
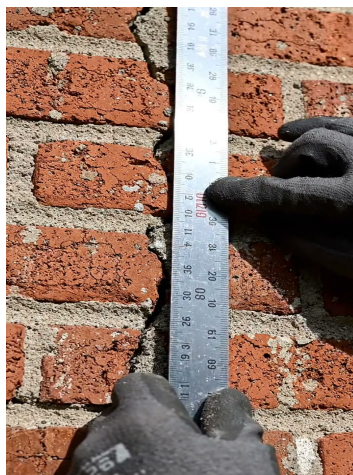
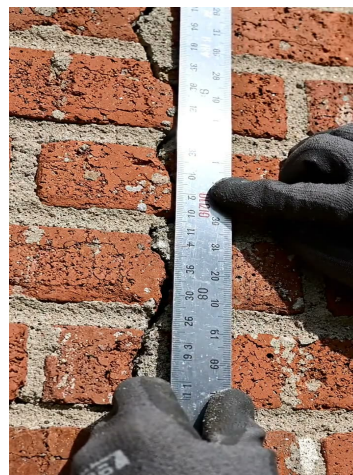
### 02 Crack close up with a scale

A close view shows the stepped crack in the mortar with a steel rule held beside it.

Record the reading and compare it with the last visit; refer any widening.

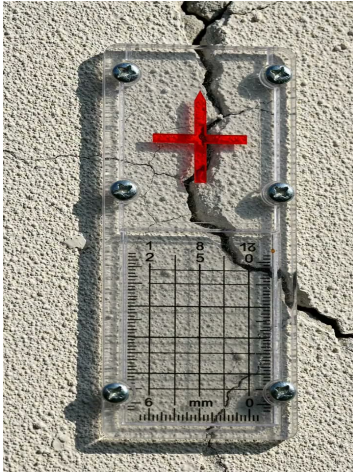
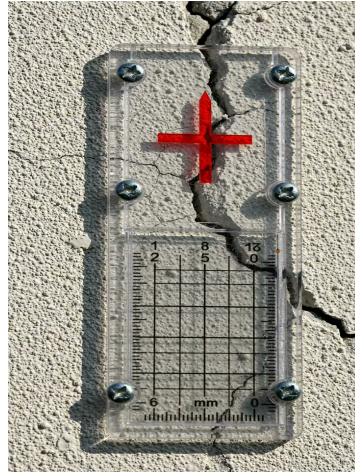
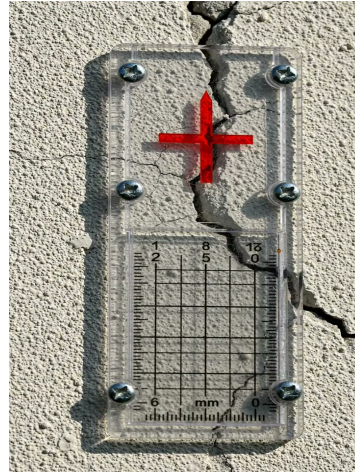
### 03 Tell-tale or reference marks

A plastic tell-tale crack monitor fixed across the crack is filmed square on.

Note the cursor position and the date beside the previous reading.

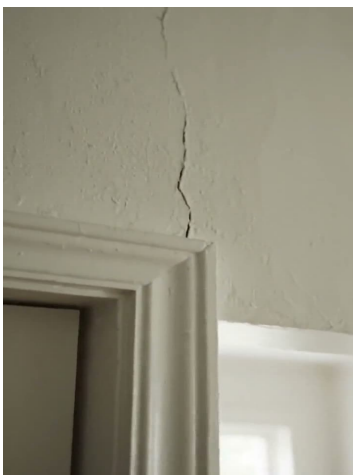
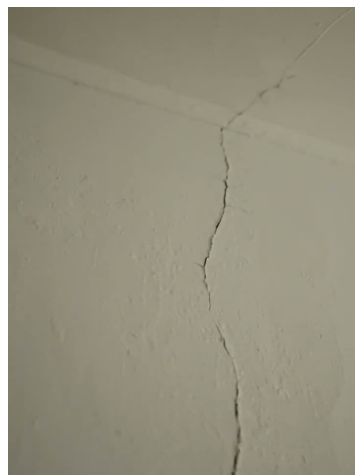
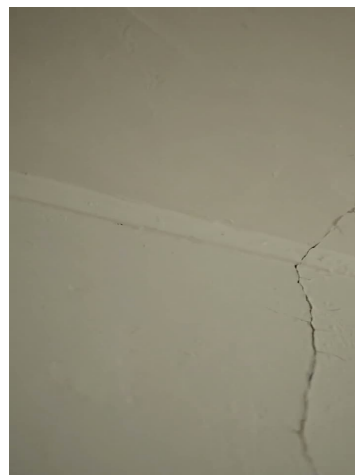
### 04 Matching crack inside

A diagonal plaster crack runs up from the corner of an internal door frame.

Check whether the inside crack lines up with the outside one and record both.
