# Façade condition visual inspection

DEMO-FACADE-001

Illustrative office façade / four independent scenes

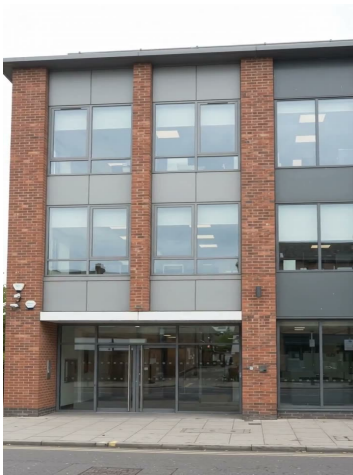
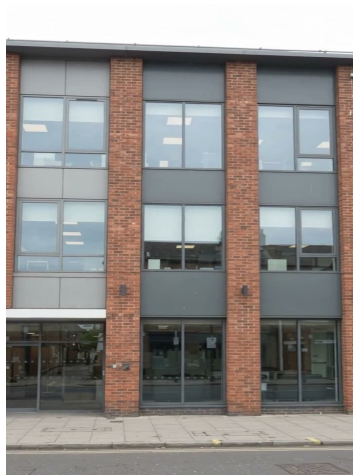
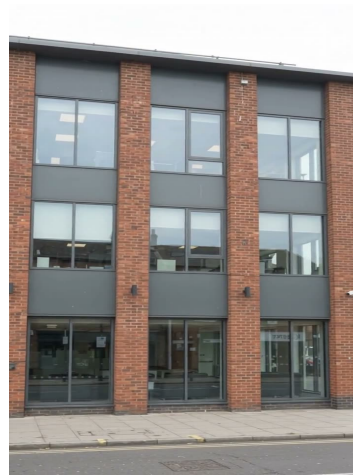
### 01 Whole elevation and reference

An illustrative office façade is visible from ground level; its compass orientation is not established.

Locate the exact elevation on the real building plan.

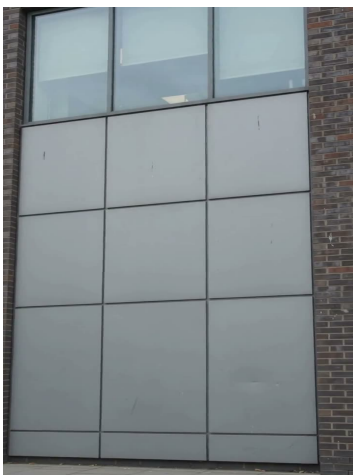
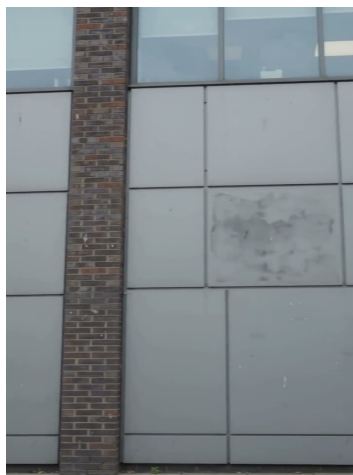
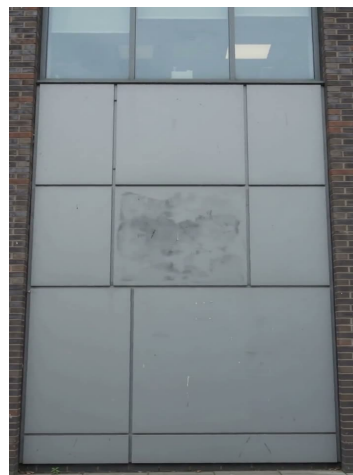
### 02 Accessible panel surface

A lower façade panel surface is visible in the example.

Refer any suspected damage for competent close-range review.

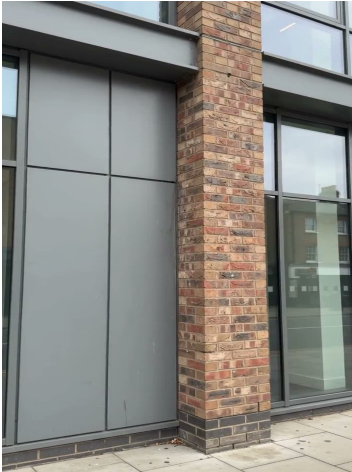
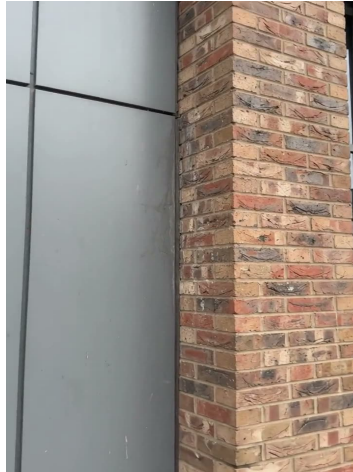
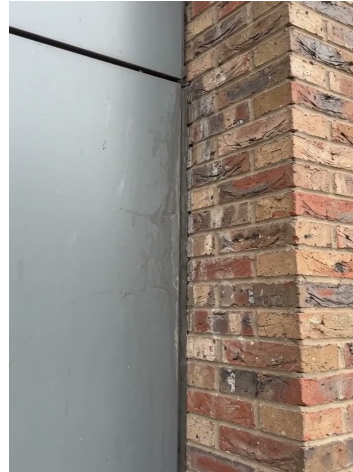
### 03 Visible panel-to-brick joint

The panel-to-brick junction is visible from ground level; its condition and performance are unverified.

Refer any suspected gap or staining for competent close-range review.

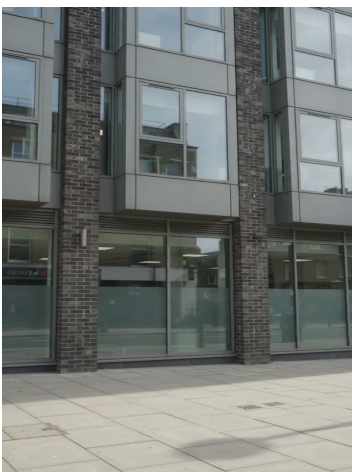
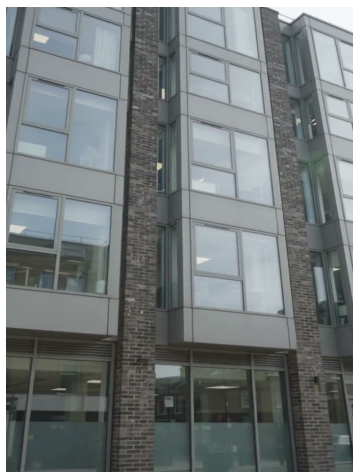
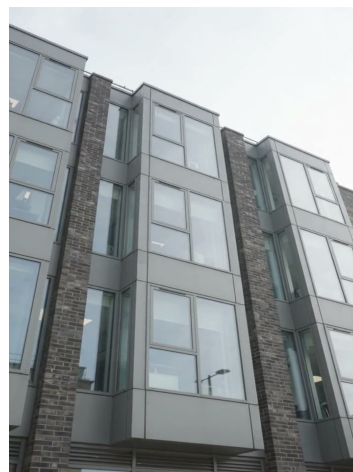
### 04 Upper façade and access limits

Upper areas are only visible at a distance in the example.

Plan specialist access where detailed assessment is required.
