## SITE SURVEY REPORT

# Flat Roof Condition Visual Inspection

| Site | Example commercial building / roof area R-01 |

| Report reference | DEMO-ROOF-001 |

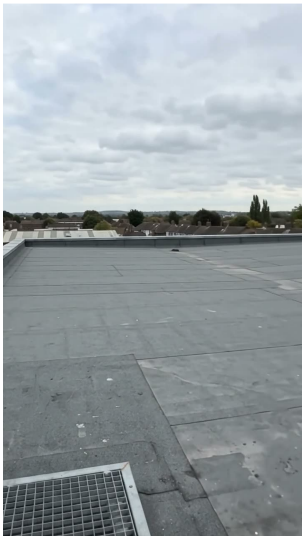
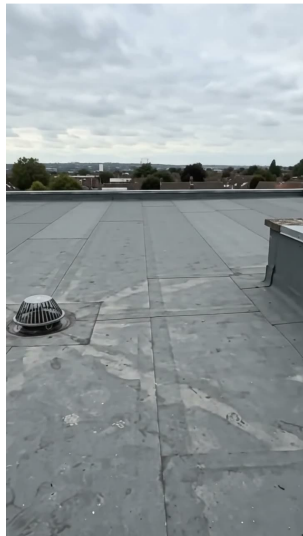
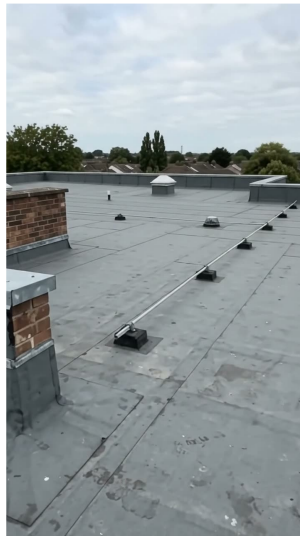
WC-01 / Flow example frames at 00:01, 00:04 and 00:07

1. The broad roof surface is shown; the footage does not establish that access is safe.  
Illustrative observation - verify against the real site before use.

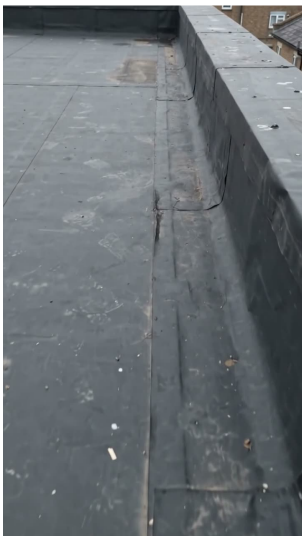
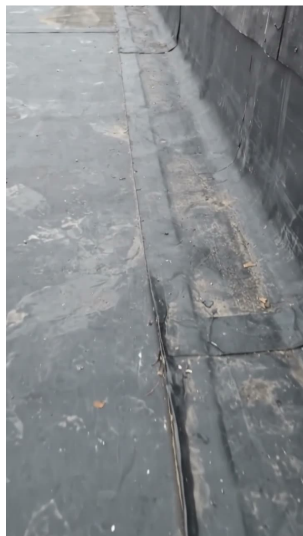
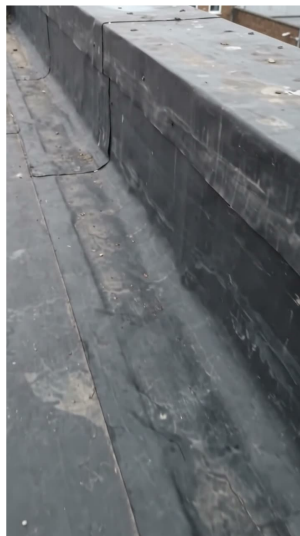
WC-02 / Flow example frames at 00:01, 00:04 and 00:07

1. A raised-looking edge is visible at one membrane detail; its condition needs hands-on assessment.  
Illustrative observation - verify against the real site before use.

| Follow-up action | Refer the visible details to a competent roofing contractor under a planned safe access method; document their assessment and any repair separately. |

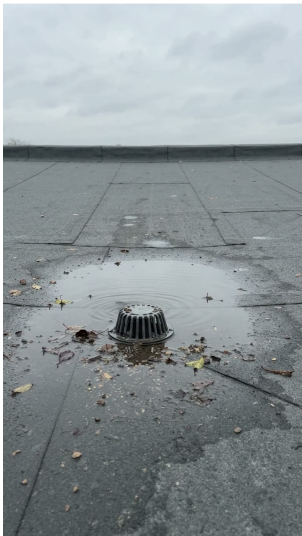
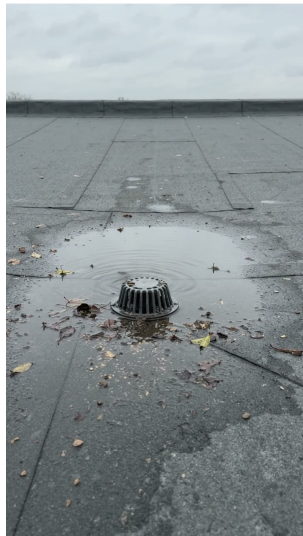
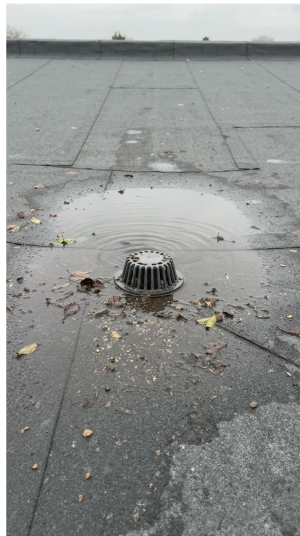
WC-03 / Flow example frames at 00:01, 00:04 and 00:07

1. Shallow standing water and small debris are visible near the outlet.  
Illustrative observation - verify against the real site before use.

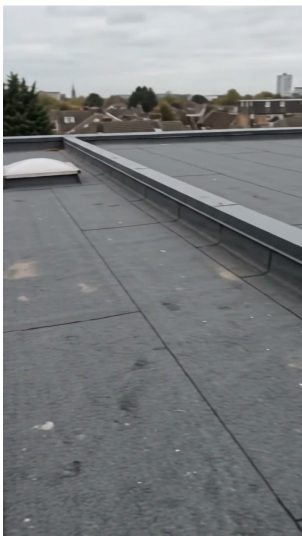
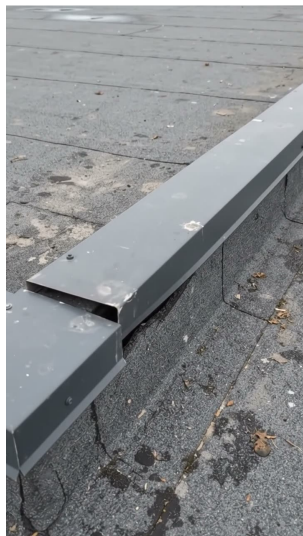
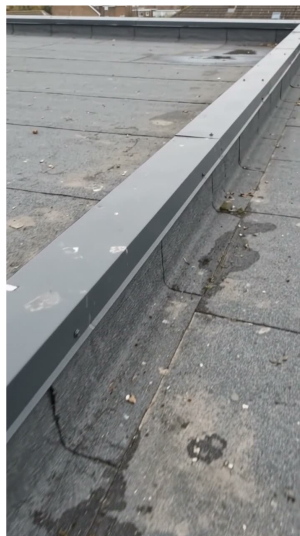
WC-04 / Flow example frames at 00:01, 00:04 and 00:07

1. The parapet and one loose-looking trim section are visible from the protected area.  
Illustrative observation - verify against the real site before use.
