## SITE SURVEY REPORT

# Gutter Condition Visual Inspection

| Site | Example single-storey property / rear elevation |

| Report reference | DEMO-GUTTER-001 |

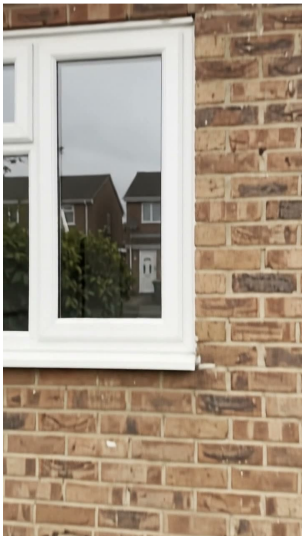
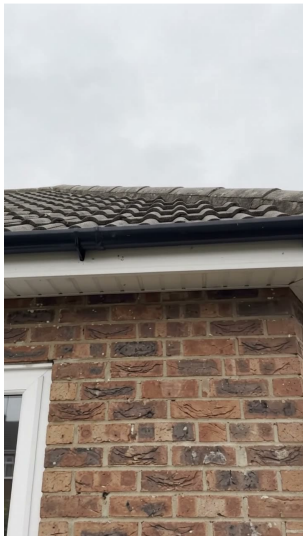
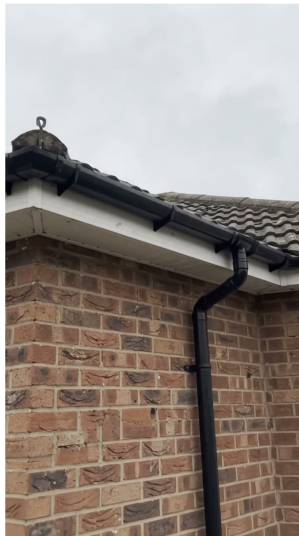
WC-01 / Flow example frames at 00:01, 00:04 and 00:07

1. The rear elevation and continuous visible gutter run are shown.  
Illustrative observation - verify against the real site before use.

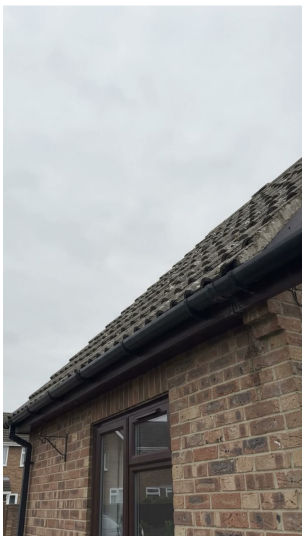
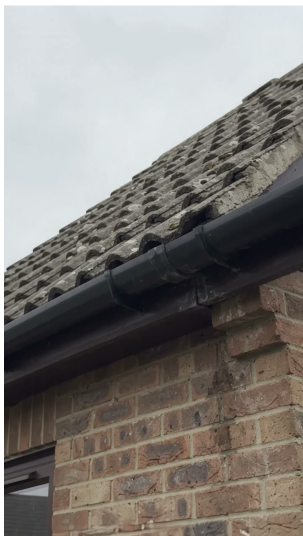
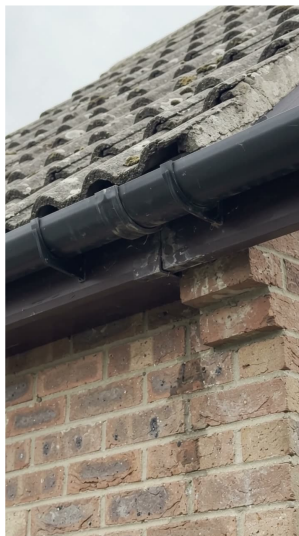
WC-02 / Flow example frames at 00:01, 00:04 and 00:07

1. The gutter joint and adjacent roof edge are visible; support and seal condition cannot be confirmed from the clip.  
Illustrative observation - verify against the real site before use.

| Follow-up action | Check the real installation using a safe work method, clear accessible debris where authorised and investigate the joint and wall staining. |

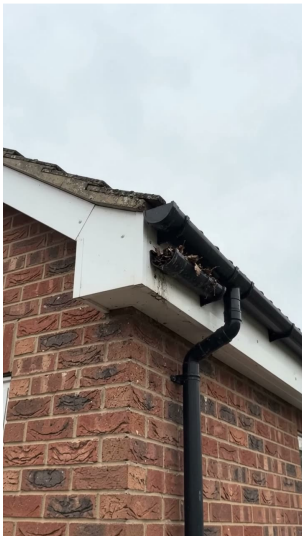
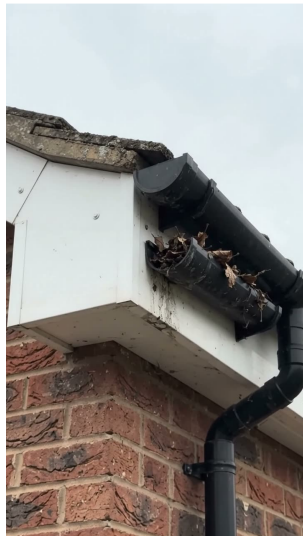
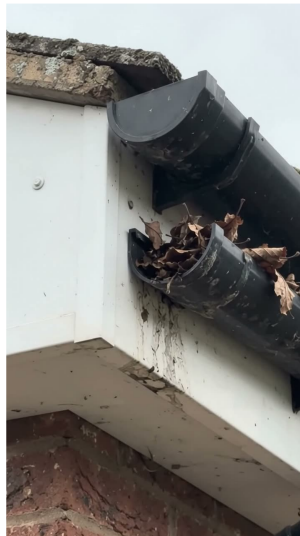
WC-03 / Flow example frames at 00:01, 00:04 and 00:07

1. Leaf material appears near the visible outlet opening.

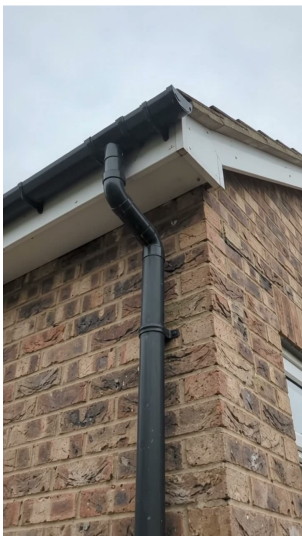
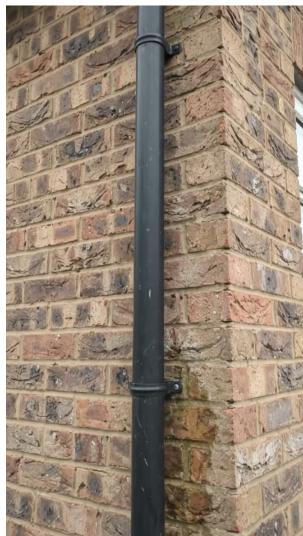
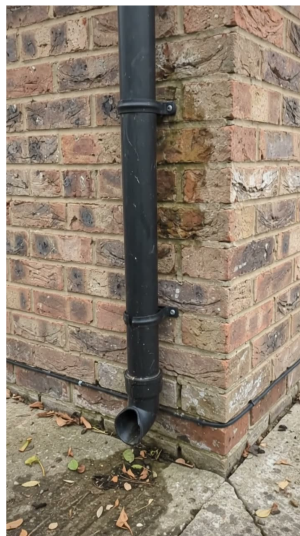
WC-04 / Flow example frames at 00:01, 00:04 and 00:07

1. The external downpipe route and joints are recorded against the brick elevation.
