## SITE SURVEY REPORT

# Paint Finish Visual Inspection

| Site | Example flat / fictional lounge wall |

| Report reference | DEMO-PAINT-001 |

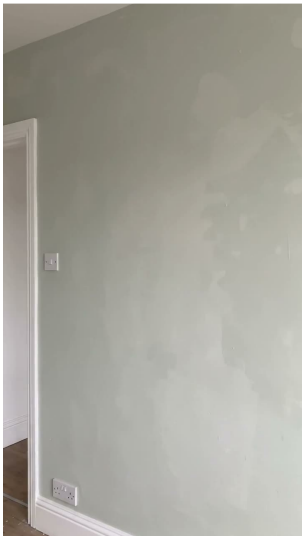
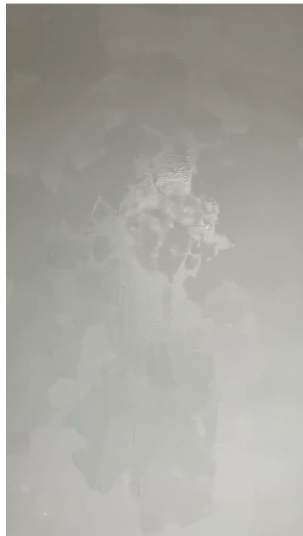
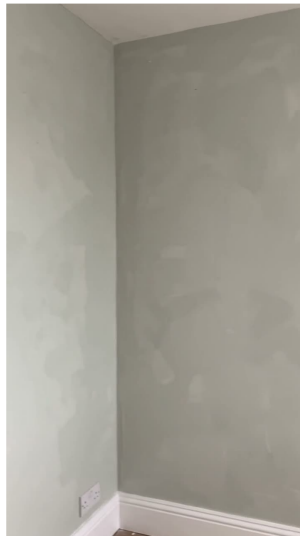
WC-01 / Flow example frames at 00:01, 00:04 and 00:07

1. The staged footage shows part of a painted wall; the full room and actual surface identity are not established.  
Illustrative observation - verify against the real site before use.

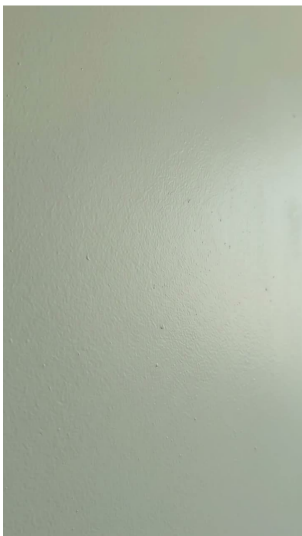
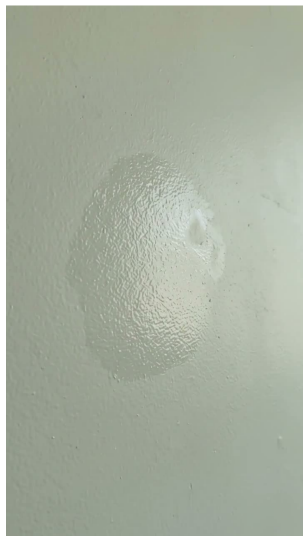
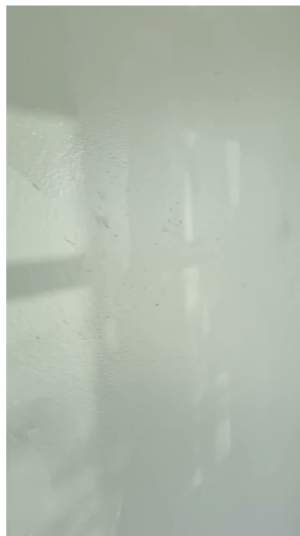
WC-02 / Flow example frames at 00:01, 00:04 and 00:07

1. An apparent sheen patch is visible in the staged wall view; camera exposure and lighting may affect its appearance.  
Illustrative observation - verify against the real site before use.

| Follow-up action | Record the exact location and lighting, compare with the agreed specification, ask the responsible decorator to review and document any remedial work. |

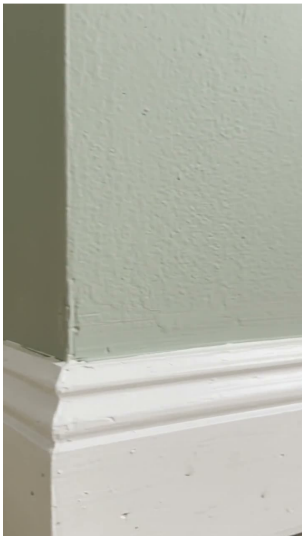
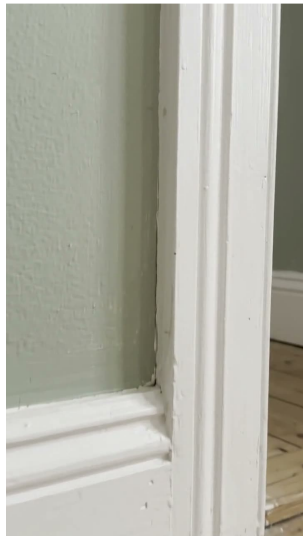
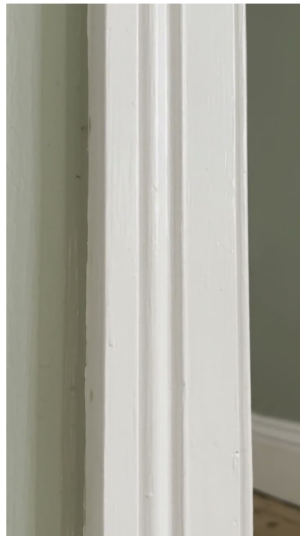
WC-03 / Flow example frames at 00:01, 00:04 and 00:07

1. An accessible trim edge is shown; hidden or unfilmed edges remain unknown.  
Illustrative observation - verify against the real site before use.

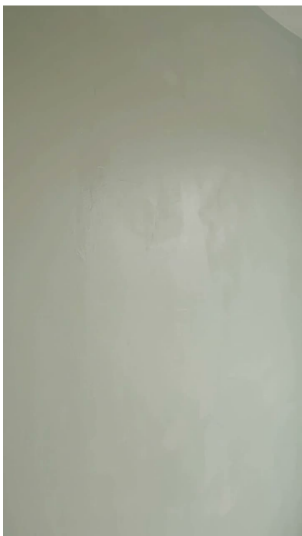
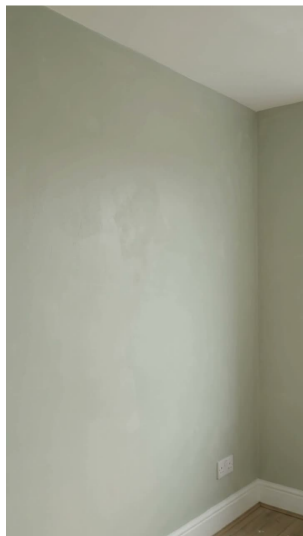
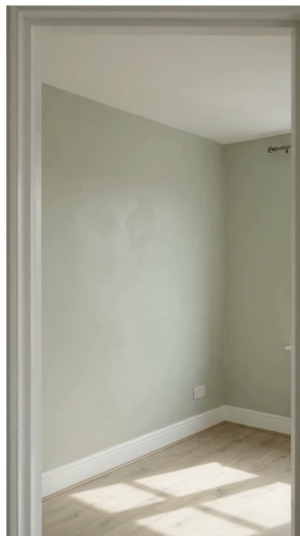
WC-04 / Flow example frames at 00:01, 00:04 and 00:07

1. The final staged view shows more of the wall and skirting; it does not certify completion.  
Illustrative observation - verify against the real site before use.
