# Coating and corrosion inspection visual route

DEMO-PROTECTIVE-COATING-001

Illustrative industrial building frame / four separate scenes

Illustrative condition walk before maintenance painting

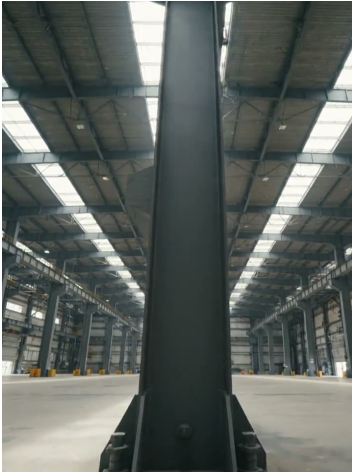
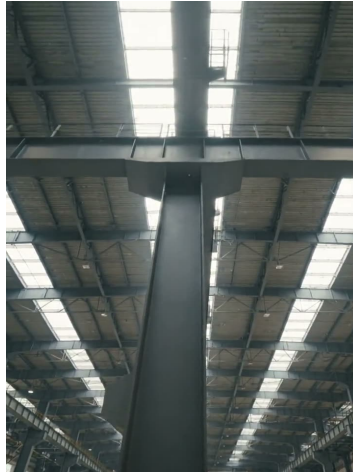
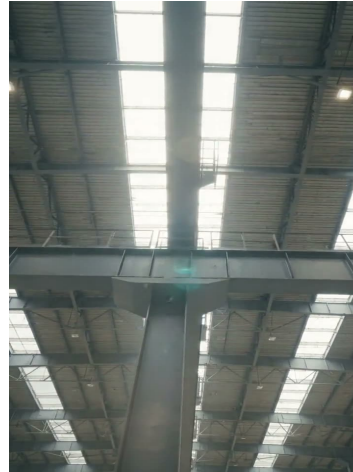
### 01 Structure and area reference

Painted structural steel columns and beams in an industrial building are shown in a wide view.

Confirm the gridline or member mark on the drawing.

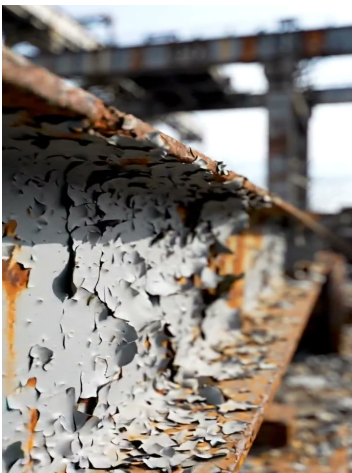
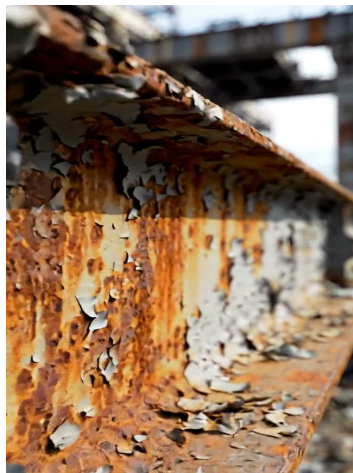
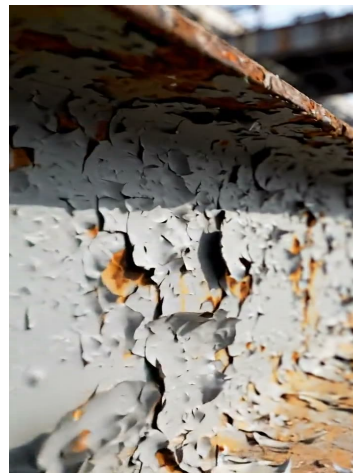
### 02 Coating breakdown

Blistered and flaking paint is visible on a lower steel flange.

Mark the area for a coating inspector to measure and grade.

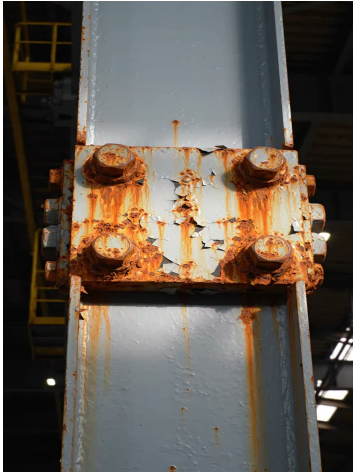
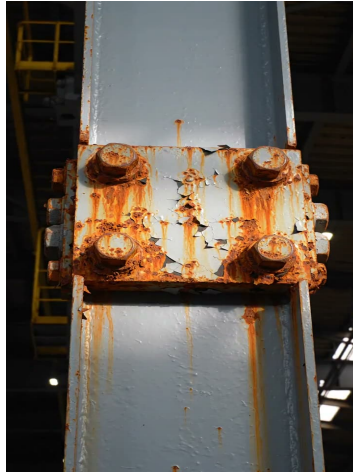
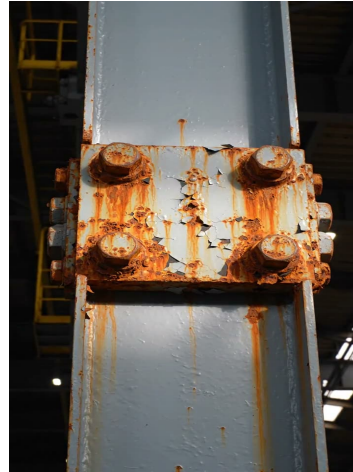
### 03 Bolted connection and edges

Rust staining runs from the bolts of a beam to column connection.

Add bolted connections to the maintenance painting scope.

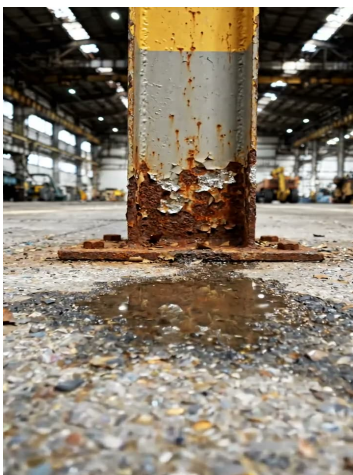
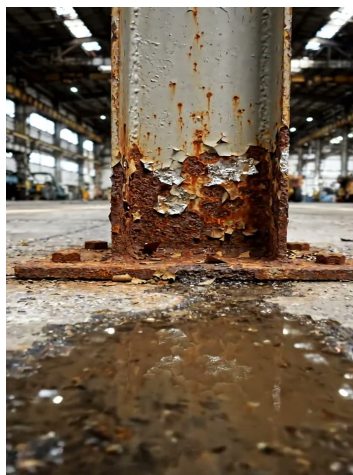
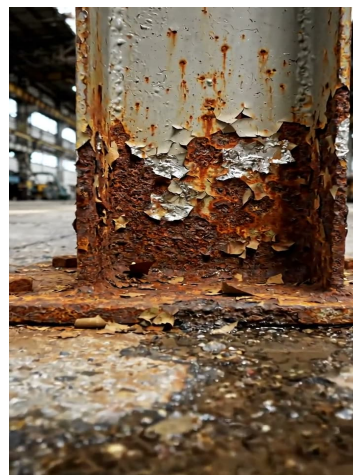
### 04 Column base and limits

Corrosion is visible where a column meets the concrete floor.

Check for standing water at the base and record any section loss for an engineer.
