## SITE SURVEY REPORT

# Shipping Container Visual Inspection

| Site | Example depot / container DEMO-001 |

| Report reference | DEMO-CONT-001 |

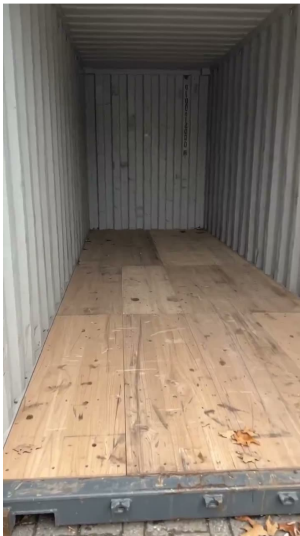
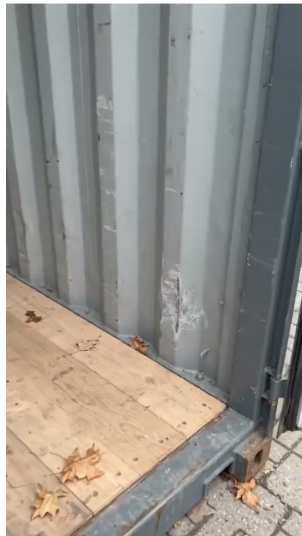
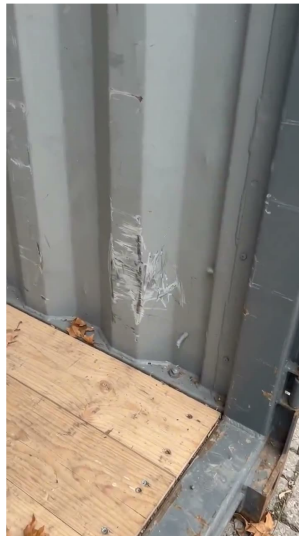
WC-01 / Flow example frames at 00:01, 00:04 and 00:07

**Walk Cam evidence****2. Floor and interior**

1. Dry leaves and minor surface scuffs are visible at the threshold; no load or underfloor condition can be assessed.  
Illustrative observation - verify against the real site before use.

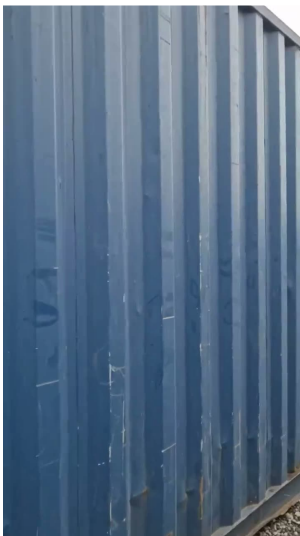
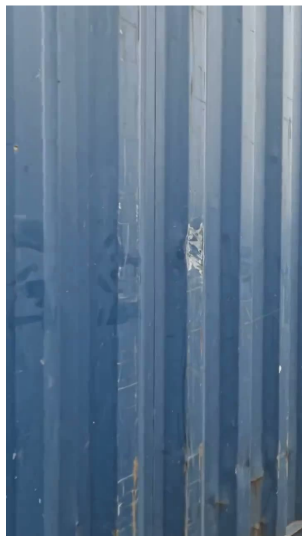
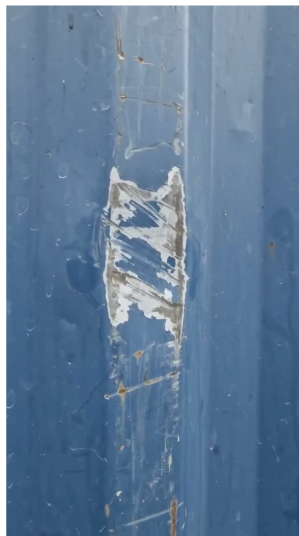
WC-02 / Flow example frames at 00:01, 00:04 and 00:07

**3. Exterior side walls**

1. Scuffs and a shallow-looking area of distortion are visible on the accessible side wall.  
Illustrative observation - verify against the real site before use.

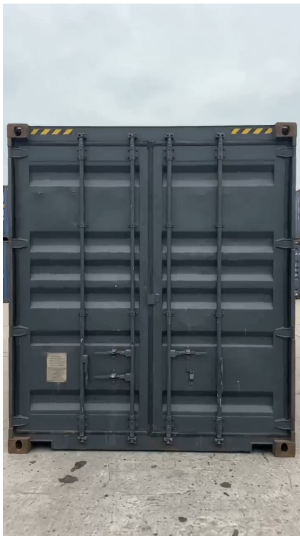
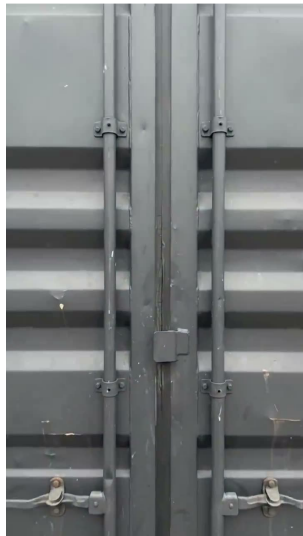
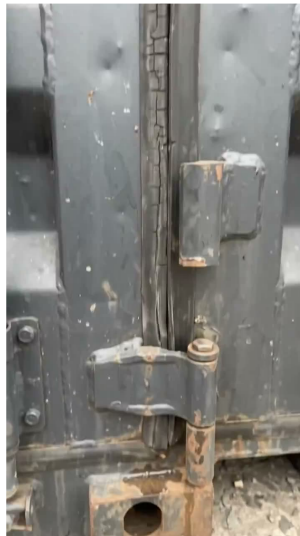
WC-03 / Flow example frames at 00:01, 00:04 and 00:07

**Walk Cam evidence****4. Doors and closure**

1. Surface wear is visible around the double-door area. Seal performance was not tested.  
Illustrative observation - verify against the real site before use.

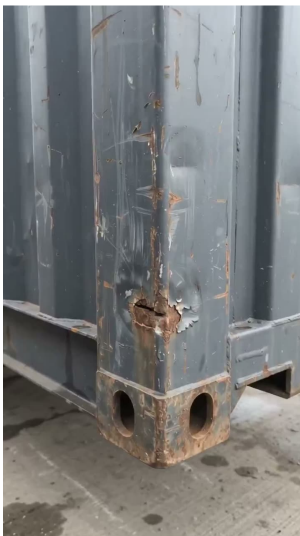
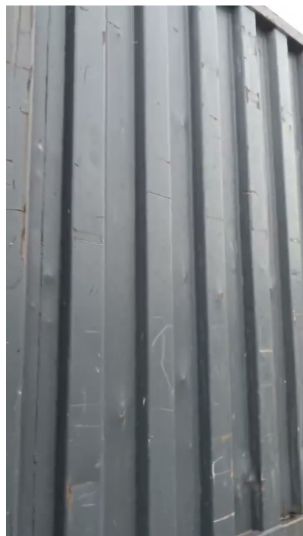
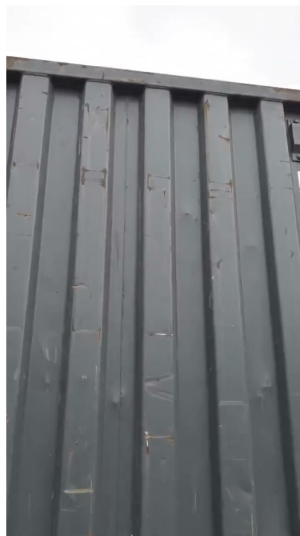
WC-04 / Flow example frames at 00:01, 00:04 and 00:07

**5. Corner post and lower structure**

1. Localized surface rust staining is visible at the lower corner area.  
Illustrative observation - verify against the real site before use.
