# Tiling workmanship visual inspection

DEMO-TILING-001

Example refurbished bathroom / shower area B-01

Illustrative pre-handover finish review

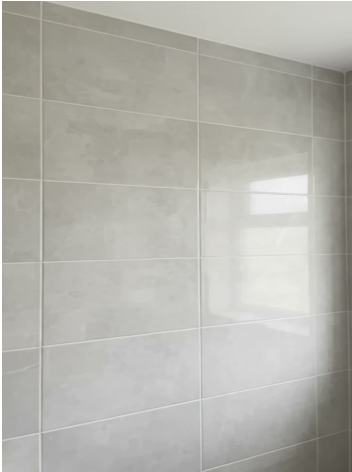
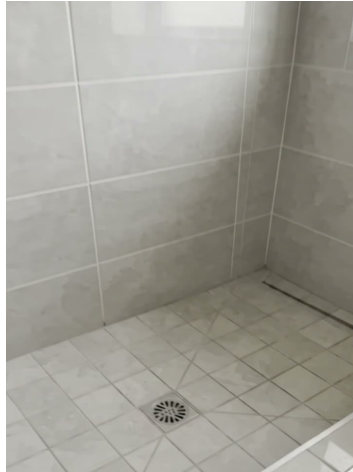
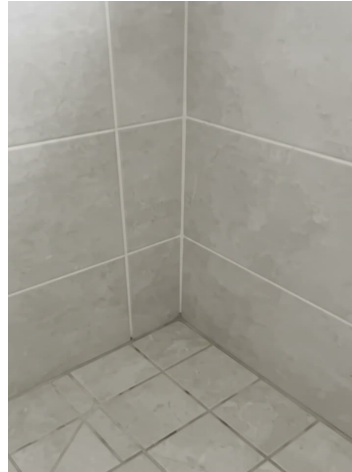
### 01 Whole tiled area

The shower wall and floor are visible in a wide example view.

Confirm the room and finish reference on a real visit.

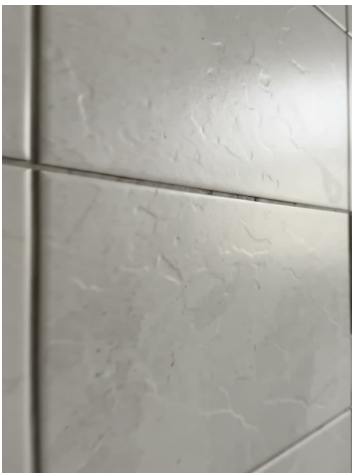
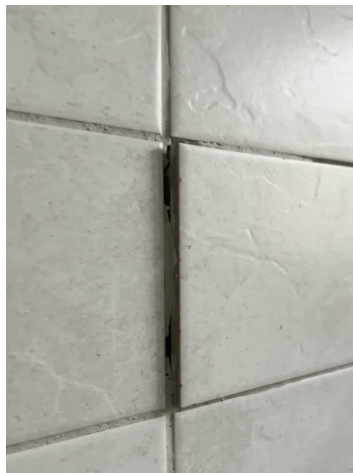
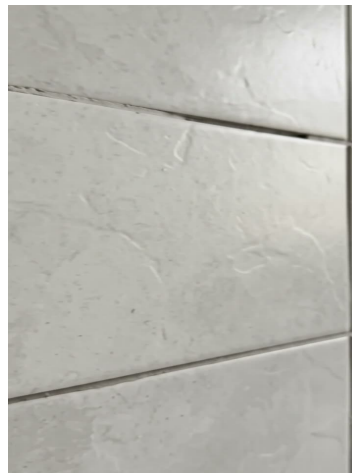
### 02 Adjacent tile edges

One wall-tile edge appears to sit slightly proud of its neighbour.

Inspect and measure the edge in person if acceptance depends on it.

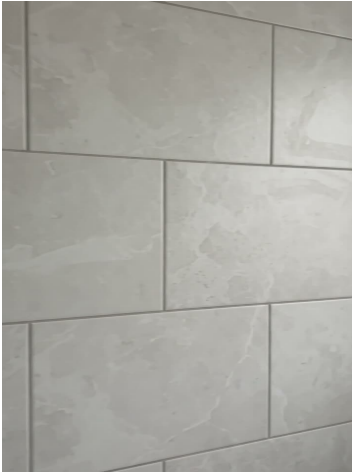
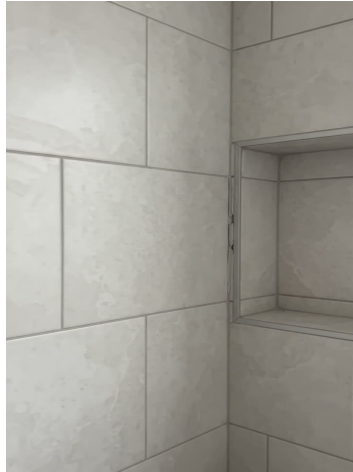
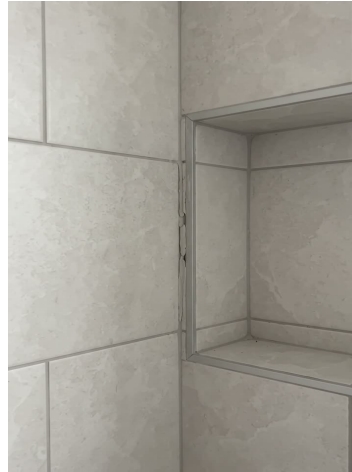
### 03 Grout joints and niche

A grout joint looks uneven beside the shower niche.

Agree any finish correction with the installer and record it.

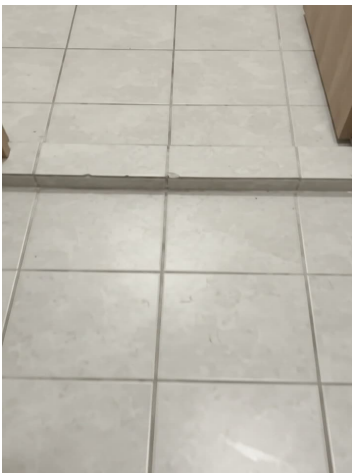
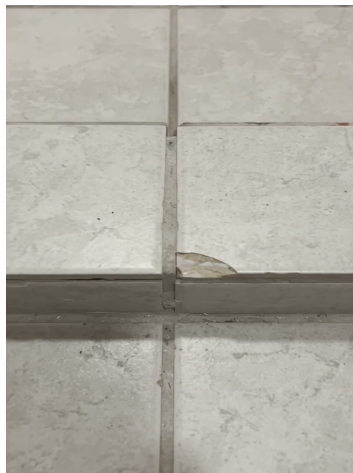
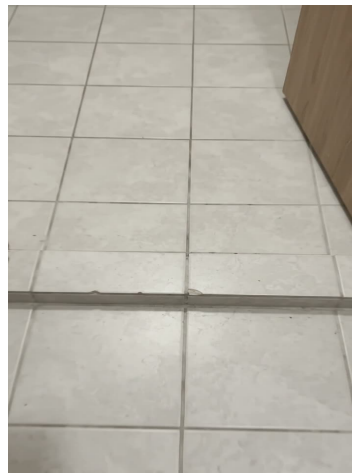
### 04 Tile edge at threshold

A small chip is visible on one tile edge near the threshold.

Confirm the chip and decide whether repair or replacement is appropriate.
