# Dry rot and timber decay inspection visual route

DEMO-TIMBER-DECAY-001

Illustrative Victorian terrace / four separate scenes

Illustrative investigation of a damp wall

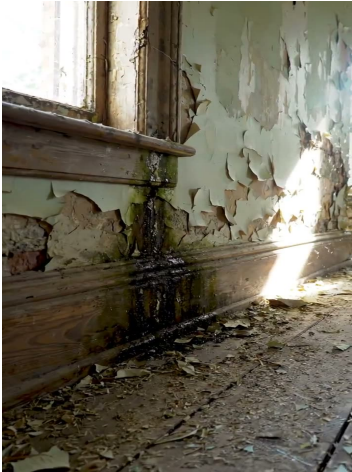
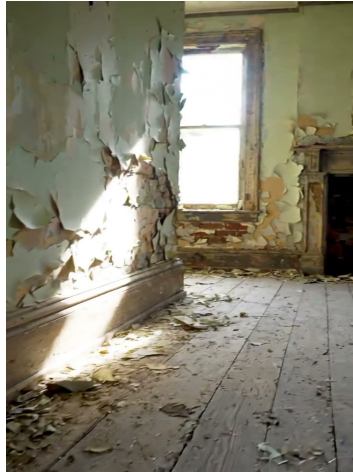
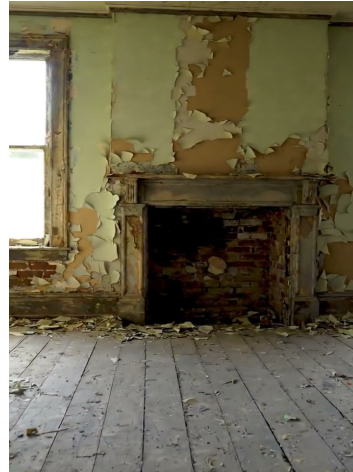
### 01 Room and moisture source

A ground floor room with damp staining low on an external wall is shown.

Find and stop the moisture source before any timber repair.

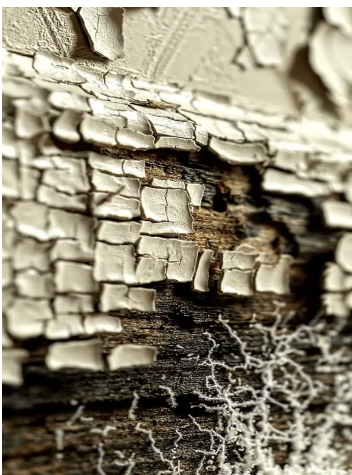
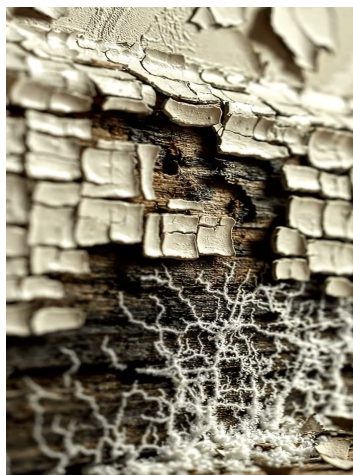
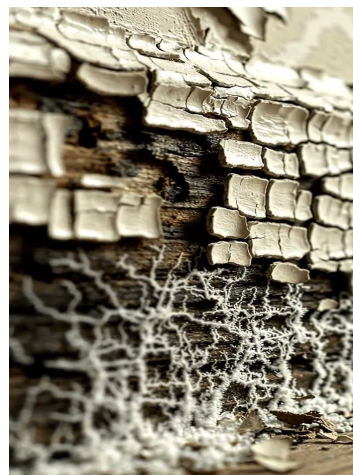
### 02 Skirting and joinery

A skirting board shows cracking and darkened, shrunken timber.

Ask a timber surveyor to confirm the decay and its extent.

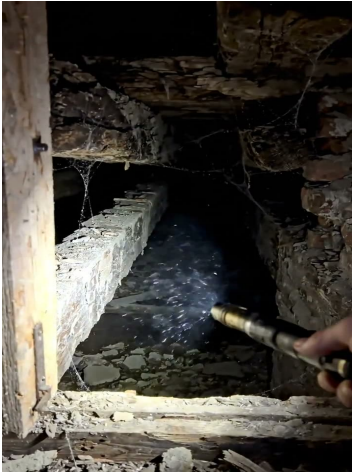
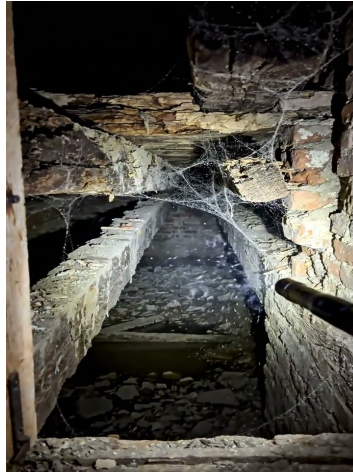
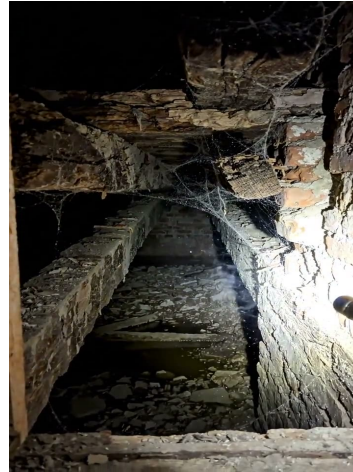
### 03 Floor void through an opening

Floor joists below an open hatch show darkened timber near the wall.

Record which joists are affected and how far along the wall.

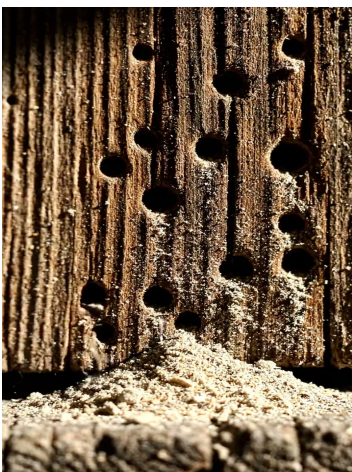
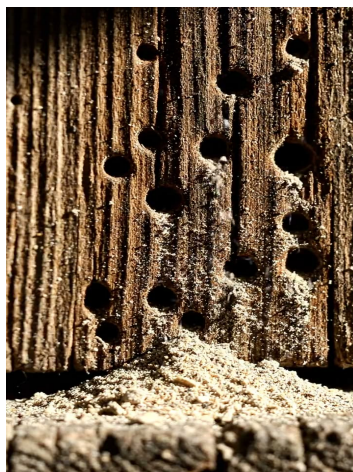
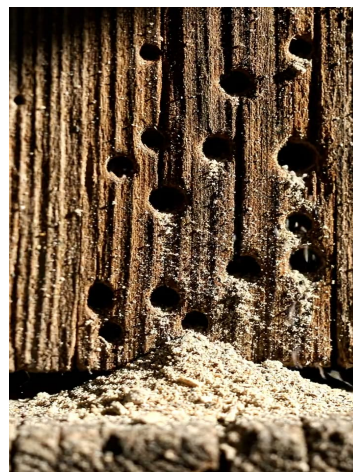
### 04 Woodworm holes and frass

Small round exit holes are visible in an old timber beam.

Check for fresh dust over the coming weeks to see if activity continues.
