# Warehouse Racking Visual Inspection

| Site | Example warehouse / fictional aisle B bay 04 |

| Report reference | DEMO-RACK-001 |

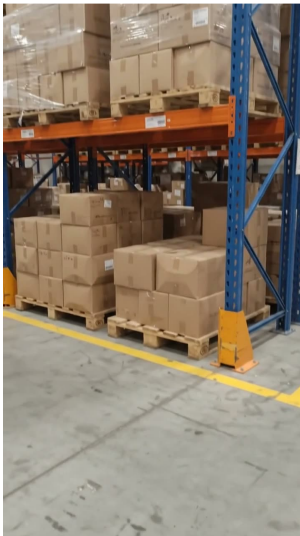
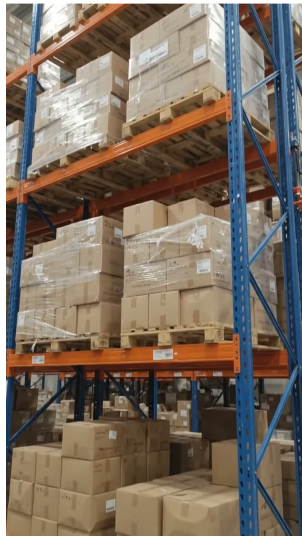
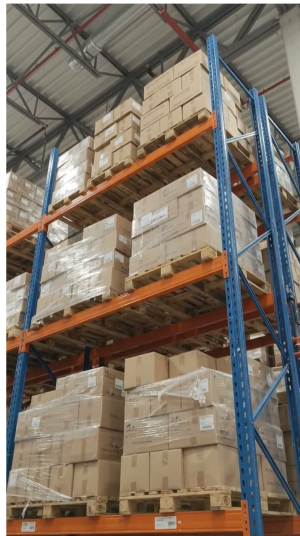
WC-01 / Flow example frames at 00:01, 00:04 and 00:07

1. A staged warehouse rack bay is shown; the actual ID is fictional.  
Illustrative observation - verify against the real site before use.

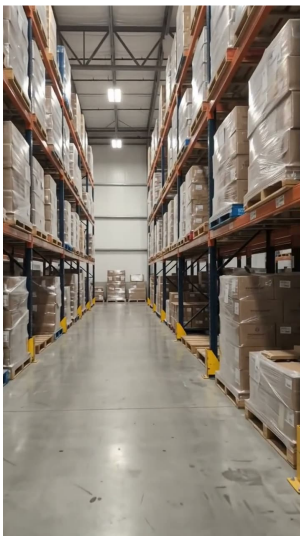
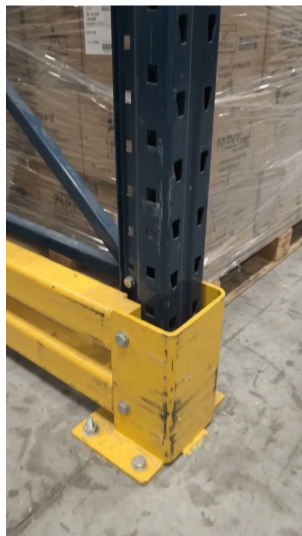
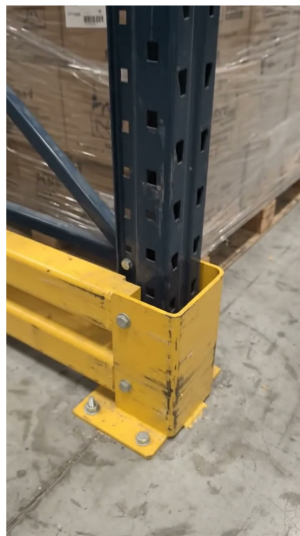
WC-02 / Flow example frames at 00:01, 00:04 and 00:07

1. The lower upright and adjacent protection are visible; impact severity is not assessed.  
Illustrative observation - verify against the real site before use.

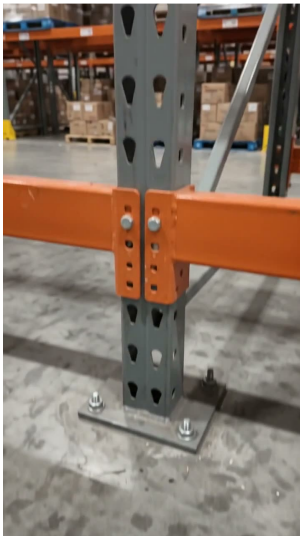
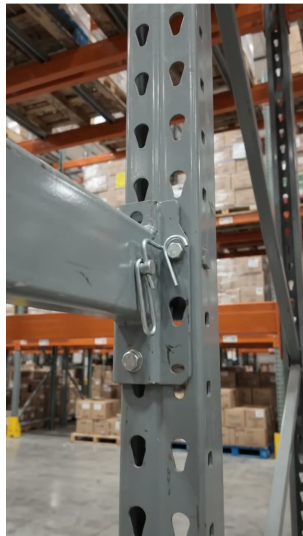
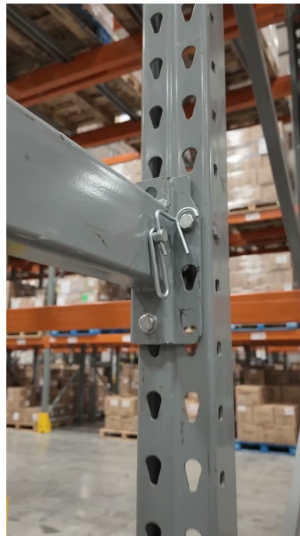
WC-03 / Flow example frames at 00:01, 00:04 and 00:07

1. A beam junction is illustrated; locking and capacity are not established.  
Illustrative observation - verify against the real site before use.

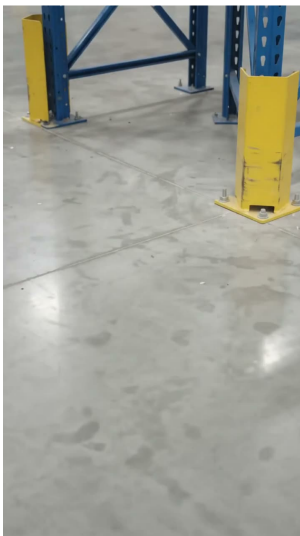
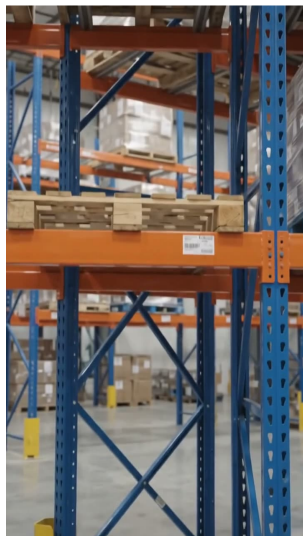
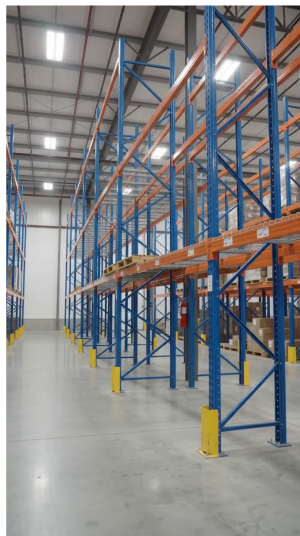
WC-04 / Flow example frames at 00:01, 00:04 and 00:07

1. A final staged bay view provides context but no safety classification.  
Illustrative observation - verify against the real site before use.

| Follow-up action | Notify the person responsible for racking safety, apply immediate site controls if damage is suspected, and obtain the required competent assessment before use decisions. |
