# Water Damage Visual Inspection

| Site | Example flat / fictional living room |

| Report reference | DEMO-WATER-001 |

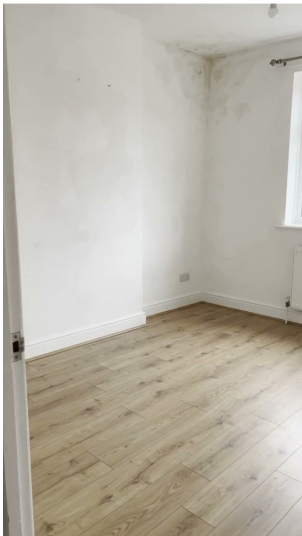
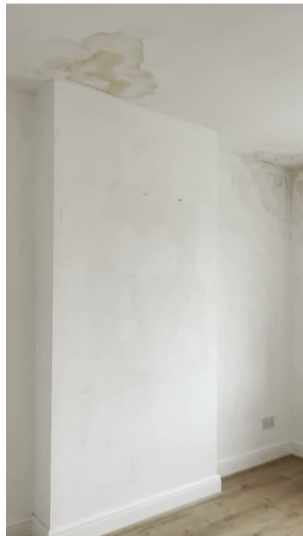
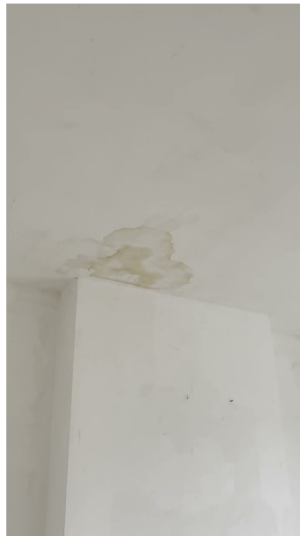
WC-01 / Flow example frames at 00:01, 00:04 and 00:07

1. The empty living room is shown from the doorway with ceiling and wall marks in context. Illustrative observation - verify against the real site before use.

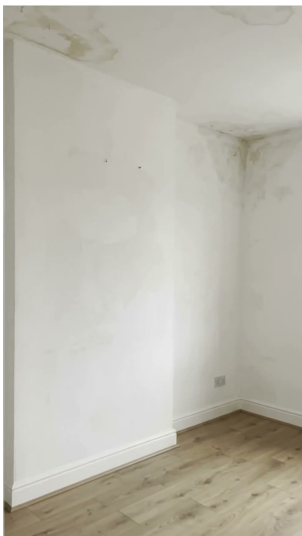
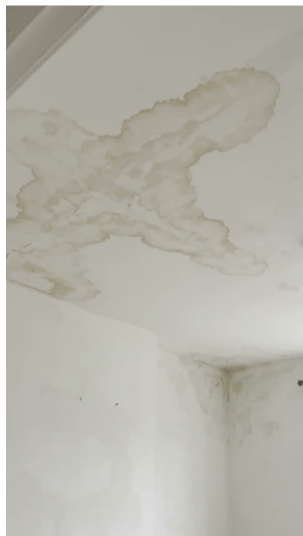
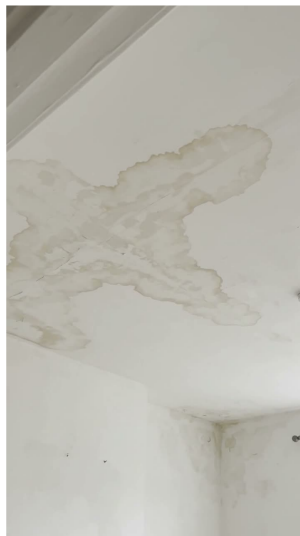
WC-02 / Flow example frames at 00:01, 00:04 and 00:07

1. A pale brown discoloration is visible on part of the white ceiling. Illustrative observation - verify against the real site before use.

| <b>Follow-up action</b> | Notify the property lead, preserve the original record, obtain the applicable specialist assessment and record the agreed next visit or repair action. |

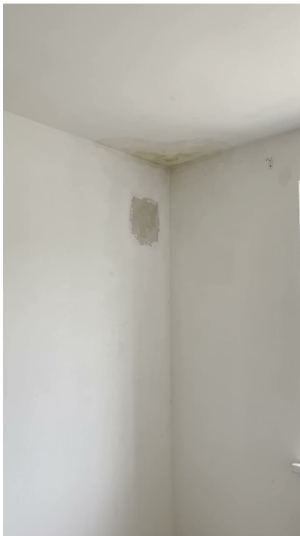
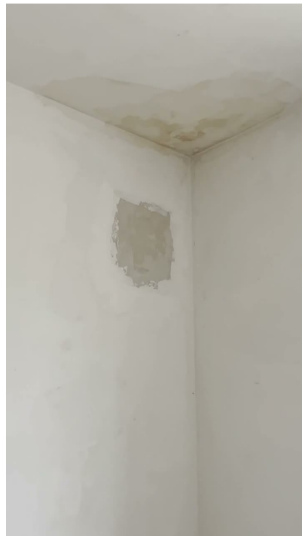
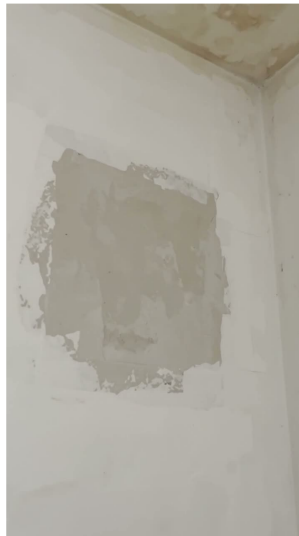
WC-03 / Flow example frames at 00:01, 00:04 and 00:07

1. An altered rectangular finish patch is visible on the upper wall beneath the marked ceiling edge; its cause is not established. Illustrative observation - verify against the real site before use.
