# Air Conditioning Commissioning Record

| Site | Bridge House, 2nd floor offices |

| Project | Bridge House, 2nd floor offices: split system commissioning (completed example) |

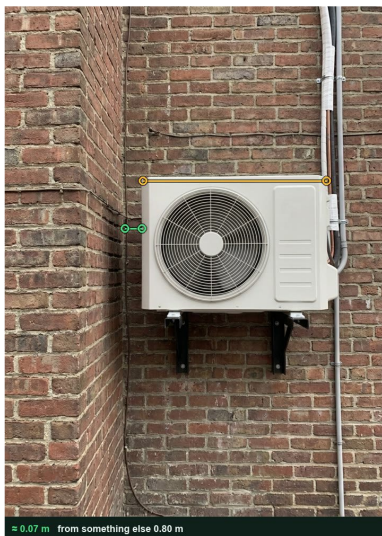
## Smallest clearance around the outdoor unit (m): measuring photo

| Smallest clearance around the outdoor unit (m) | 0.07 |

| Minimum clearance in the installation manual (m) | 0.10 |

| Clearance against the manual | Less than the manual asks for |

A result is outside the manual or the target. Record what was done about it before handover, or why the system is left as it is, in the photos and notes.
