# Automatic Door Service Record

| Project | Greenway Health Centre: six-monthly automatic door service (completed example) |
| Service date | 5 Oct 2026 |
| Company | Entrance Services SW |

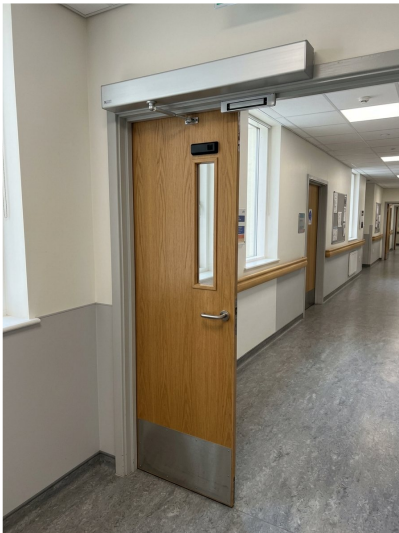
| Position in this area | Accessible WC corridor |
| Safety sensors stop or reverse the door on an obstruction | Defect |

| Result | Unsafe: taken out of service |
| Defects and recommendations | Safety sensor not detecting on the closing side. Door switched to manual; sensor on order. Closing force limits from the operator manufacturer's installation manual, section 6. |

| Who was told it is out of service, and when | P. Grant, practice manager, in person and by email at 09:15 on 5 Oct. |

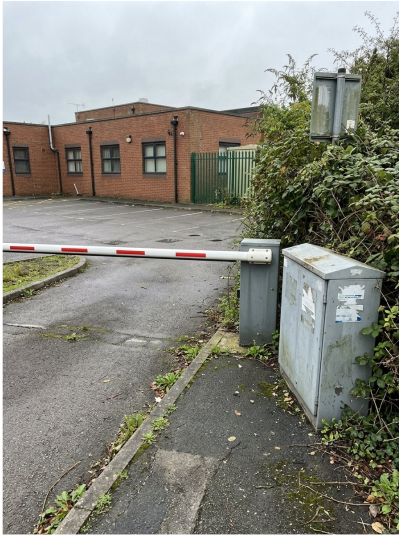
| Position in this area | Entrance barrier |
| Signs and markings | Defect |
| Result | Safe with recommendations |
| Defects and recommendations | Warning sign on the barrier post faded and partly hidden by the hedge. Replace the sign and cut back the hedge. |
