## SITE SURVEY REPORT

# AV Maintenance Visit

| Project | Ashford Lane Academy, Kettering: termly AV maintenance |
| Job or contract reference | AVM-2026-118 |

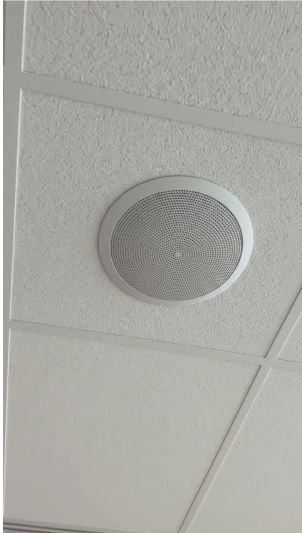
**Photos**

| Speakers | Defect |
| Describe the defect and what you did | Ceiling speaker 3, left side, crackles at assembly volume. Reseated the connection, still intermittent. Speaker to be replaced. |

**Priority** Soon: within a month

**Who will fix it?** J. Hughes

**By when?** 16 Oct 2026

| What needs doing next, and who will do it? | Replace hall ceiling speaker 3. J. Hughes to order and fit by 16 October 2026. |
