# Dilapidations Survey

| Project | First floor, Wharfside House, Leeds: schedule of dilapidations |
| Property address | First floor, Wharfside House, 14 Canal Wharf, Leeds LS11 5PX |

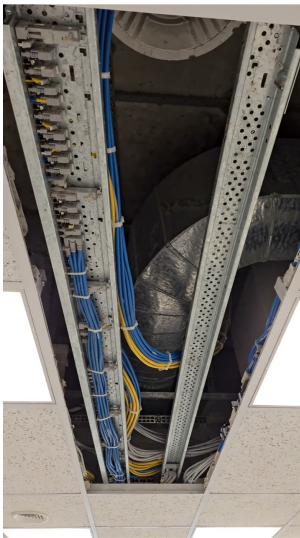
| What you can see | Tenant's data cabling and two lengths of cable tray left in the ceiling void, installed under the 2021 licence. Cabling now redundant. |
| Schedule of condition page or photo compared | Page 5, photo 13: ceiling void clear, landlord's services only |
| Measured extent of the defect | About 40 m of tray and cabling over Office 1 |

**Remedial works required** Strip out the tenant's tray and data cabling back to the riser, make good the ceiling tiles disturbed

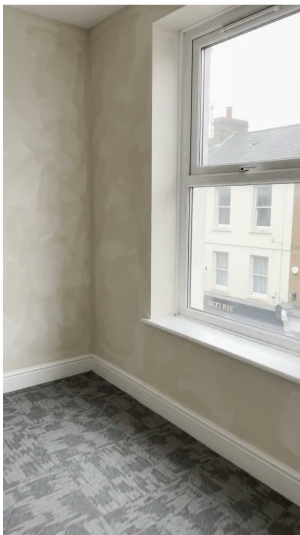
**What you can see** Double glazed windows open and close, seals sound, sills clean.

**Schedule of condition page or photo compared** Page 5, photo 12: windows in good order

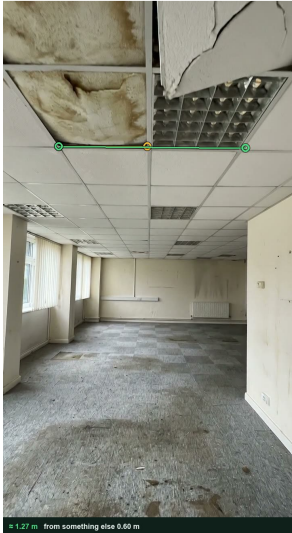
| What you can see | Water stained tiles by the window bay, one tile broken and hanging from the grid over the light fitting. Further staining to the next run of tiles. |

| Schedule of condition page or photo compared | Page 6, photo 16: ceiling tiles clean and complete |

| Measured extent of the defect | 14 tiles stained or broken |

| Remedial works required | Replace stained and broken 600 x 600 tiles to match. Lift tiles first to confirm the source of the water; withdraw the item if it is the landlord's riser. |

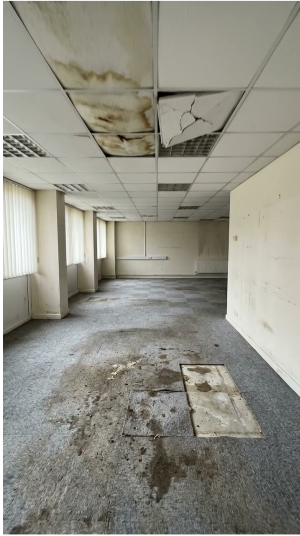
| What you can see | Carpet tiles heavily stained through the middle of the room, two tiles missing and one lifted near the window bay. |
| Schedule of condition page or photo compared | Page 6, photos 14 and 15: new carpet tiles, no staining |
| Measured extent of the defect | 85 m <sup>2</sup> of the 120 m <sup>2</sup> floor |

| Remedial works required | Lift and dispose of carpet tiles in the affected area, supply and lay new tiles to match |

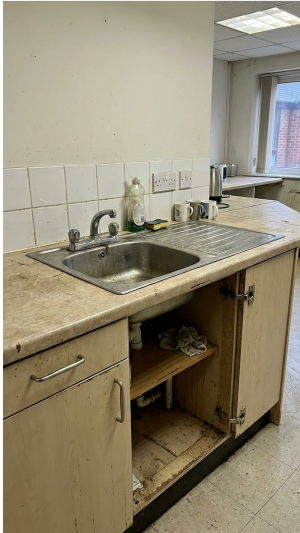
| What you can see | Worktop worn through at the front edge, sink base unit swollen and chipped, two cupboard doors missing, base of the sink unit water damaged. |
| Schedule of condition page or photo compared | Page 7, photos 19 and 20: kitchenette fitted new in 2021 |
| Measured extent of the defect | 3.2 m run of units |

| Remedial works required | Replace worktop and sink base unit, supply and fit two cupboard doors to match, reconnect the sink |

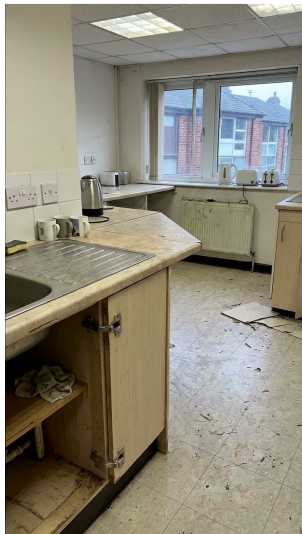
| What you can see | Vinyl floor stained and scored, a lifted section by the door, debris left on the floor. |
| Schedule of condition page or photo compared | Page 7, photo 21: new safety vinyl |
| Measured extent of the defect | Whole kitchenette floor, 9 m <sup>2</sup> |

| Remedial works required | Uplift vinyl, level the subfloor and lay new safety vinyl with welded seams and coved edge |

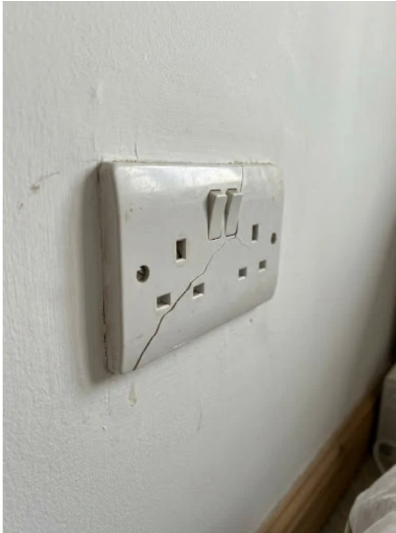
| What you can see | Double socket by the worktop with a cracked faceplate. Not tested. |
| Schedule of condition page or photo compared | Page 7, photo 20: sockets complete |

| Remedial works required | Replace faceplate by a qualified electrician and test the circuit |

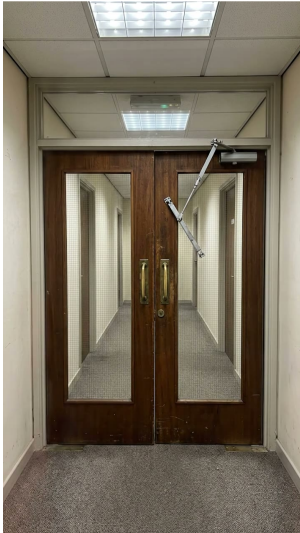
What you can see Corridor double doors: closer arm loose on the right hand leaf, leaf does not close onto its stop.

Schedule of condition page or photo compared Page 4, photo 8: closer working, door closing fully

Remedial works required Refix closer arm and adjust so the leaf closes onto its stop

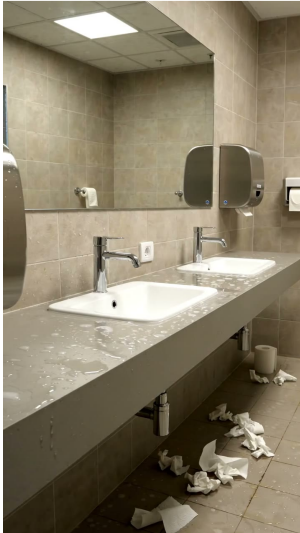
| What you can see | WC vanity unit and basins sound, but litter left on the floor, standing water on the counter and dispensers left dirty. |
| Schedule of condition page or photo compared | Page 8, photo 23: WCs clean and complete |

| Remedial works required | Clear rubbish and deep clean both WCs, including dispensers and sanitaryware |
