# Final Walkthrough Checklist (New Home)

| Date | 20 Oct 2026 |
| Site | 2318 Larkspur Glen Drive, Raleigh |

| Project | 2318 Larkspur Glen Drive, Raleigh: final walkthrough (completed example) |

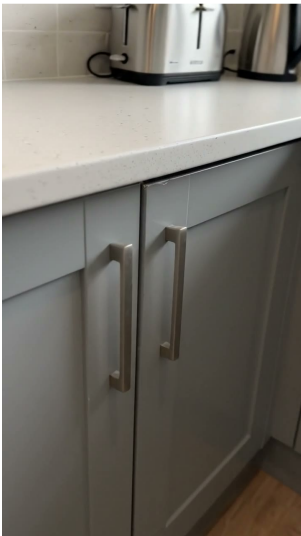
| Tape number or item | Tape 1 |

| Exactly where | Base cabinet doors left of the range |
| What is wrong | Pair of doors out of line, right door sits low and proud of the left. |

| Action | Adjust the hinges on the base cabinet doors left of the range (tape 1). |

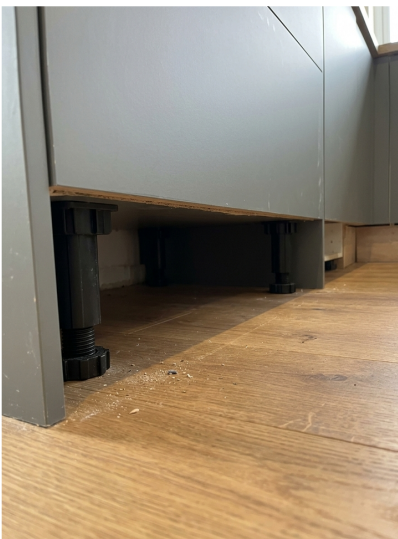
Tape number or item Tape 2

Exactly where Toe kick under the sink base

What is wrong Toe kick panel missing, cabinet legs showing.

| Date fixed | 21 Oct 2026 |

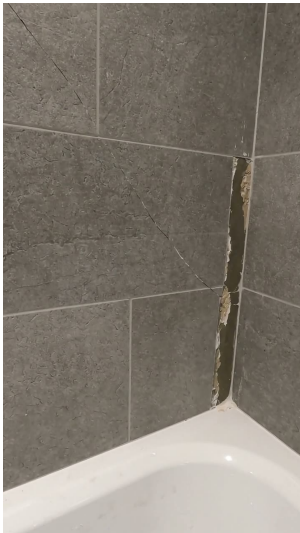
| Tape number or item | Tape 3 |

| Exactly where | Tub surround, back right inside corner |
| What is wrong | Corner joint above the tub open and unfilled for most of its height. |

| Action | Fill and caulk the tub corner joint (tape 3). |

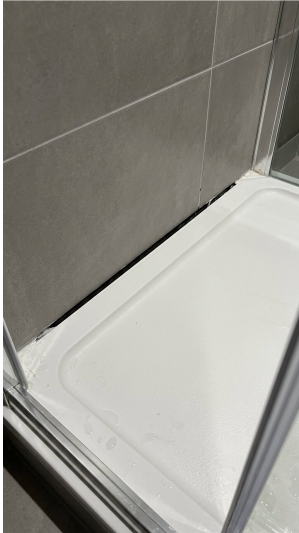
| Tape number or item | Tape 4 |

| Exactly where | Shower base, back edge |
| What is wrong | Caulk line along the back of the shower base has a gap. |

| Date fixed | 22 Oct 2026 |

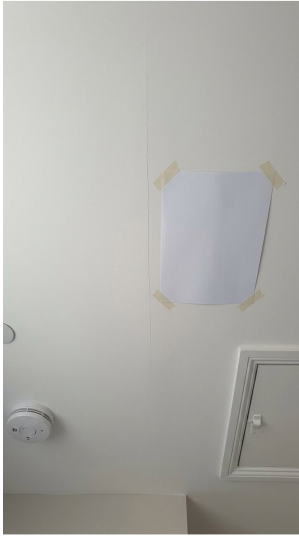
| Tape number or item | Tape 5 |

| Exactly where | Ceiling outside bedroom 2, by the attic hatch |
| What is wrong | Hairline crack along a drywall joint, about 3 ft long. |

| Action | Tape, mud and paint the hall ceiling crack and nail pops (tapes 5 and 6). |
