# Fire Stopping Installation Record

| Site | Riverside Apartments, level 3 |

| Project | Riverside Apartments, level 3: fire stopping to service risers (completed example) |

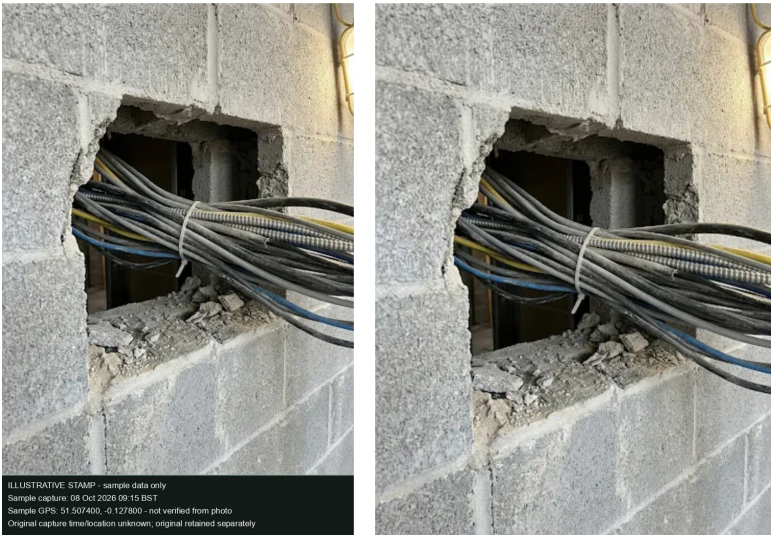
Before photo

| Label or reference number | L3-R1-001 |
| Position in this area | Riser R1, wall to corridor |
| Services through it | Cables |
| Opening width (mm) | 150 |
| Opening height (mm) | 100 |
| Product or system | Intumescent batt and mastic |

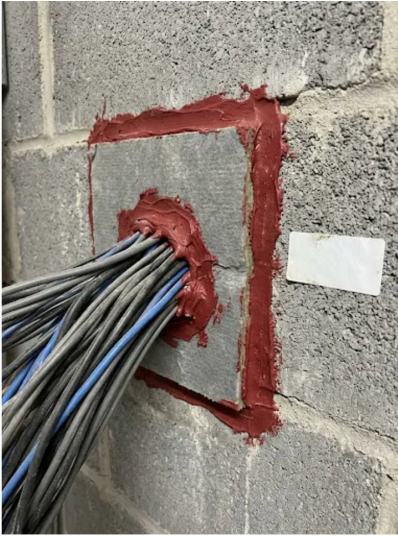
After photo (with label)

| Size against the tested detail | Within the tested detail |

| Result | Complete |

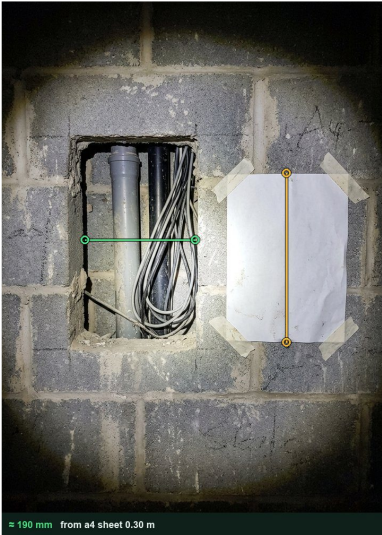
Opening width (mm): measuring photo

| Opening width (mm) | 190 |

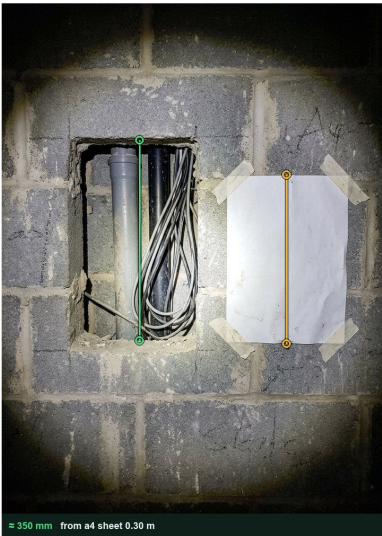
Opening height (mm): measuring photo

| Opening height (mm) | 350 |

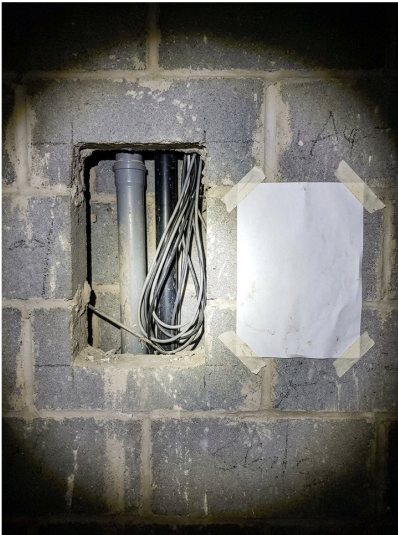
Before photo

| Label or reference number | L3-R2-002 |
| Position in this area | Riser R2, wall to lobby |
| Services through it | Plastic pipe, Cables |

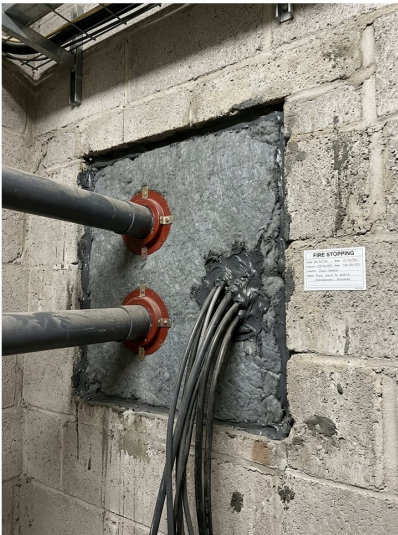
After photo (with label)

| Product or system | Ablative coated batt with intumescent pipe collars and mastic |

| Result | Complete |
