# Flooring Installation Inspection

| Project | Unit 4 Tannery Yard, Northampton: office floor finishes (completed example) |

| Room, floor and area reference | First floor open plan office and tea point, rooms 1.01 and 1.03 |

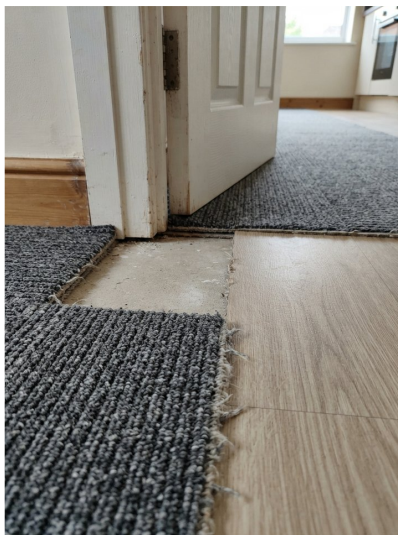
### Installation evidence

| Action, limitation or reason not applicable | Threshold strip missing between carpet and vinyl at the tea point door. Installer to fit before handover. |
| Action, limitation or reason not applicable | Adhesive smear on four carpet tiles near column C2. Clean or replace. |

| Defects, repairs and reinspection | Missing threshold strip and adhesive marks on tiles at C2. Reinspect on 2026-10-02. |

| Action and evidence reference | Fit threshold strip at tea point door |

| Action and evidence reference | Replace four marked carpet tiles at column C2 |
