# Generator Maintenance

| Project | Hillside Distribution Centre, Northampton: standby generator service (completed example) |
| Generator make and model | ExampleCo Power SP200, acoustic canopy |

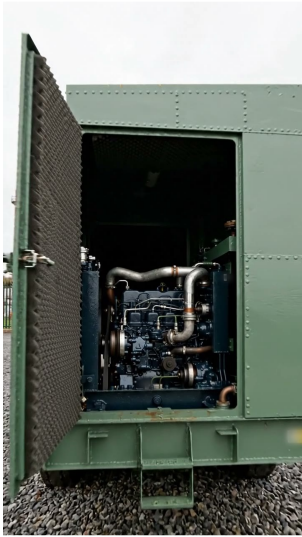
## Photos on arrival

| Oil, coolant or fuel leaks | Minor weep |

| What needs doing next, and who will do it? | Oil weep at the rocker cover gasket and a worn alternator belt. Both to be replaced at a short follow-up visit, parts on order. S. Doyle. |
