# Grease Trap Maintenance Log

| Project | Quayside Kitchen, Gloucester: grease trap service (completed example) |

| Trap or separator ID and location | GT-1, under-sink grease trap on the pot wash outlet, main kitchen |

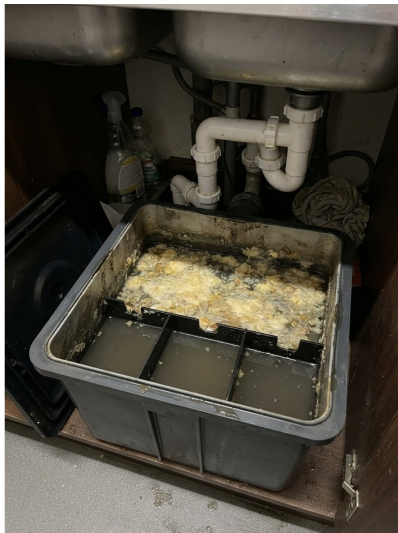
#### Before and after evidence

| Action, limitation or reason not applicable | Grease layer about 90 mm thick, roughly two thirds of the working depth. Solids settled at the inlet end. Fuller than expected for a four-week interval. |

| Material removed and estimated quantity/unit | About 35 litres of grease and food solids |

| Cleaning and reinstatement performed | Grease and solids pumped out into sealed drums, baffles and walls scraped, trap refilled with cold water. Lid refitted with the old gasket and sealed with tape until the new gasket arrives. |

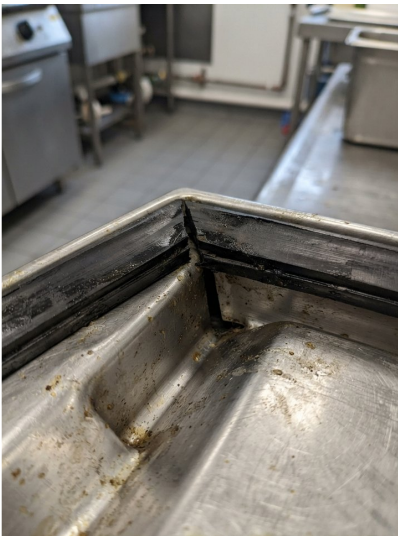
Condition and defect evidence

| Action, limitation or reason not applicable | Lid gasket split at one corner, slight smell in the pot wash area. Baffles sound and in place. |

| Further action 1: Fit new lid gasket to GT-1. Order QK-PO-0461. | |
| Completion evidence | Gasket fitted 2026-10-04, lid sealed, no smell. Note added to the kitchen log. |
